Lyddington Manor History Society Historic Building Survey

1 The Green, Caldecott, Rutland

HISTORIC BUILDING SURVEY REPORT

1 THE GREEN, CALDECOTT

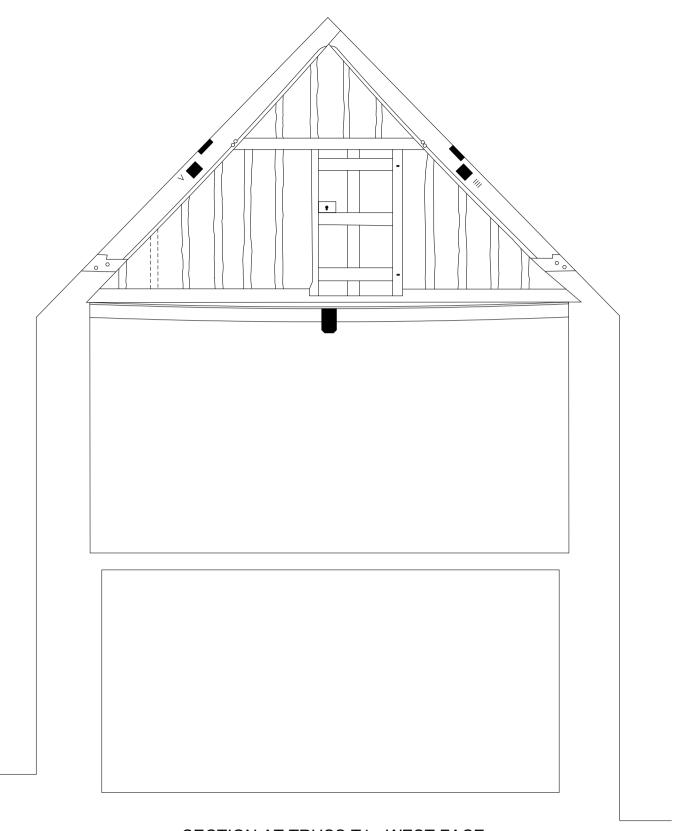
SECTION AT TRUSS T1 - WEST FACE

The attic is divided into three small rooms by two trusses with studding. The trusses have principal rafters, a tenoned collar (with two close-set pegs), a bridled apex and tenoned purlins. Both trusses have a very unusual feature: the lower tie-beam, which is quite thin, is located <u>above</u> the attic floor boards and has <u>no</u> joints to the principal

rafters (probing showed there are no tenons). The attic floor structure is carried by the W-E spine beams of the 1st floor ceiling, quite independently of the roof structure. The tie-beams are fixed with iron straps, formed of pieces from iron cart tyres. In the absence of any other jointing, the iron straps must be original to the roof structure. There are similar straps to the principal/collar joints, though these are also tenoned and pegged. Studs are thin and irregular, some probably of ash poles. They are stub tenoned at the foot and nailed at the head; reed is fixed with nailed lath to one face and lime-plastered both sides. The purlins are tenoned and in-line, with an unusual and fully consistent series of carpenter's marks, to either end of the purlins: II, III, IIII, V, VI, VII; the marks I and VII were presumably on the W ends of the E purlins, but are no longer visible. No numbers were needed on the purlin ends bearing into the masonry gable walls. The rafters, probably original to the roof structure, are of softwood and run over the back of the purlins and are nailed to a ridge-board, which is supported by nailed battens at the truss apex. The W bay has two raking braces which rise from the purlins to the apex of the W gable wall.

Truss T1 to the W has a puzzling feature: there are empty joint matrices for a former cogged, lapped collar, with some skew pegs still in situ. This truss also has some cut-off trenched timbers, probably the remains of previous purlins. Truss T2 has no such matrices, though the trusses are otherwise identical in detailing, and the whole structure, with its numbered purlins, fully consistent. Tree-ring dating (see below) has shown that the principal rafters of truss T1 date from the 1680s, whereas the principals of truss T2 and the purlins date from 1810. So it seems that the roof was fully rebuilt in 1810, re-using only the principals of T1 from the original roof. The whole of the rest of the roof structure is consistent with the 1810 date.

A major programme of work was undertaken in 1810, when the roof structure was replaced, presumably to eliminate the obstructive collars. The new roof structure had to be tightly fitted into the available space, so an ingenious solution was devised. The earlier attic floor structure was left in situ, and new roof tie-beams of slender proportion were fitted, jointed with iron straps instead of carpentry joints. The attic was now divided into three rooms, though the central room seems to have been unlit. These rooms would have been used for servants or storage, the inner western room preserving an original, lockable door. The two 1st floor windows must have had their stone mullions removed at this time, with new heads, incorporating a keystone, probably set a little higher. The blank stone on the front elevation was probably also inserted, perhaps bearing a painted date and owners' initials. The east extension was probably also added as part of the 1810 works, providing a separate kitchen.

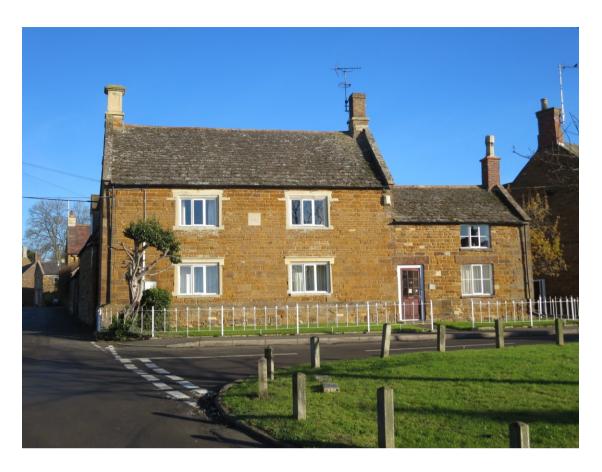
The south front

The main block S front has well-coursed, neatly cut ironstone walling, with good ironstone/brownstone quoins and chamfered plinth. The walling is of larger courses above the mid-height level of the 1st floor windows. The elevation has a symmetrical design, with two 3-light windows to ground floor, and two similar windows to the 1st floor, set directly above. Between the upper windows is a blank limestone plaque – no evidence of inscribed initials or dates, though it may originally have been painted.

All 4 windows may originally have had stone mullions, but these have been lost. The ground floor windows retain the original jambs, with the outer chamfer retained but the ovolo moulding cut back; the cill is square and of C18/19 date; the heads, with thin cornices, are modern. The 1st floor windows retain their ovolo-moulded heads, jambs and chamfered cills; the plain stone over the heads may be a cut-back cornice. The heads to both windows have a most unusual feature: the central section is formed as a voussoir with sloping sides, rather than the straight joint usually seen over the vertical mullions. It seems that the head has been re-worked when the mullions were removed. The original masonry here is all of finely-grained Ketton stone.

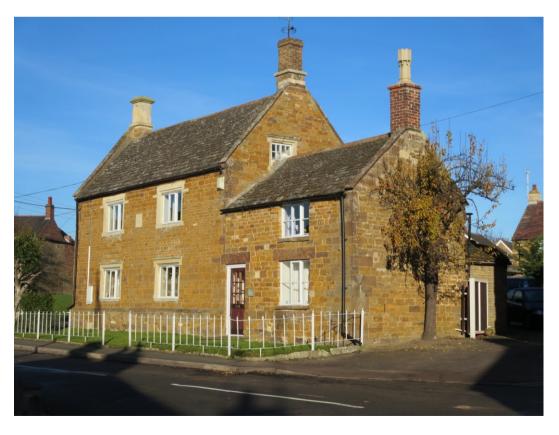
View from south-east

The E extension S front has well-coursed ironstone; front door set to the W, and 3-light ground floor window, both with deep, flat brownstone lintels. 3-light 1st floor window set directly above; both windows have square brownstone cills. E gable with coped parapet, plain kneelers, seating for a single-flue stack of brick; chamfered corner to NE to ease access into yard. The N side of this block is largely blocked by a modern extension.

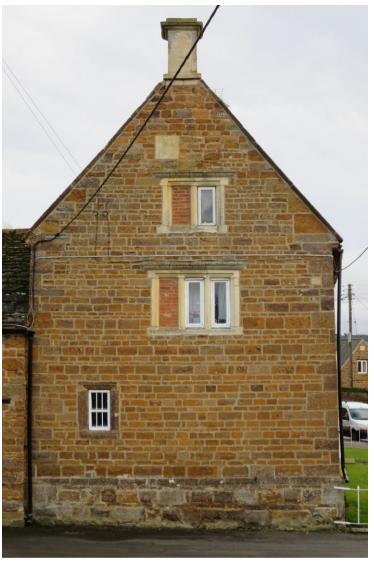
The west gable

The main block W gable has similar masonry to the S front, with well-coursed ironstone, good quoins to N and S, and chamfered plinth. The windows are arranged irregularly, probably to accommodate the fireplace flue. Single-light window, of ironstone not limestone, offset to ground floor. 3-light ovolo-moulded mullioned window of Ketton stone to 1st floor, with cyma-moulded cornice, the left light blocked with brick. Set directly above this is a similar 2-light window (though both windows are offset from the central axis of the gable). Cyma-moulded cornice and brick-blocked light to left. Both windows have the peculiar feature, as noted on other windows locally, that the ovolo moulding at the junction of the mullion and head is 'unshot', ie the corner of the head has been finished short of the mullion. Above, offset further left, is a plain, square date-stone of Ketton stone, with quite well-formed, incised lettering:

One might expect the date-stone to have been set centrally over the attic window, and there is indeed an area of disrupted masonry here, perhaps indicating its original position. Coped gable parapet of brownstone, with ogee half-pendant corbels. At the apex the gable has been re-worked, and there is no seating to the coping for the chimneystack. Single-flue stack of Ketton, with square-cut projecting plinth, slab shaft and ovolo/cyma moulded cornice, with square blocking course above.

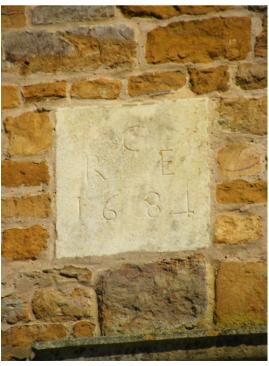
Date-stone to west gable:

CRE 1684

C R E 1684

The date-stone CRE 1684 indicates that a good quality building was constructed in 1684 for a man with the initials 'RC' (forename and surname), and a wife with initial 'E'. It seems likely that this is the Robert Colwell who was assessed in the 1712 Land Tax holding lands in Caldecott worth 12s per quarter. A search of the Rutland parish registers produces the following evidence. A Robert Colwell married Elizabeth Renolds at Lyddington in 1680. Robert Colwell, the son of Robert and Anne, was buried at Caldecott in 1726/7. Elizabeth Colwell, a widow, was buried at Caldecott in 1741. Also a Robert Colewell held a 1-hearth house in Lyddington at the 1665 Hearth Tax. No other relevant entries could be found.

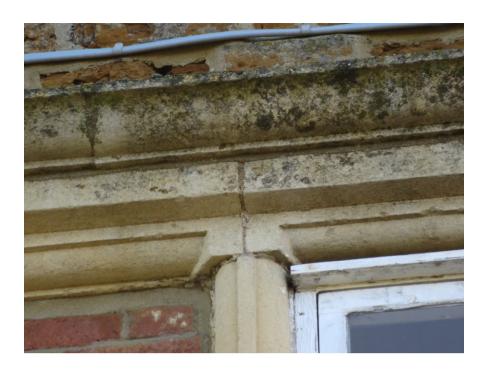
Ovolo-moulded window to west gable, with 'unshot' moulding joint $% \left(1\right) =\left(1\right) \left(1\right) \left($

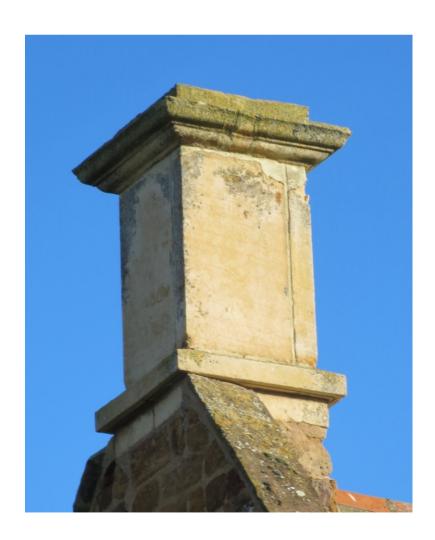
Chimneystack to west gable

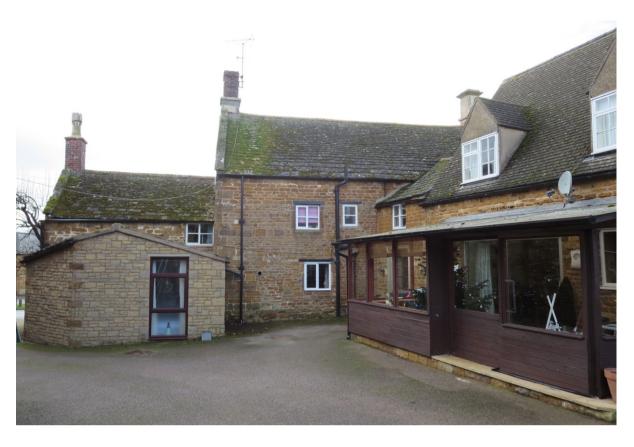
The rear north side, with former barn to right

The main block N side is blocked to the W by an added outbuilding. Much of the ironstone walling is of lesser quality than the front, though there are some large

blocks. The ground floor has a 2-light timber window which seems originally to have been a larger window, of which some chamfered cill stones survive; re-worked, with a partial straight joint to lower right, and a timber lintel, suggesting it may also once have been a door. Another re-worked window to 1st floor, with ovolo-moulded jambs and chamfered cill – probably a 2-light stone mullion originally, though the timber lintel has early-looking ogee chamfer stops. Small modern window to W, for inserted bathroom.

To the NW of the house is a long stone outbuilding. This was formerly a large barn, probably C18, a little under 20m in length and separated from the house by a short gap, later infilled. The upper part of the barn has been lost, except to the S end, which has been converted to domestic use; the original roof has gone. The barn had good ironstone walling, with quoins to its N and S ends; chamfered plinth to the W and square plinth to E walls. Large opposing barn doorways, wider to E than W. The W wall to the S has a blocked pedestrian doorway, now a window, with blocked vent slits to either side. At the N end of the barn is a small shed with hipped Collyweston roof, probably once a privy.

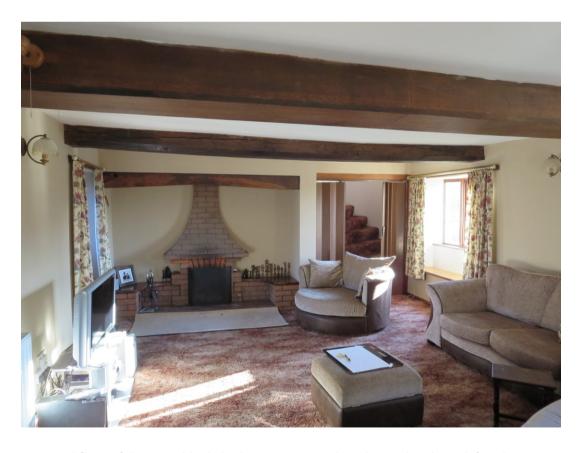
Ground floor of the main block, looking east towards re-located inglenook fireplace

The ground floor of the main block now forms a single space, as a cross-wall has been removed and replaced with a cased-in RSJ. The larger E room had an inglenook fireplace against the E gable, but this was dismantled and rebuilt a little further W in the late C20, re-using the slightly arched ingle beam. To the side of the ingle is a winder stair, with curved recess into both the S and E walls. It has an old newel and bearer timbers, but is probably of C18-19 date, not original. The transverse beams to the E and W parts have good chamfer stops: ogee with bar, and raised flat section with chamfered corners. The W gable has a shallow projecting chimneybreast, but the fireplace has been blocked up and is not visible. In the ceiling by the small window in the W gable is an old timber, perhaps a trimmer for a former 1st floor hearth.

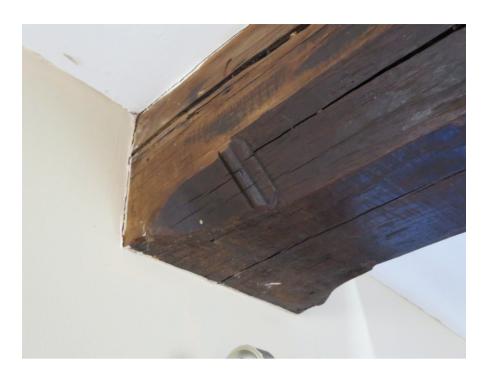
Ogee and bar chamfer stop to ground floor ceiling beam

Typical features for the 1684 date include: the mullioned windows with cymamoulded cornices; the use of Ketton stone; the ovolo/cyma moulded chimneystack; and the ogee & bar chamfer stops to the ground and first floor ceiling beams. The 2-room plan form makes the house quite compact, though there was some additional space in the attics. The barn which was added in the 18th century is of considerable size for a relatively compact house.

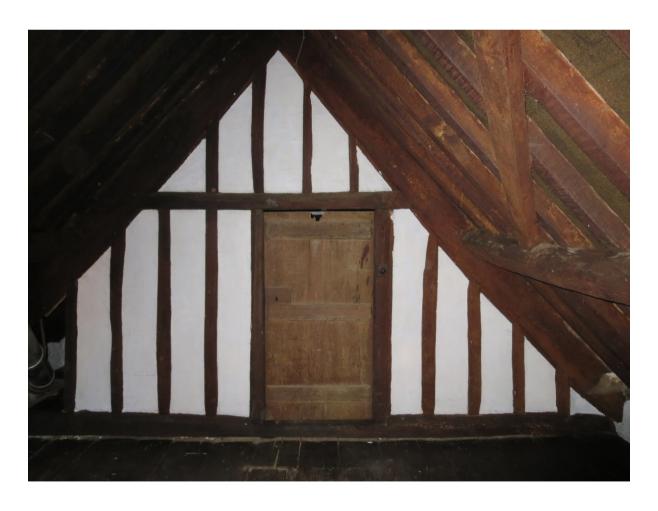
Truss T1, west face

Tree-ring dating of the roof structure was carried out in January 2014 by Robert Howard of Nottingham Tree-ring Dating Laboratory. Two samples were taken from the principal rafters of truss T1, which gave a felling date of c.1680-84. Six samples were taken from the purlins and both principal rafters of truss T2, all of which gave a precise felling date of 1810.

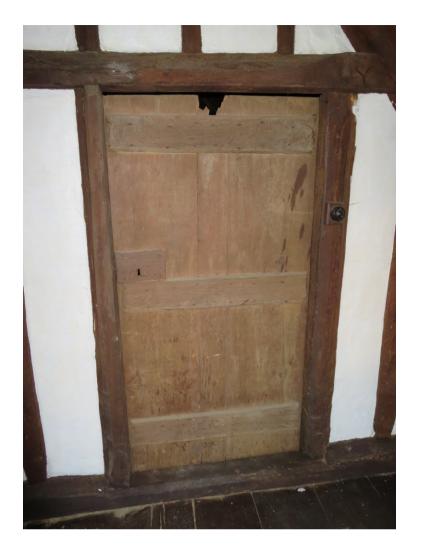
The door to truss T1

Truss T1 incorporates a doorframe and a door, probably of 1810. Pintles and nailed, shaped strap hinges. The door has chamfered ledges of oak, but the boards are of pine, bead-moulded, with a narrow central board, set recessed and only 8mm thick. Early oak lock block, nail-fixed. Truss T2 has a modern door, though evidence of the original pintle hinges remains on the door frame. The floor has wide, old oak boards. Most boards run W-E, to suit the N-S floor joists, but a few boards run N-S.

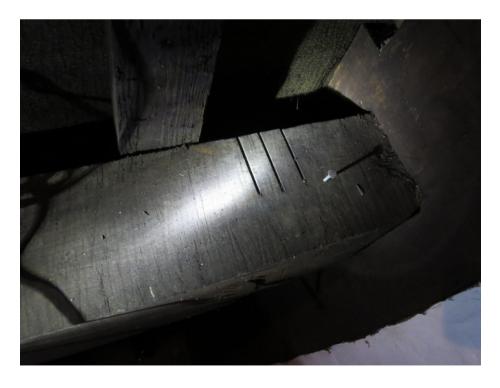
Carpenter's mark 'III' to central south purlin at joint to truss ${\sf T1}$

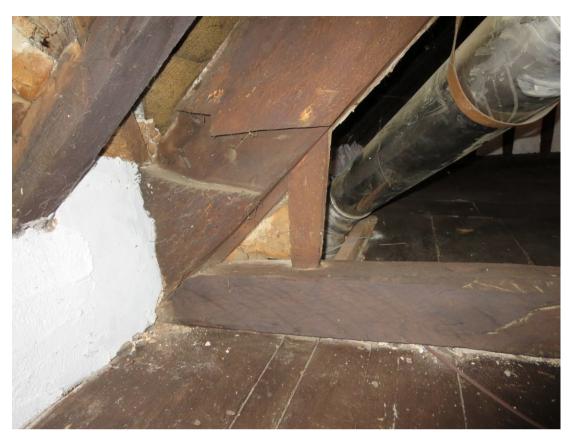
Truss T1 west face, with empty matrix of lap joint to re-used principal rafter

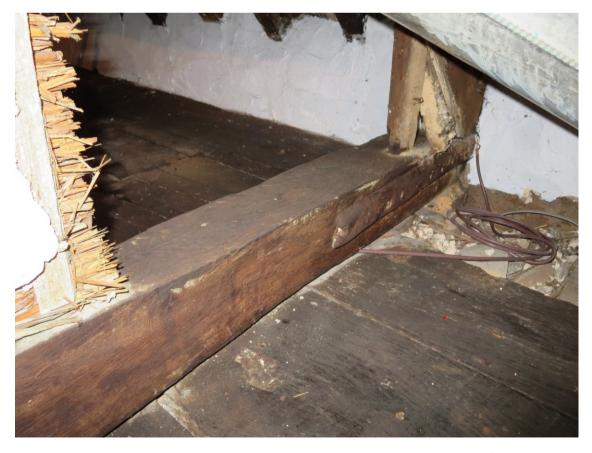
The opposite (east) face of truss T1, with original iron strap to principal/tie joint

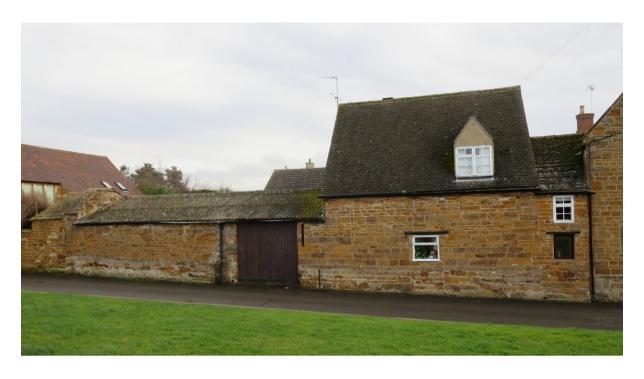
The former barn, from west side

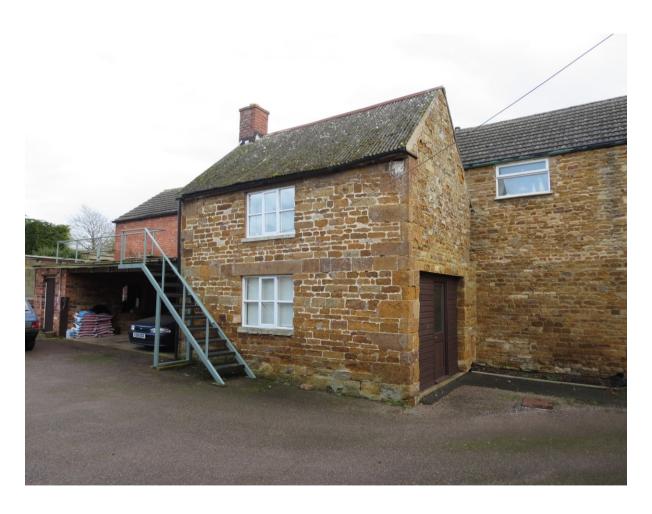
The outbuilding in the south-east part of the rear yard $% \left(x\right) =\left(x\right) +\left(x\right) +\left($

To the SE part of the rear yard is another stone outbuilding, of early C19 date. Two storeys, well-coursed ironstone, asbestos sheet roof. The W side has a deep ironstone/brownstone band course at 1st floor height, which is carried across a ground floor window. 1st floor window over, also with a brownstone lintel. The N gable has a 1st floor doorway (probably a loading hatch originally) and a single-flue stack of C19

brick. The S gable has a large modern inserted opening – the original doorway was presumably in this end wall. No features evident inside – the fireplace has been removed/blocked up. This building, well lit and probably with an original fireplace, was probably a brewhouse or similar. To the N, now within a modern-roofed area, is a stone-lined well.
