Lyddington Manor History Society Historic Building Survey

**45 Main St,
Caldecott, Rutland**

HISTORIC BUILDING SURVEY REPORT

45 MAIN STREET, CALDECOTT

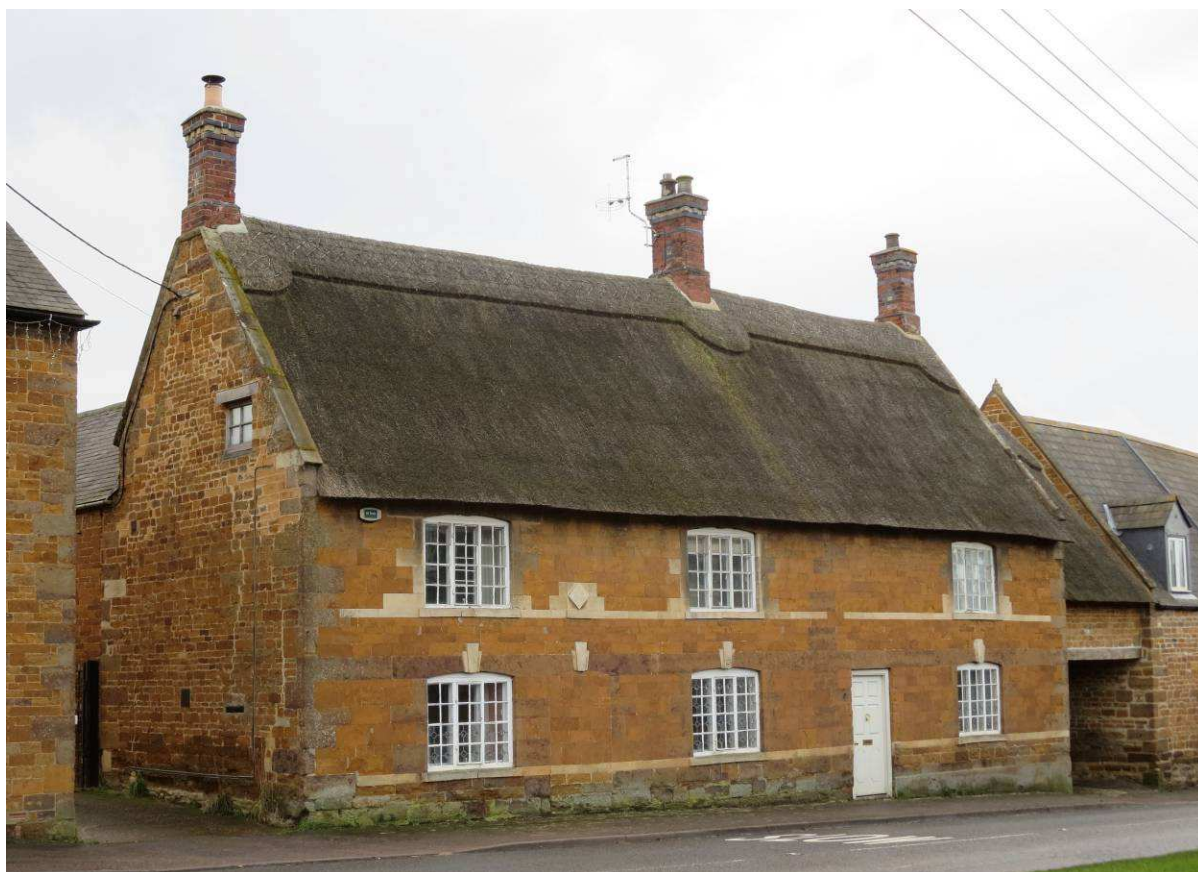
The north front

The main block is of 3-room plan form and two storeys, with rooms also in the attic. The N front is of finely jointed ironstone ashlar, with a limestone band course below the ground and 1st floor windows. The original doorway, now blocked, is offset to the E. Three ground floor windows, with three windows to 1st floor set directly above. The current front door is set towards the W, but is clearly a later insertion, with some

thin jambs and no proper lintel. Just E of this doorway, the front elevation has a slight kink, to follow the street line; a set of larger ashlar blocks are carefully cut to incorporate this change of angle. All the original openings have segmental-arched brownstone lintels and projecting limestone window cills. Triple limestone key-blocks to ground floor openings, and single ironstone key-blocks to 1st floor. Set over the original, blocked door is a date-stone:

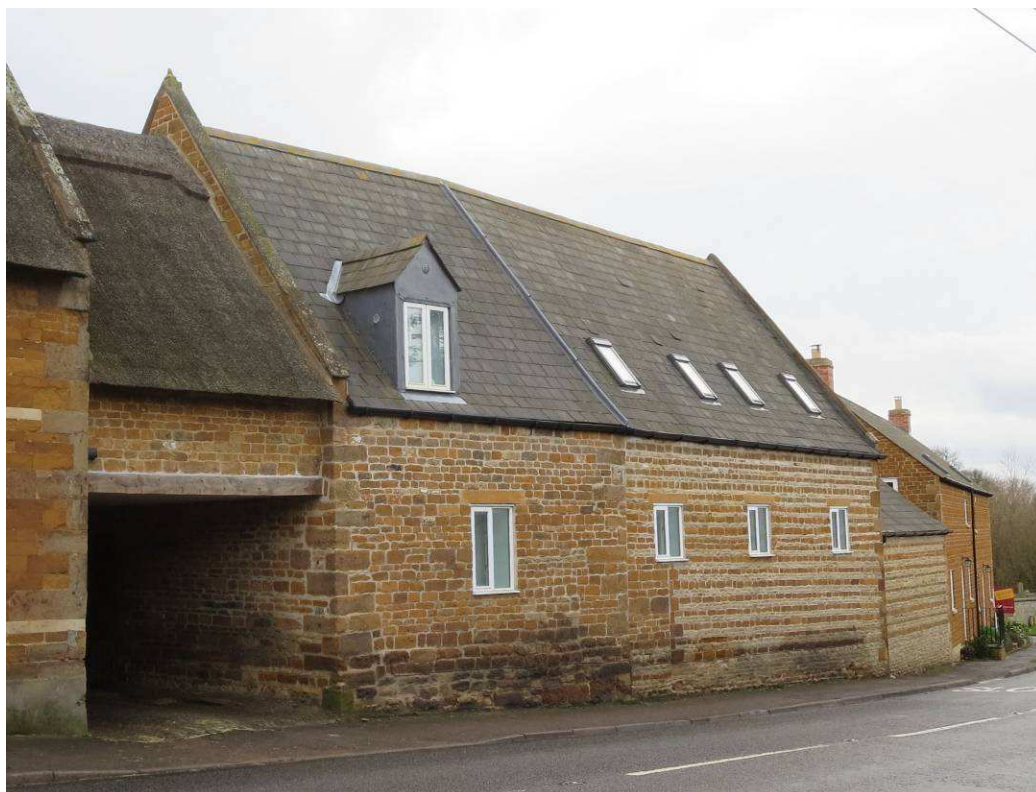
The adjoining covered access and attached buildings

The S gable is partly blocked by the covered entrance driveway, which has a low first floor and thatched roof over. The lower S gable is blank. The upper gable has a coped gable parapet and seating for a single-flue stack. Small attic windows, probably of late date, to N and S of the entranceway roof.

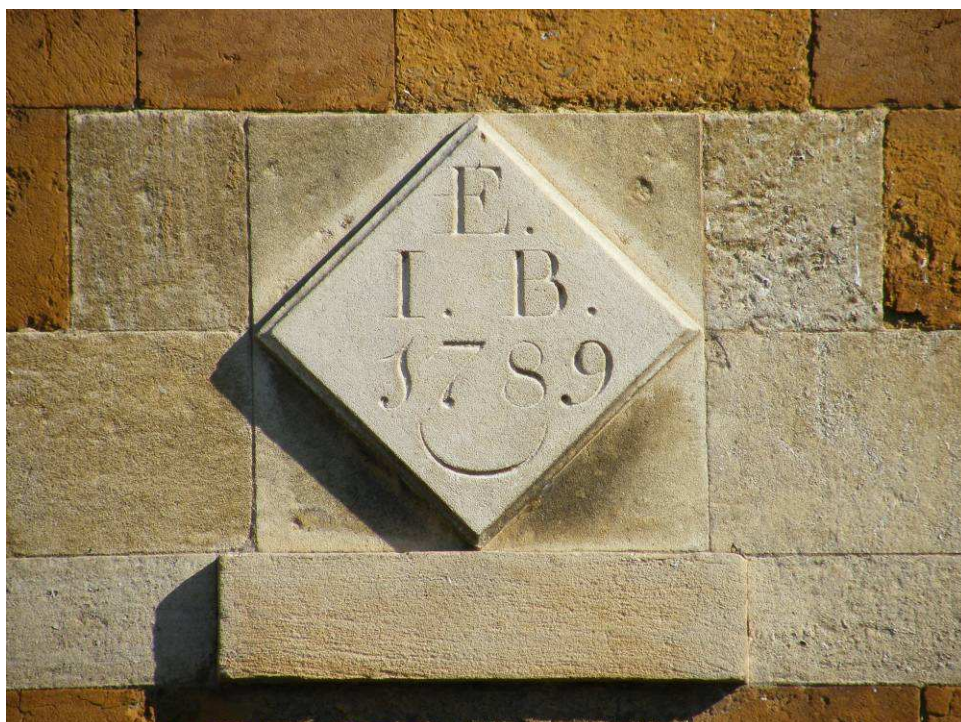
The date-stone

E
IB
1789

The date-stone is of limestone, with a raised diamond-set lozenge, and inscribed lettering of high quality.

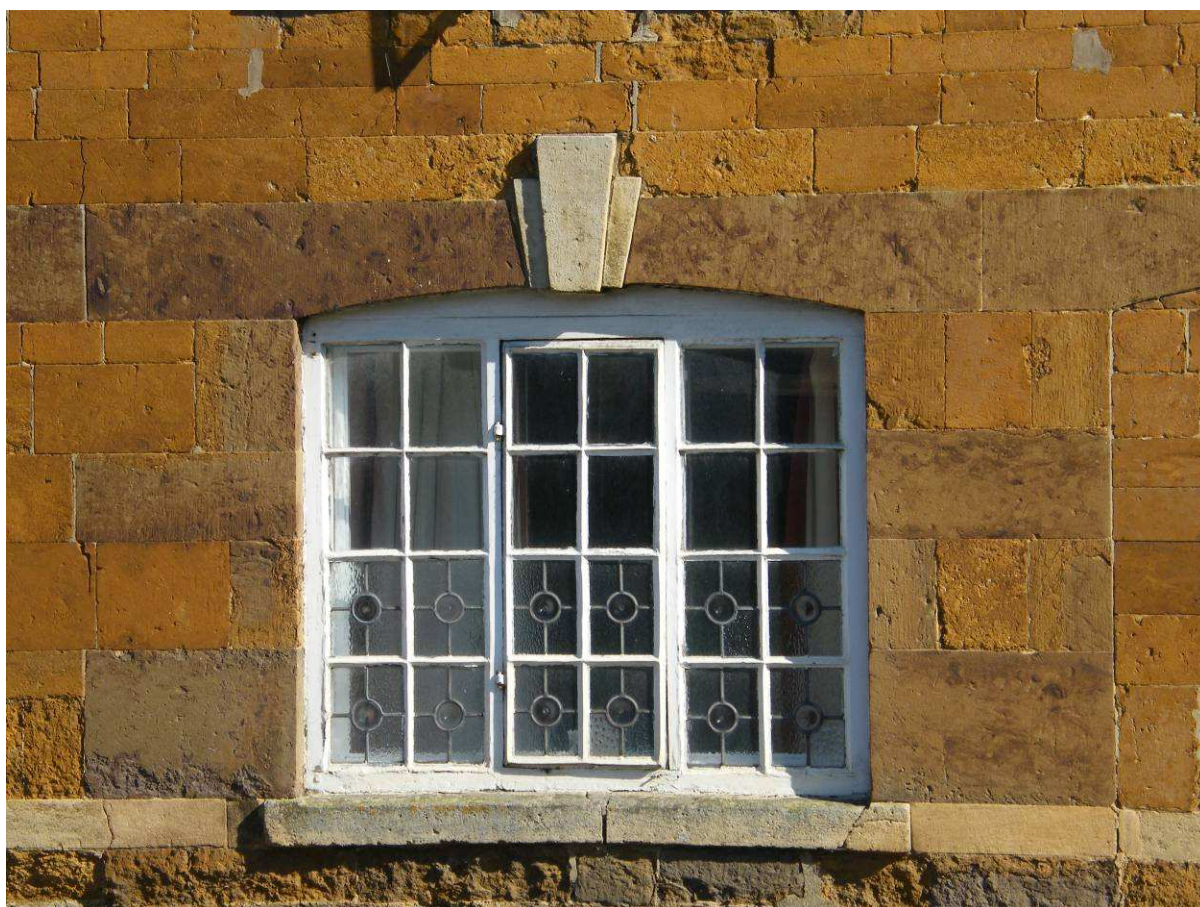
Typical ground floor window to north front

The windows are all 3-light casements, with timber frames and 8-pane iron casements, partly glazed with early 20th century leaded lights to the ground floor. The timber frames are bead-moulded inside, and the central, opening casements have some surviving pintle hinges and semicircular opening stays. Internally, the iron windows have blacksmith-forged overlap joints to the glazing bars, with iron fasteners and bottom handle. These windows are an unusual and good quality survival, probably dating from the earlier 19th century, though it is possible they are of the 1789 date.

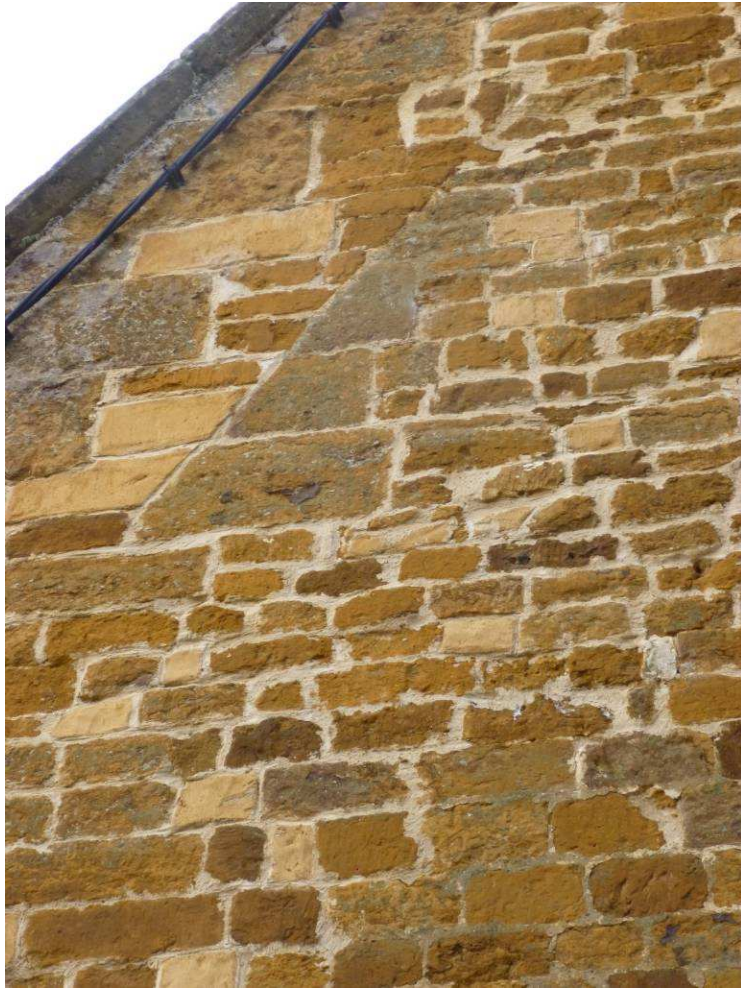
Line of previous gable visible to east end

The E gable is of coursed ironstone and blank, except for an attic window, perhaps a modern insertion. Good quoins, coped gable parapet, plain kneelers and seating for a single-flue stack. A raking line of a former gable end is visible, at a considerably lower level. It can also be seen that the masonry of the N front has an irregular joint to the earlier stonework of the gable – the front elevation is clearly a re-facing of 1789.

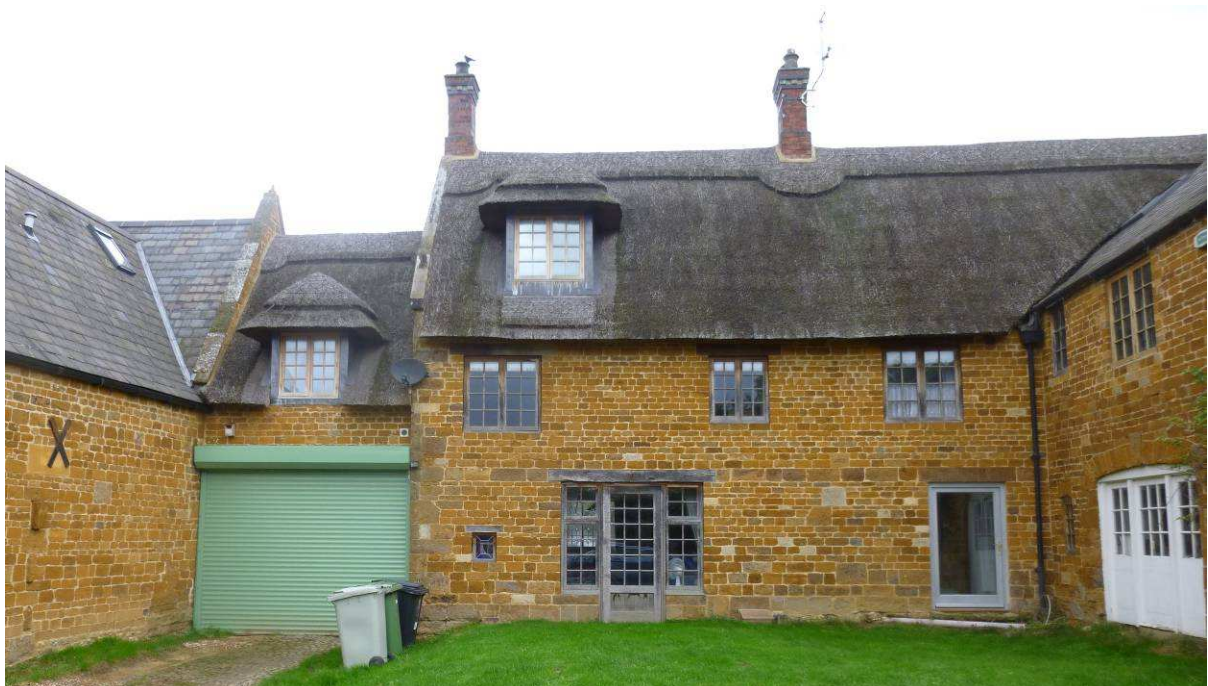
The main house from the south

The S side is partly blocked by the rear E range. Coursed ironstone, with some re-facing. All windows are modern.

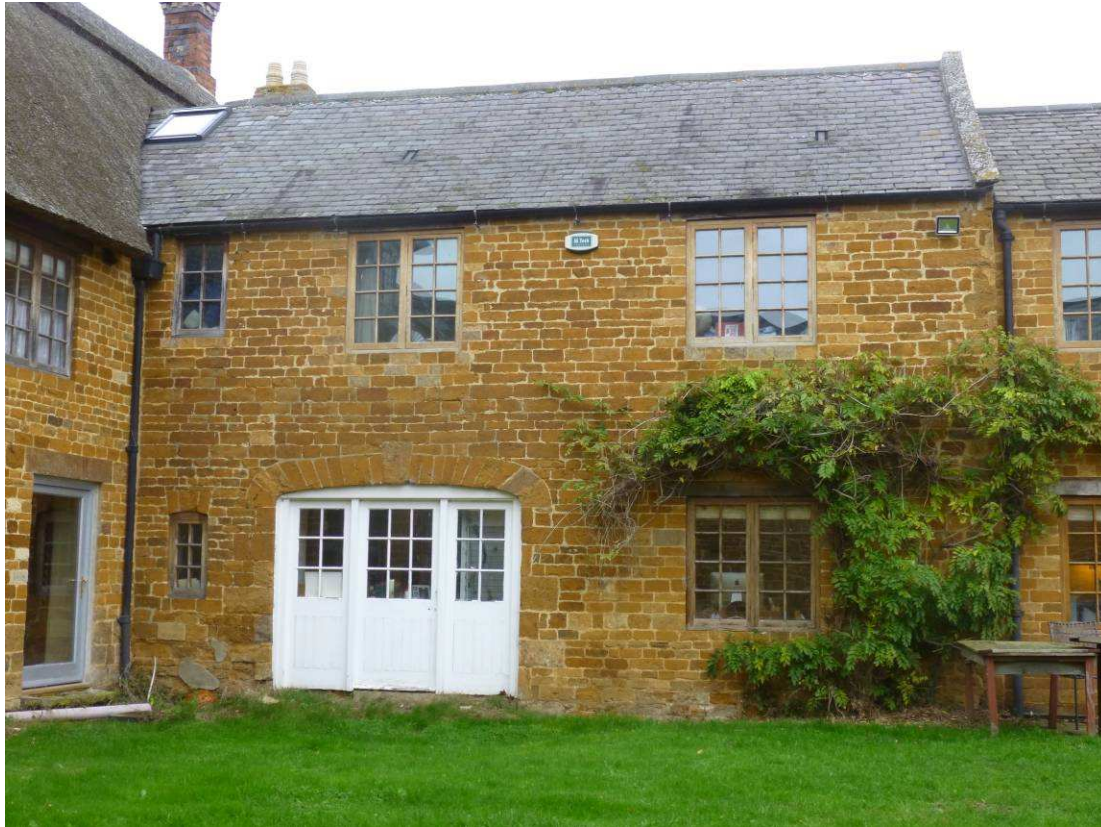
The rear east block with cart shed archway

The rear E range is of two storeys, with a slate roof at around 40° pitch. The early building extends for c.4m S of the house, with modern extensions beyond. The W front has well-coursed ironstone, with a finely built wide doorway opening, with segmental arch and central keystone. Just N of the doorway is a small window opening, with arched head of ironstone voussoirs. The window opening to the S and the 3 window openings to 1st floor may be original, or of later date. All the timber joinery is of recent date. The S gable is largely blocked by the modern extension, but there is a coped gable parapet, with plain kneelers and apex stone. Prior to the modern extension, there was a large 1st floor opening in the gable. The rear E side is blank, except for one 1st floor window near the N end, probably of late date. The ironstone

walling to c.1.5m is older, with later, more regular stonework above. At the S end, the older walling continues further S, and was clearly the boundary wall. Above this, the SE corner has good quoins. Near the S end there is a lateral 2-flue chimneystack, of limestone/ironstone, with a top shaft of limestone ashlar slabs. The wide doorway indicates the E range was originally a cart/carriage shed or similar, with a storage loft on the 1st floor.

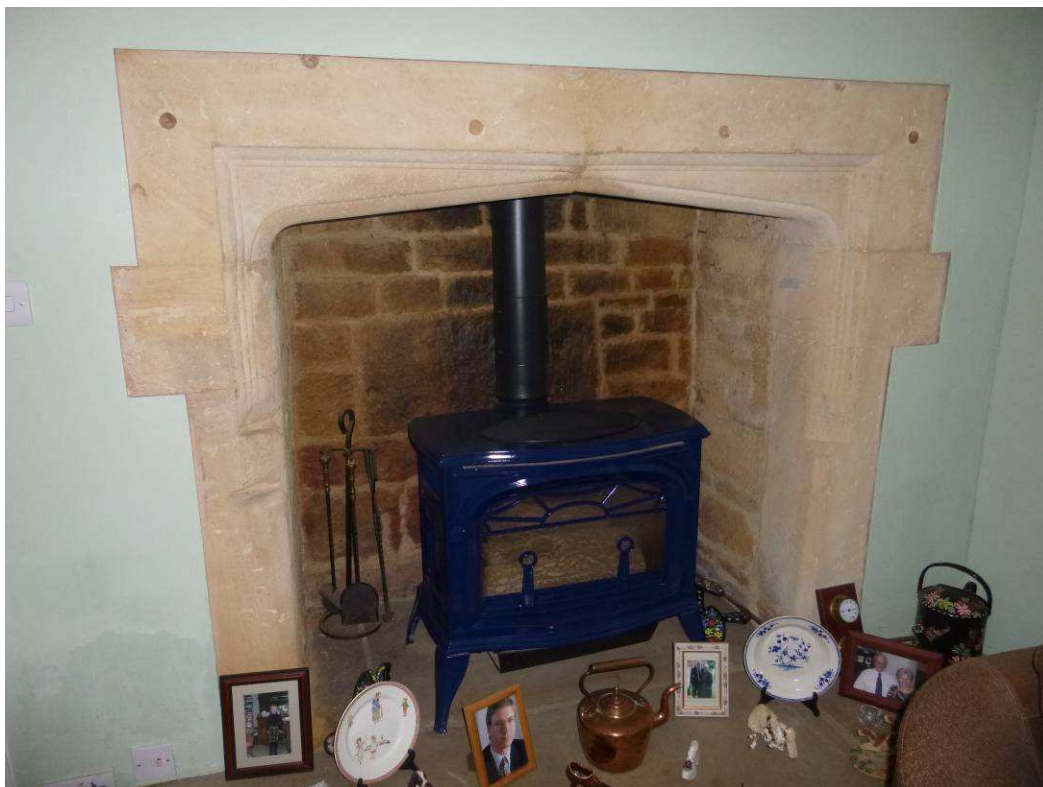
17th century stone fireplace to west room (parlour)

The W room is larger than the other rooms. Fine 17th century fireplace, limestone with 4-centred moulded arch, high-set stops to jambs. Set flush, with no evidence of cornice, but the fireplace had been covered, with fixing holes for a surround/mantelshelf. Semicircular recessed cupboard to N. Cased spine beam, with the cut-off stub of an earlier beam remaining in the W wall, with chamfers.

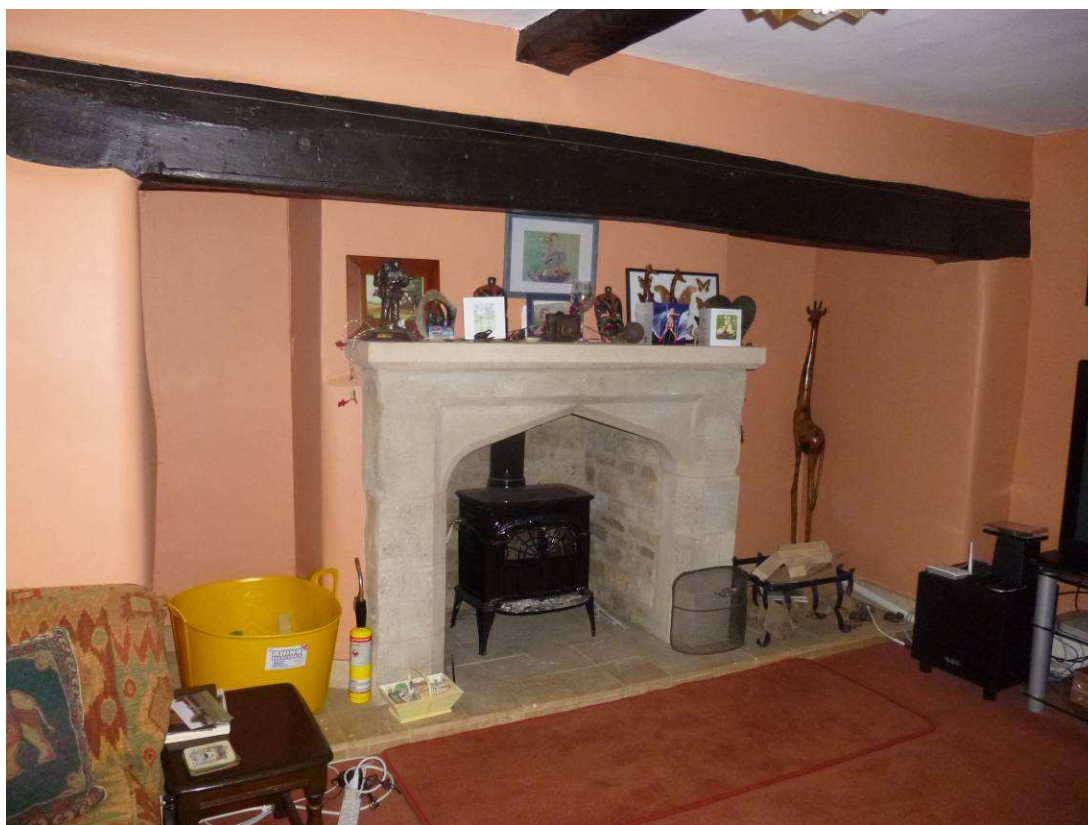
Inglennook fireplace to east room

The E room has a large inglenook fireplace: ovolo-moulded beam with ogee stops to both ends; the large block of masonry to N probably contained a bake oven. Within the fireplace, uncovered in recent years, is a limestone fireplace with chamfered jambs and 4-centred arch – probably of C19 date. Chamfered spine beam with step stops to E, but cut off with a run-out stop towards the W, where it is supported crudely on an inserted beam. It is clear that the original spine beam was supported on a partition, which formed the E side of a cross-passage from the blocked front doorway. The original spine beam would have extended further W, but was truncated when the cross-passage partition was removed, and supported on a new, inserted beam. At the S end of the former cross-passage a doorway leads into the E range, with an old lintel of chamfered ironstone – of C17 or C18 date.

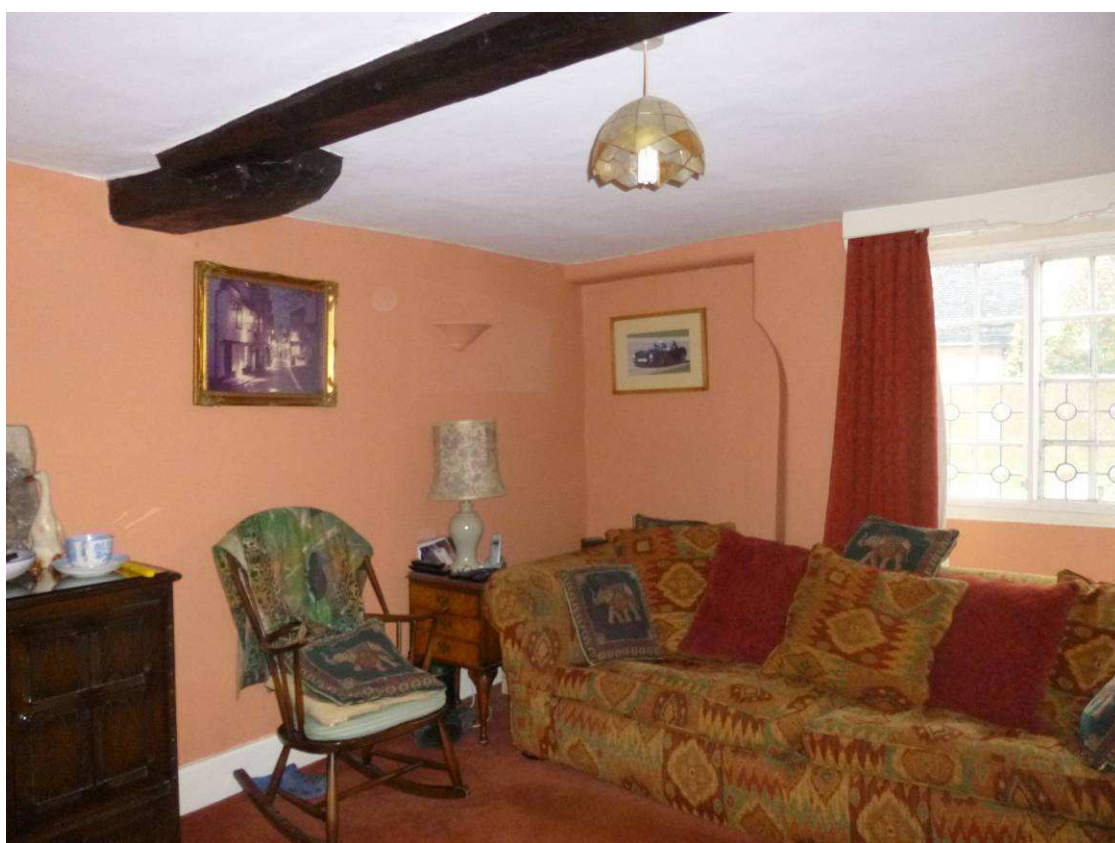
The east room, looking north-west towards former front door and cross-passage

Around the mid-19th century, there was some further upgrading. The cross-passage partition was removed, the doorway blocked up, and a new front door inserted further west. The central room was made into an elegant entrance hall, with a plastered, segmental arched opening from the front doorway and a fashionable staircase. The room still served however as a living space, and received a new fireplace, with good quality timber surround. The parlour was upgraded, with a semicircular recessed cupboard, and probably a new fireplace front over the old 17th century stone surround. A fireplace was added to the west bedroom, with a new brick chimneystack to the gable – probably the first time that any of the bedrooms had independent heating.

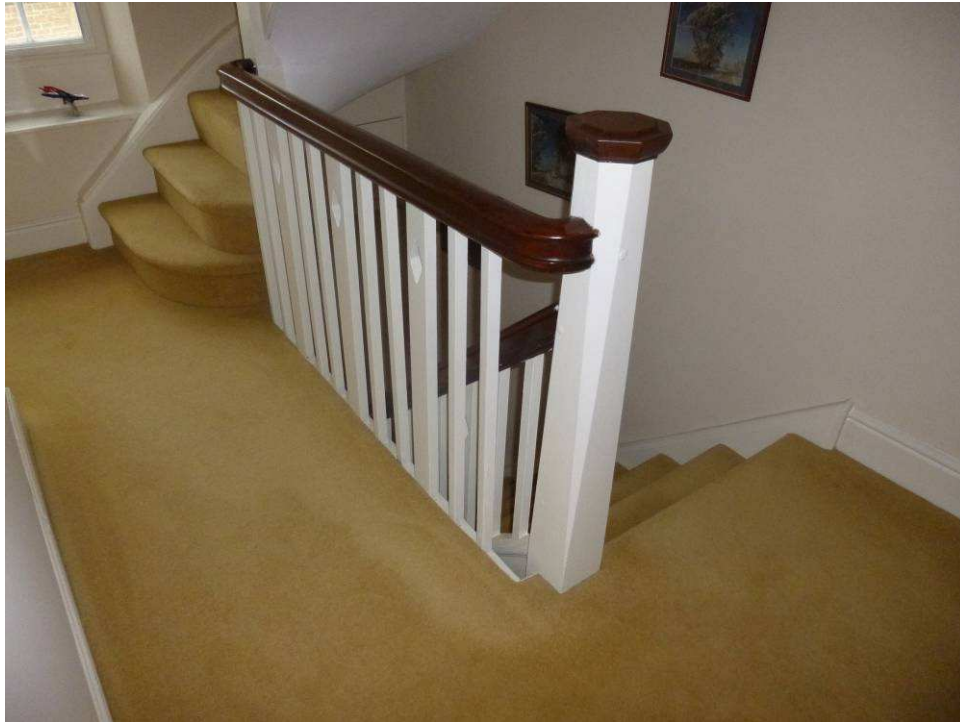
The early 19th century stair

The central room has an elegant segmental archway to the front door lobby. Fireplace set on projecting chimneybreast, moulded timber surround with roundels, ornate cast iron fireplace. Elegant staircase with newel tapering to a mahogany octagonal cap, mahogany handrail, stick balusters with spaced wider splat balusters, which have a diamond cut-out near the top. The mahogany handrail and baluster detail continues around the 1st floor landing, but becomes plainer for the attic stair, with the upper rail modern.

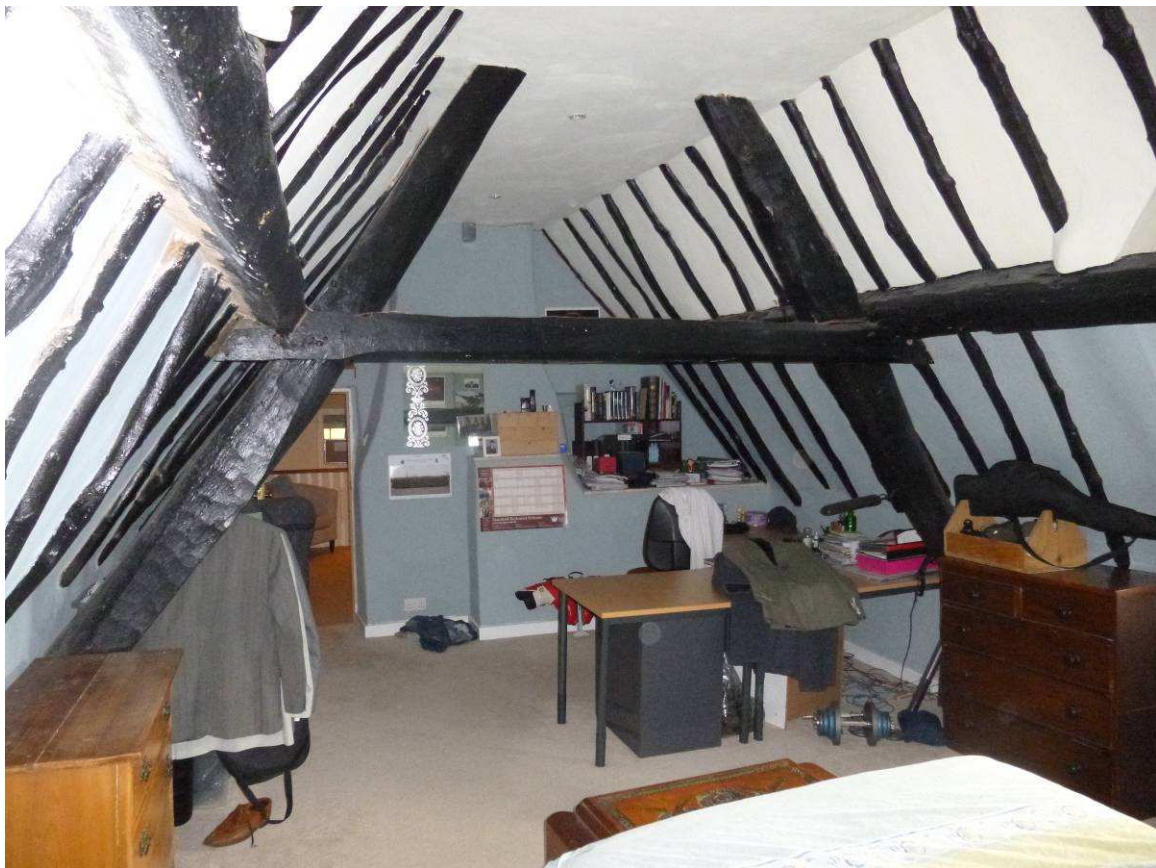
Truss T1, west side

The roof structure is largely open to the attic floor. There is a single truss to the W, with the central and E bays spanned by purlins, bearing onto masonry. The truss has roughly shaped principals and a chamfered collar, with a shallow lapped dovetail joint, fixed with two big skew pegs. The collar passes beyond the principals to support the purlins, which bear into a large notch. The collar is evidently re-used from an earlier roof, as each end has an additional large skewed peg hole, beyond the principal rafters. There are no clear signs of re-use on the principal rafters. The apex is ceiled off and not visible, but is likely to be of scissor form, with a ridge. The purlins are roughly shaped, with splayed scarf joints. The rafters are mainly of ash pole type. One of the cased ceiling beams to the first floor is aligned with the truss, but it is unclear whether it is jointed to the feet of the principal rafters, or whether the truss is of simple A-frame form. The purlins to the central and E bay are large and roughly shaped, though rafters are not visible here. At the E gable there are cut-off projecting timbers beside the purlins, perhaps the ends of earlier, smaller purlins. Both the central and east stacks have big, stepped chimneybreasts. The roof structure of the E range is not visible, except for a short, cased section of A-frame roof truss.

Eleven samples were taken from the barn roof structure. The barn roof gave a precise felling date of 1789 – which, of course, coincides exactly with the house date-stone. The two purlins from the house also had a similar date. The principal rafters of truss T1 dated to 1626-51, and the collar failed to date.

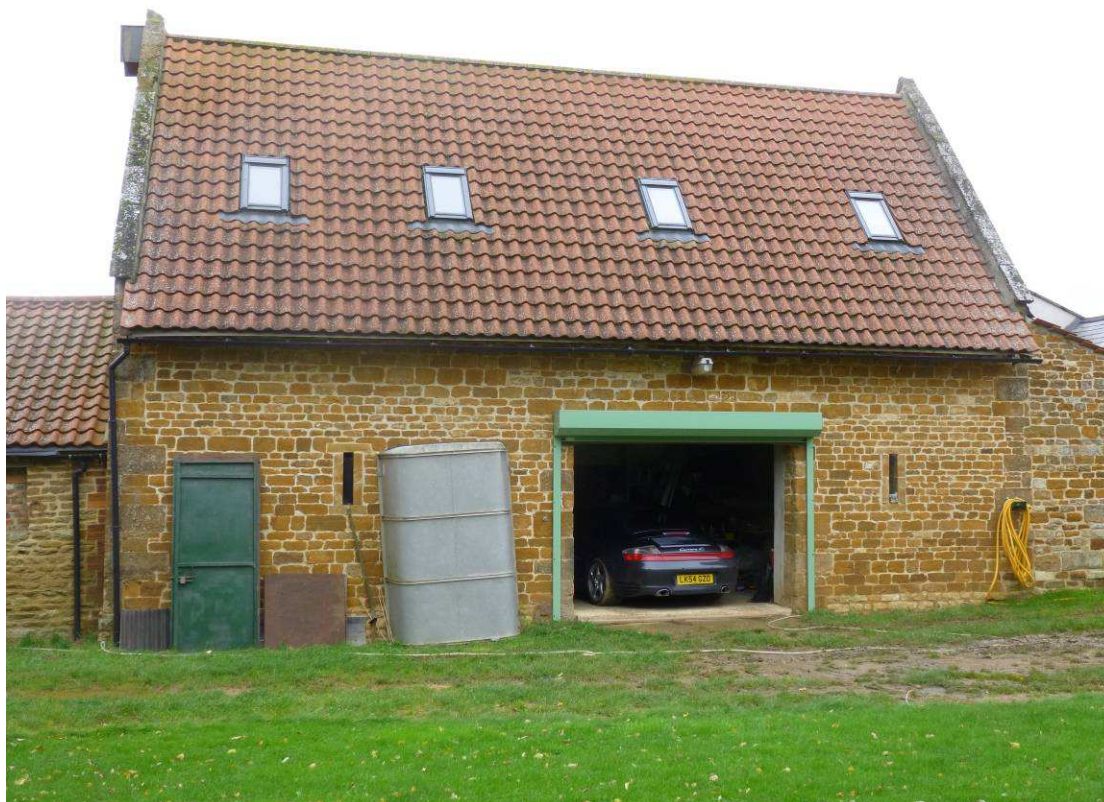
The barn to south-west, east front

A well-preserved barn is located to SW of the house, of 18th century date. Well-coursed ironstone, dressings often of brownstone. The E side has a large barn door opening, offset to the N, which rises to around 1m below the roof line. Vent slit (with renewed masonry) to either side of the doorway. The W side had a full-height doorway, recently blocked up. Here, there is a vent slit to the larger S end of the barn, but none to the N. The gables have good quality quoins, plain kneelers and coped parapets, with a small square owl hole at the top. The roof has been renewed recently in modern pantiles.

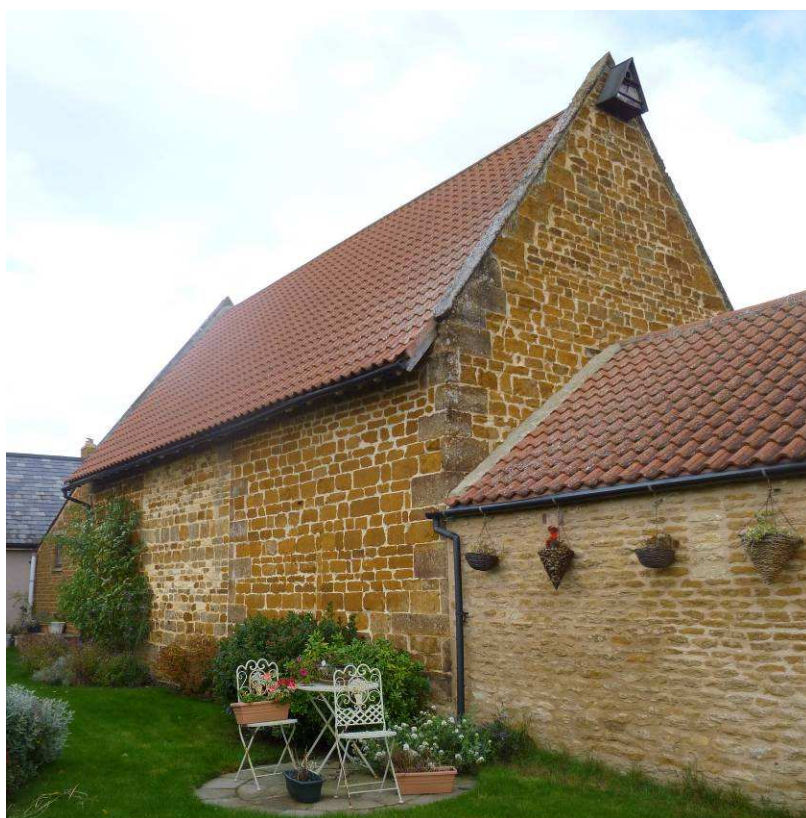
The barn, from the south-west.

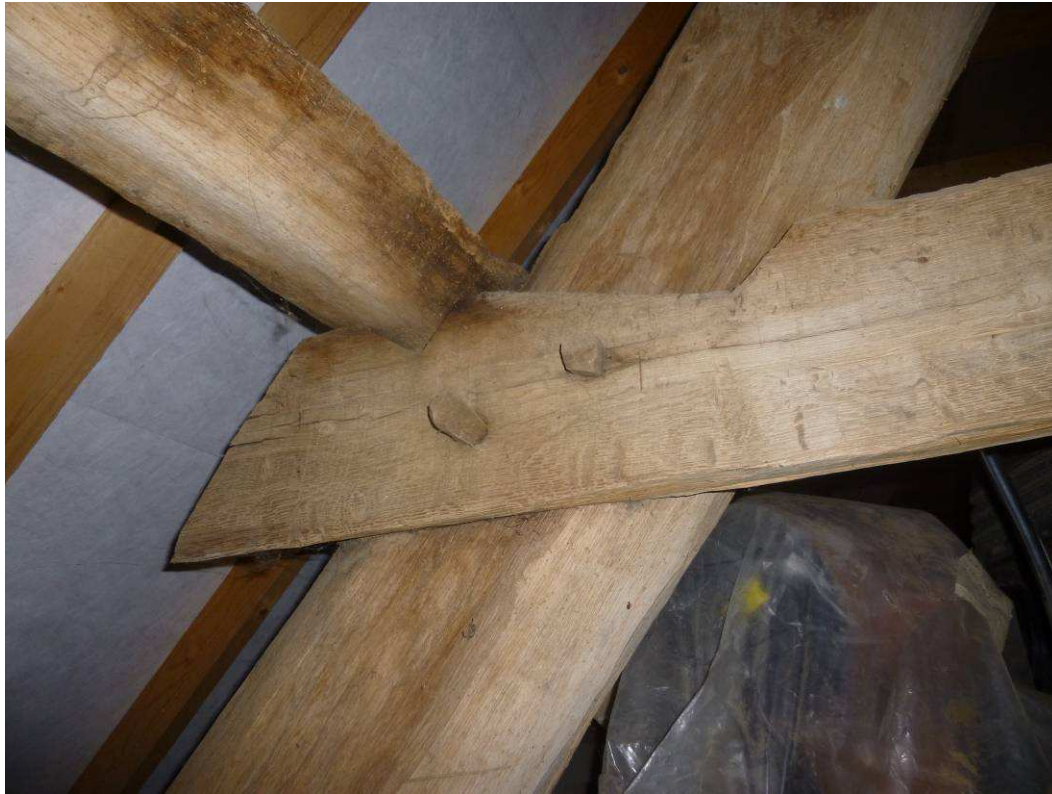
Lower collar joint to truss T2, south side

Inside, a good roof structure survives. Two trusses (T2 and T3) are set either side of the main doorway, with principal rafters tenoned to a large tie-beam. Two sets of collars, with lap dovetail joints, which extend to carry the original purlins. Scissors apex carries the ridge. Truss T1 to the narrower S bays has two collars but no tie-beam. The upper collar is of re-used timber, with mortices for studs. No original rafters survive. The timbers (all oak) are all fairly roughly shaped, with sapwood or square edges and occasional rough chamfers. The lap joints are fixed with big skew pegs, often square in shape. The purlin and ridge beams have straight-splayed scarf joints. Chiselled carpenter's marks to T2 and T3, but all are a 'I' only and on west side only. Three timbers have very interesting marks which may be shipping or lumber-trade marking: the W principal of T2, the lower collar of T1 and the lower E purlin of bay T2/T3. The marks are made on the rounded external sapwood face of the log, and on T1 they appear to have been partly cut away when the timber was cut to size.

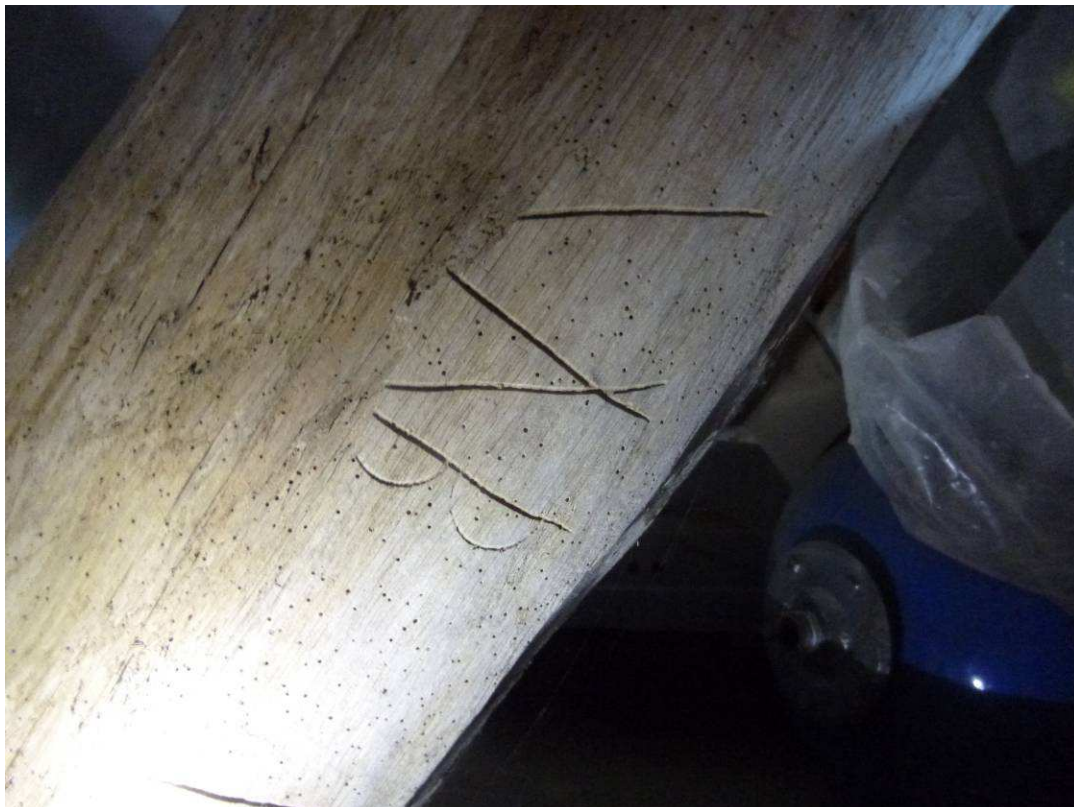
Unusual lumber mark on the west principal rafter of truss T2

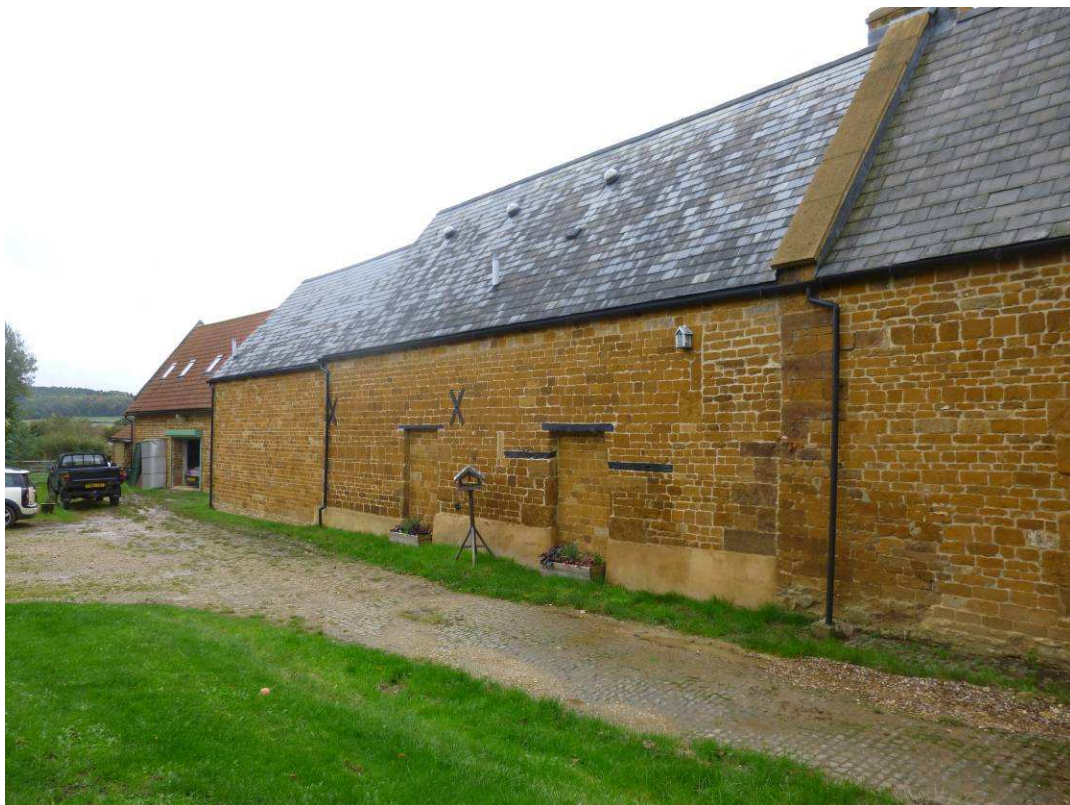
The former stables range to west, looking south-west

To the W of the covered entrance into the yard is a former stable, with walls of coursed stone and a slate roof. Prior to its conversion to a house in 2007 this had a thatched roof, and a truss above the stone wall on the W side of the covered entrance. The truss had roughly cut principal rafters, a lapped collar and scissors ridge, with single purlins and ash pole rafters. A coped parapet was inserted during the conversion works, to separate the new slate roof of the former outbuilding from the thatched roof over the covered entrance; it has an apex finial, which must be re-set from elsewhere.

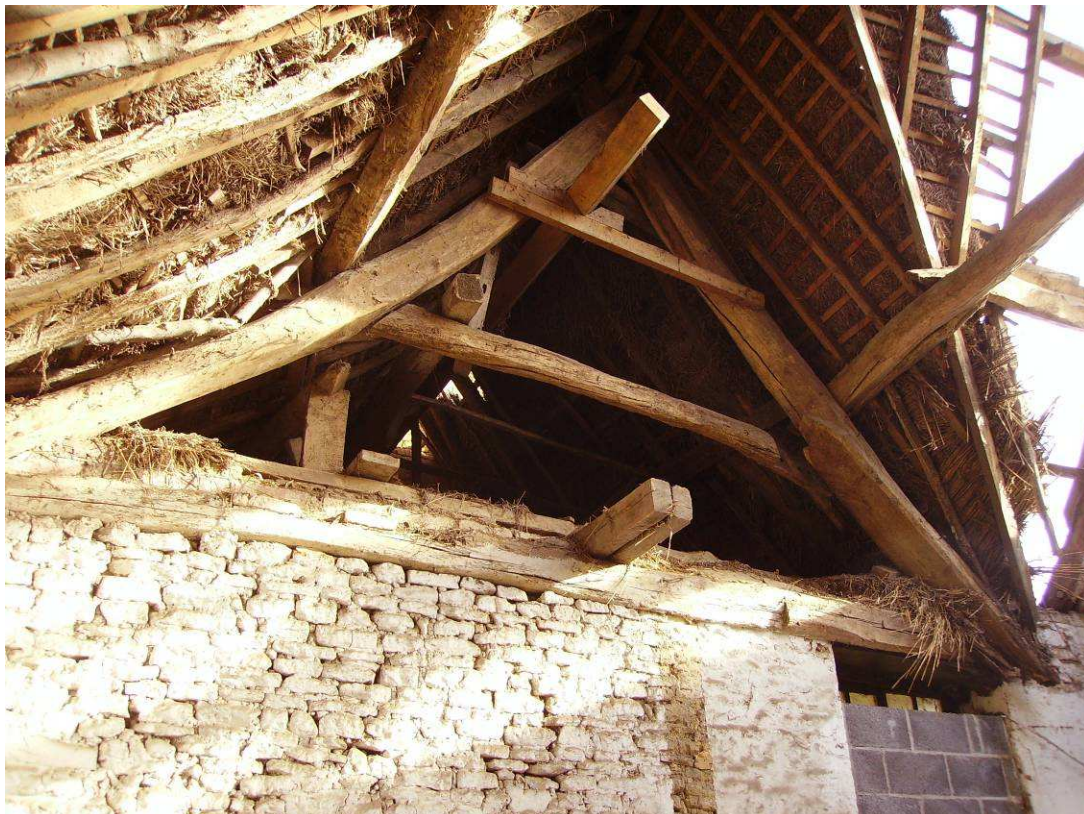
The wall and truss above which divided the covered archway from the outbuilding to its west, looking east
