Historic Building Survey

6 Main Street Caldecott, Rutland

HISTORIC BUILDING SURVEY REPORT

6 MAIN ST, CALDECOTT

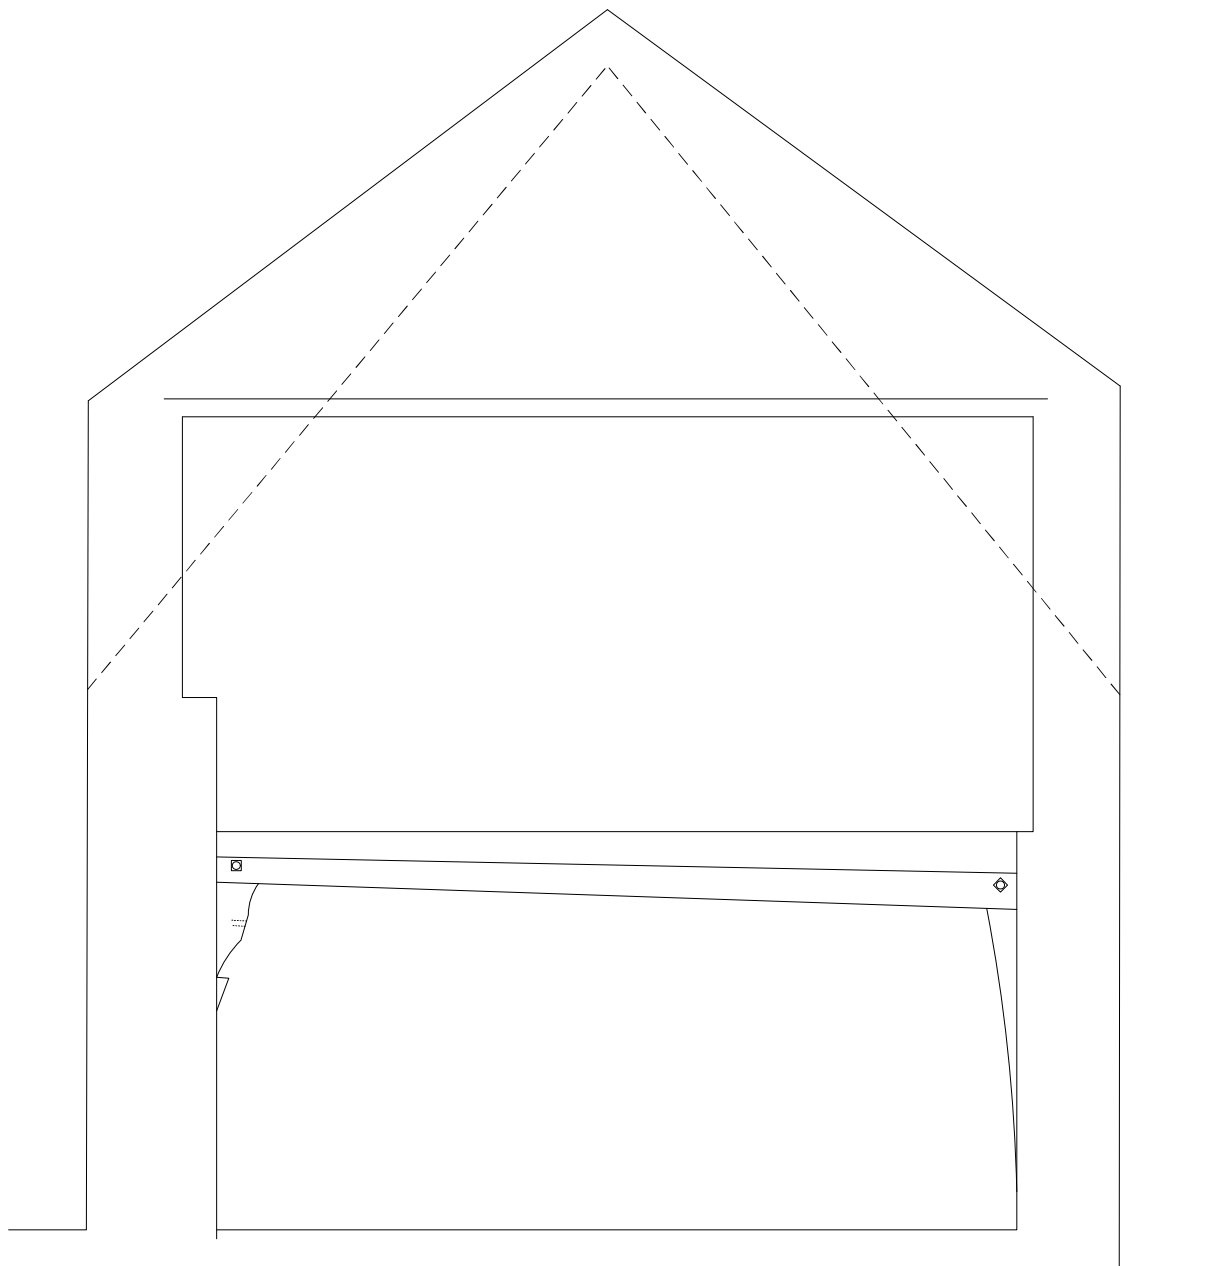
SECTION OF FORMER CRUCK TRUSS – WEST FACE

The W room contains a feature of considerable interest: the cut-off remains of a cruck truss, dating from the late medieval period. The cruck blade in the N wall is clearly visible. It is c.145mm thick with uneven chamfers to the inner edge, and a large notch cut into it, just above the level where it disappears into the wall. The inner E face of the cruck blade has a 30mm diameter peg in situ – a detail observed on some other crucks in the area, but whose function is unclear. The S blade is covered over, but the curving inner face can be seen, here descending to just above floor level. A ceiling beam has been bolted onto the W face of the cruck blades, an irregular, halved oak timber, with sapwood face to the W. There are single threaded bolts with square nuts, probably dating from around the early 19th century. Although the cruck blades survive quite well to the ground floor, they have been cut off at first floor level and removed. A very small section of cruck blade is also visible in the SW corner of the W room at high level – enough to show that there were two cruck trusses in the building, though no details are visible here. A halved oak beam has also been inserted at ceiling level here, across the cruck truss. The N wall and the W gable wall also have early characteristics, with a thickness of c750mm thick, and an internal batter. The S wall however is 560mm thick, so this wall seems to have been rebuilt.

The survival of cruck trusses indicates that the early house dates back to the 15th or early 16th century. It probably formed a house of three bays, on the existing footprint, and gable-end on to the road. It is likely that an open hall occupied two bays, with the third bay forming a service end. The hall would have been open to the roof, with a central hearth and no chimneystack. The plot boundaries suggest that, while the entry would have been in the long south wall, there was no opposing door for a cross-passage. The original walls may have been of mud, but the north and west walls are of early date, of considerable thickness and with an internal batter.

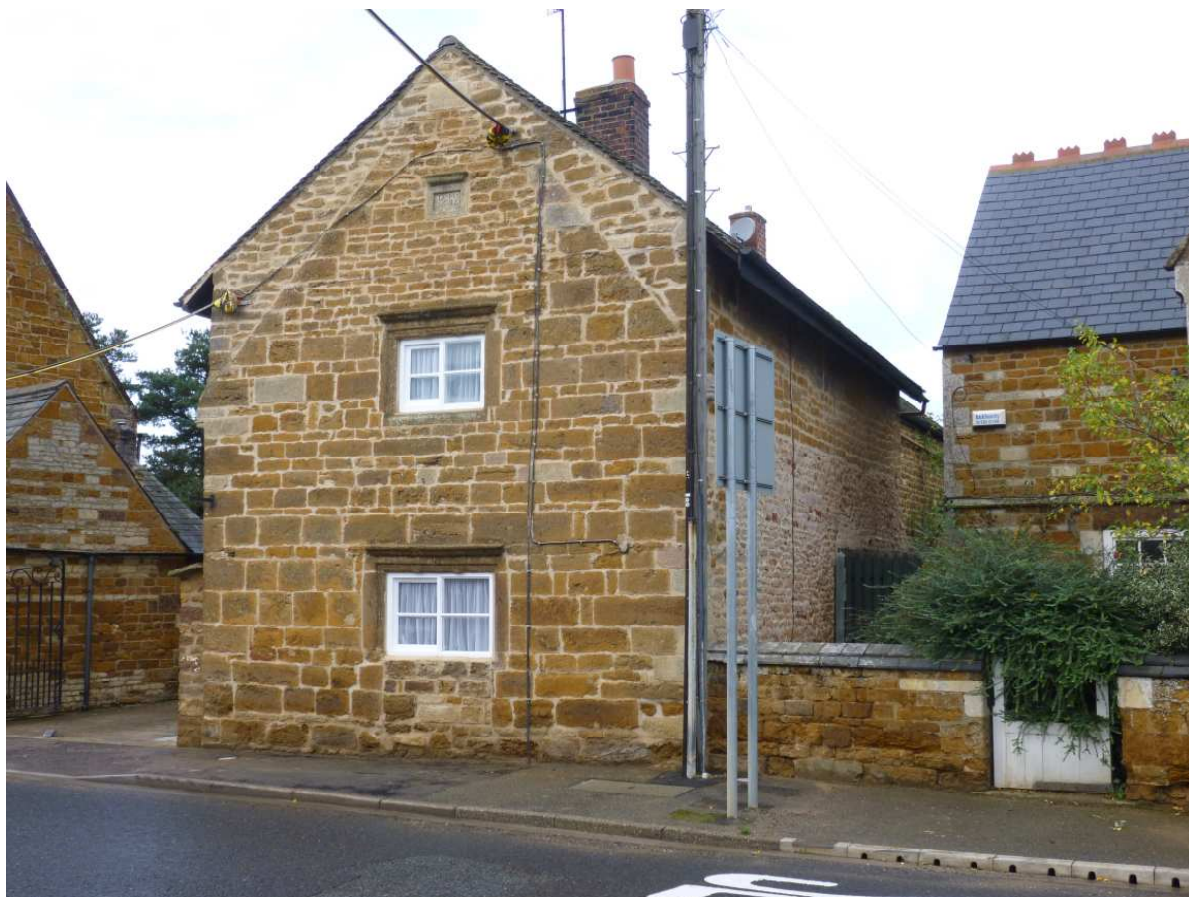
View from the east, with raised roof line

The front E gable is built of large, well-squared ironstone blocks with a few limestone blocks, except for the upper gable. Former 3-light mullion window to ground floor, with ironstone ovolo-moulded surround, but mullions replaced by C20th timber window; cyma-moulded cornice. The window was previously converted to a door, with straight joints below, then changed back to a window. Similar window, formerly 3-light mullion, to 1st floor. The raking line of the earlier gable is clearly visible, with later build-up above. Good half-ogee pendant corbels of limestone, below ironstone kneelers. A limestone date-stone near the top: DH 1646 in a recessed panel, with a cyma-moulded cornice. The surrounding masonry indicates the date-stone is original, as the coursing differs to either side of it. To the right of the date-stone are three triangular limestone blocks, one of which is fire-reddened. At the top is another

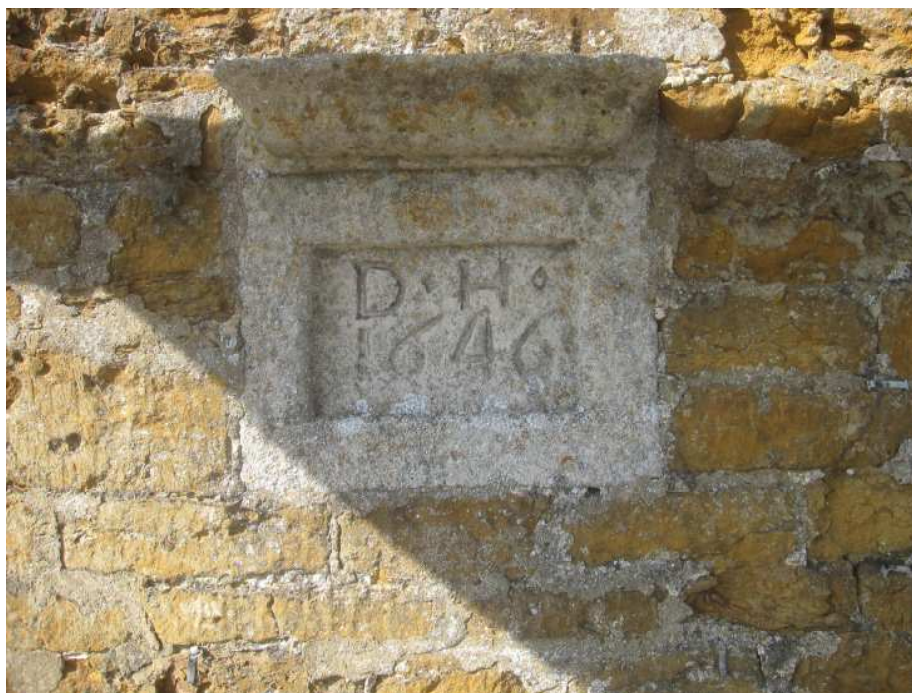
Date-stone to east front

A major programme of alterations and upgrading was carried out in 1646. The front east gable was rebuilt with high quality masonry, including large, regular stone blocks, two 3-light mullioned windows and a coped gable parapet with shaped corbels. The south wall was also given a high-quality treatment, rebuilt with alternating courses of ironstone and limestone. The less visible north and west walls, may also have been rebuilt or re-faced at this date, but here much more irregular stone was used. The internal plan of this building cannot be determined, though there would have been at least one fireplace and chimneybreast. The first floor window to the gable shows that there was now a first floor, at least to the eastern part, though the eaves height remained restricted by the cruck roof structure. Evidence for other windows or doorways, except for the front east gable, is absent. The owner responsible for this phase was clearly proud of his work, and fitted a date-stone with his initials, DH and the date 1646. The Hearth Tax of 1665 records a Daniel Hill paying tax on two hearths. In the parish registers, a Daniell Hill was baptised in 1622 and died in 1679/80. There are no other persons with the initials DH in the Hearth

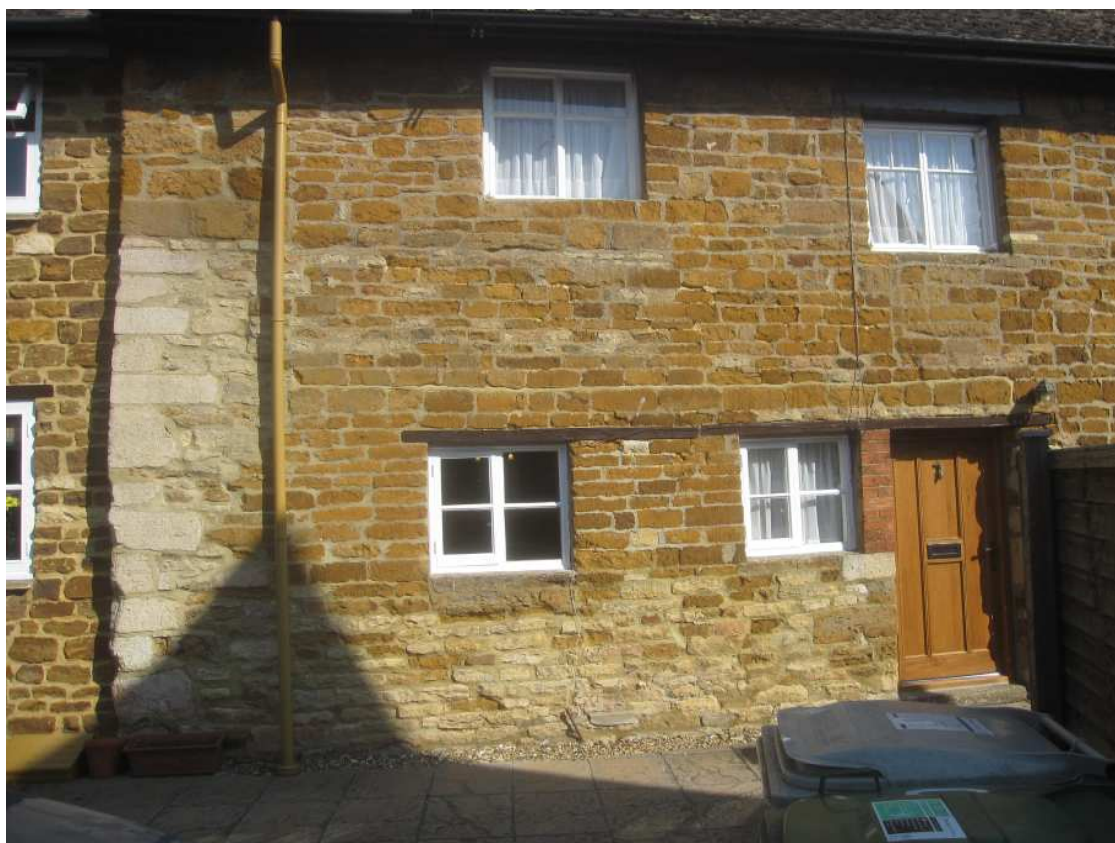
The south side, with original limestone quoins to left

The S wall has alternating coursed ironstone and limestone rubble towards the E and lower down, but later re-facing of ironstone towards the W. The top part (around 1m) is of 1949, with 3 modern windows. The ground floor has a 3-light timber casement window to the E, with an old timber lintel. Next to the W is the front doorway, with some older jambs, but some replacements and 19th century brick to the upper W. Set closely beside this, with a continuous timber lintel is another window. Above the doorway is a blocked square opening, the bottom of which is only just above first floor level. At the W end is a third window, whose lintel extends to the E. It is evident that this wall face has been considerably re-worked over the years, with considerable alteration to openings. The SW corner has good quality, though somewhat weathered, limestone quoins.

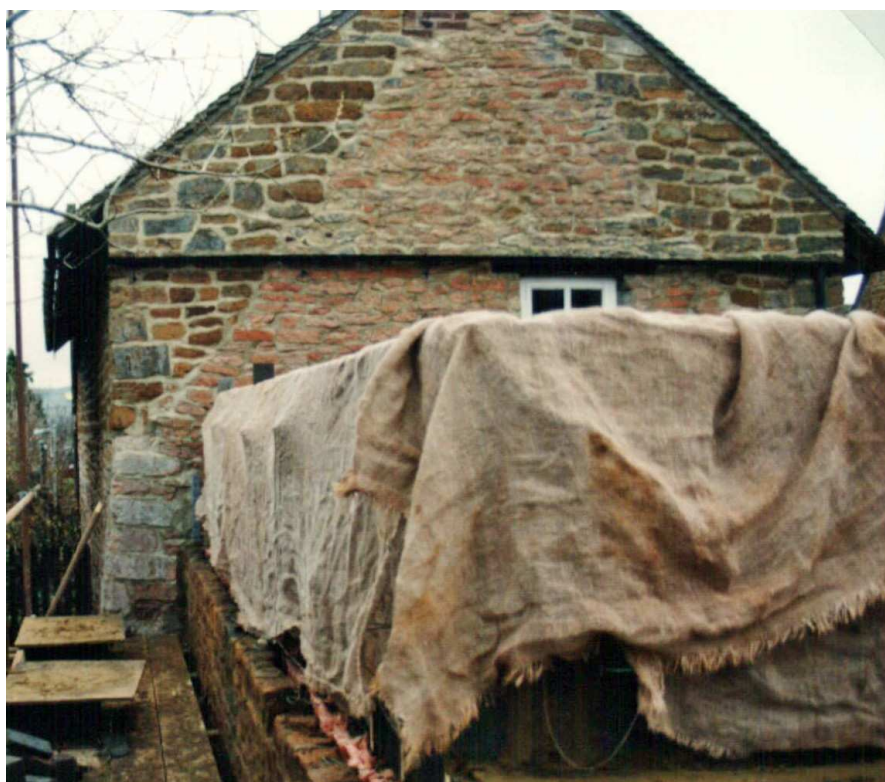
West gable in c.1990s, showing original lower gable

The W gable is now concealed by the modern extension. Photos taken of the exposed upper gable show that it was built of irregularly coursed rubble, with much fire-reddened stone. The earlier lower rake of the gable, coming down to the level of the limestone quoins, can be clearly seen. There were similar limestone quoins to the NW corner. The gable had a 2-light timber window to 1st floor.

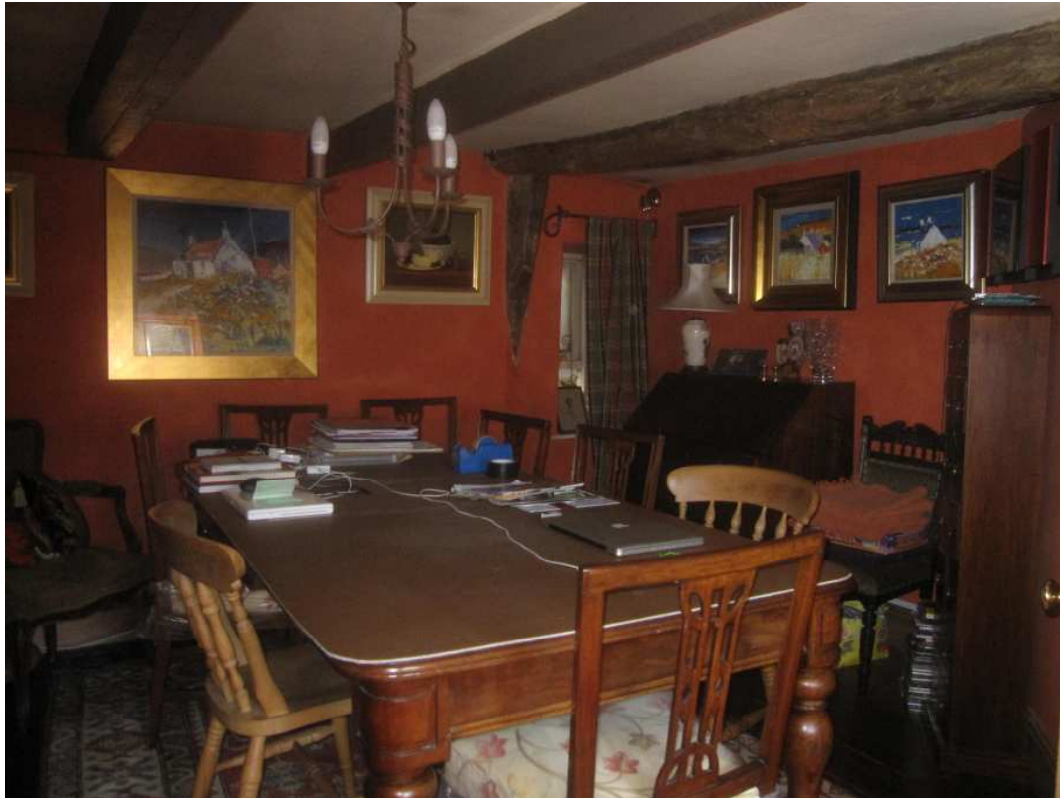
The west room looking north-west, towards cut-off cruck blade

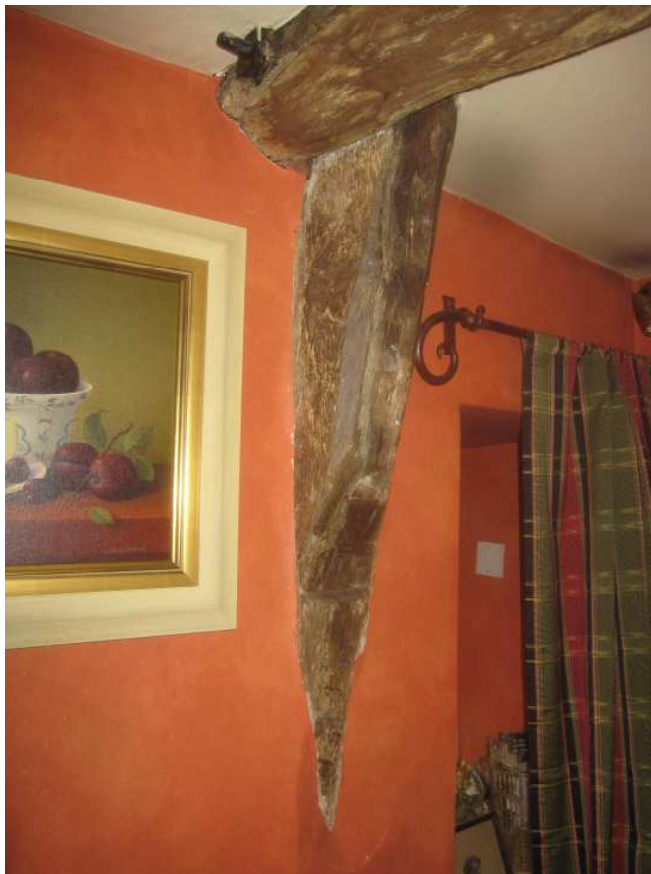
Cut-off cruck blade to north wall of west room, with bolted-on floor beam
