Lyddington Manor History Society Historic Building Survey

Glebe House 1 Church Close Caldecott, Rutland

HISTORIC BUILDING SURVEY REPORT

GLEBE HOUSE, 1 CHURCH CLOSE, CALDECOTT

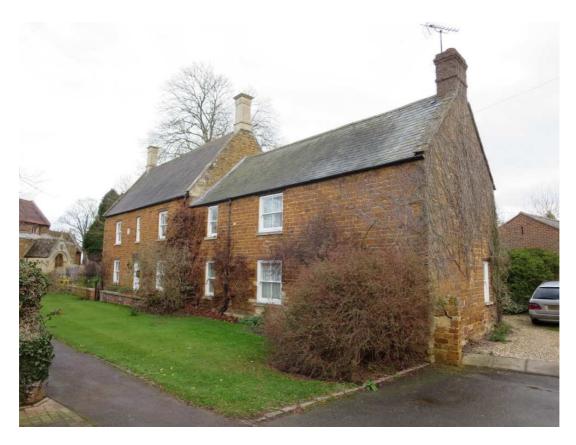
View from the south-west

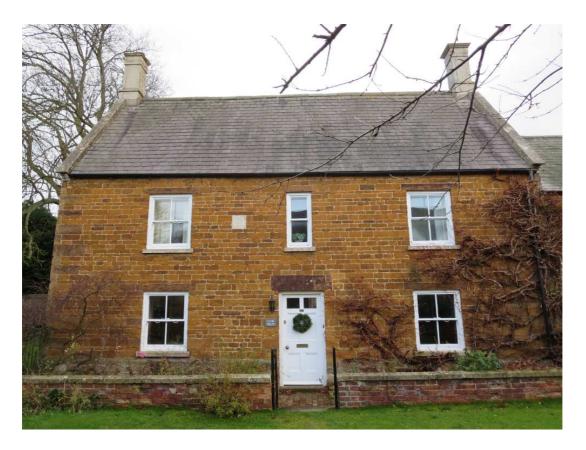
The west front

The front block is of two storeys with chimneystacks at each gable end. The W front has walling of finely coursed ironstone and a chamfered ashlar plinth. The front is now symmetrically arranged, with a central doorway, sash windows on ground and first floor to either side, and a smaller window set over the door. However, joint lines indicate that the doorway was originally set off-centre to the left, as shown on the drawing of c1838-9. A faint line from the roof of a former porch (also on the 1838-9 drawing) can be seen, and 'closer' bricks in the front boundary wall also indicate a previous gateway, aligned with the original front door. Set centrally over the original doorway position is a date-stone of 1729, of limestone with the numerals set within a diamond-set square, with no initials. The date-stone courses in exactly with the stonework, which all appears undisturbed. It is also shown on the 1838-9 drawing, and seems to be original to the building. The five window openings have plain, unchamfered lintels of a single piece of brownstone, of quite shallow height, and limestone cills. The doorway lintel is also of brownstone, but deeper, and has incised grooves for false voussoirs; it is presumably re-set from the original doorway. As the porch shown on the 1838-9 drawing would have concealed the false voussoirs, the porch was probably a later addition. The windows are of late 19th century sash type, with 2/2 lights, though the 1838-9 drawing shows casements or sashes, with smaller panes.

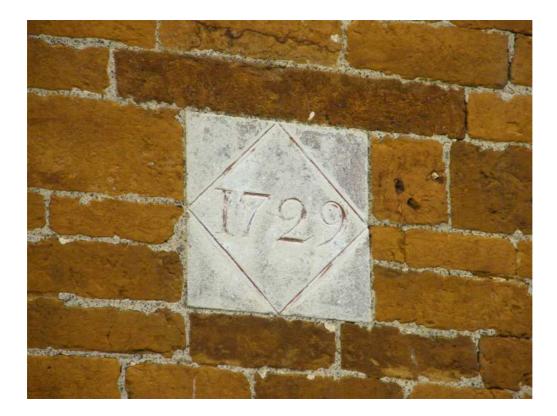
The date-stone

Evidently, the copyhold was purchased by John Brown the elder in 1727, and he then proceeded to demolish completely the previous house (and perhaps the farm buildings), and erect the new house, which he completed in 1729, as the date-stone states. Nothing of the previous house survives, except probably the re-used principal rafters of the roof truss (and perhaps the floor beams). It may have stood in the same location beside the street frontage, or elsewhere on the plot. It is interesting to note that, despite the major investment made by John Brown, the copyhold rent remained at the same figure of 1s. John the elder built it for his son John the younger, who presumably moved in after the new house was completed. Soon after the transfer of copyhold from father to son, in July 1733, John the younger married Elizabeth Brightman in Lyddington church (from the parish registers). This sequence of events may help to explain why there are no initials on the date-stone – John Brown was still single when the house was built for him, so it was not possible to include the normal initials for husband and wife.

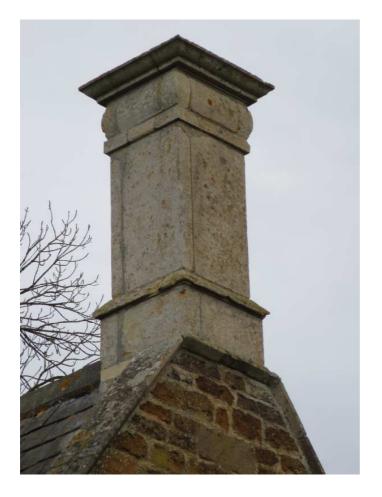
Chimneystack with moulded capping, to south gable

The S gable of the front block is now largely blocked by the added outbuilding. The top part has a gable parapet with moulded kneelers of the same pattern as those to the N gable, and an identical single-flue stack. A plain brownstone lintel for an attic

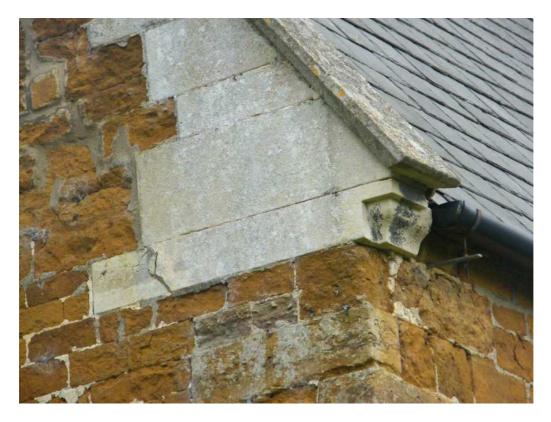
Moulded corbel and kneeler to north gable

The N gable end of the front block has finely dressed ironstone walling with a chamfered ashlar plinth, as to the W front. There are good brownstone quoins to the N, but no quoins to the ground floor stage at the junction to the rear wing, though there are brownstone quoins at first floor level. Gable parapet with limestone ogee-moulded corbel of distinctive pattern, kneeler and copings. Single-flue chimneystack with cornice of cyma and corona moulding; pulvinated frieze; square architrave; main shaft of four ashlar slabs; chamfered plinth. First floor window with plain brownstone lintel as to the W front, though the attic window has a plain chamfer (but square jambs).

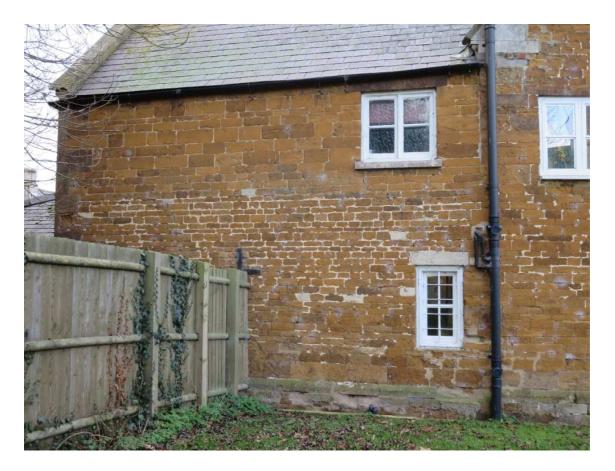
The rear east wing, with added first floor - note straight joint beside downpipe

The N wall continues on into the rear wing. The masonry shows this was single storey originally, later extended upwards in different coursed ironstone. But the rear wing at ground floor is integral with the front block: the chamfered plinth continues across, there is no straight joint, and the kinked angle of the junction has several stones which bridge across both sides, with angled faces cut to suit. Narrow ground floor window with plain Weldon type limestone lintel. First floor window has a brownstone lintel with central keystone, unlike the original windows.

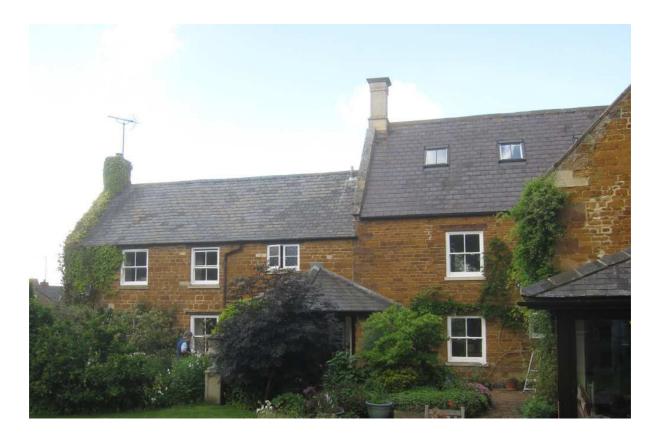
The house and outbuilding from the east

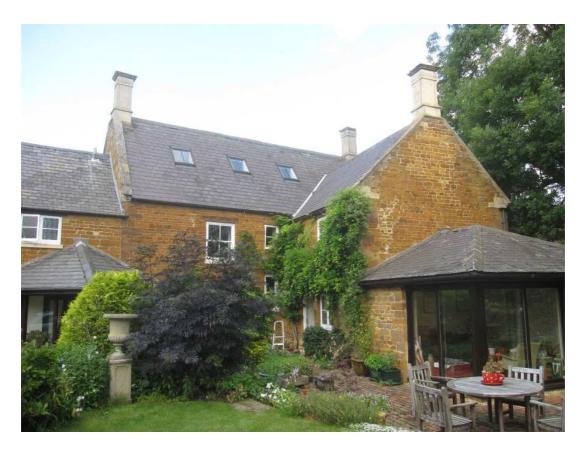
The rear of the house, with two-storey wing

The S side of the rear wing is partly obscured by planting. It has coursed ironstone walling, the 60mm rubble plinth continuing from the main block, around the 45° link wall and along the S face. The back door has a good brownstone lintel, as do the ground and first floor windows.

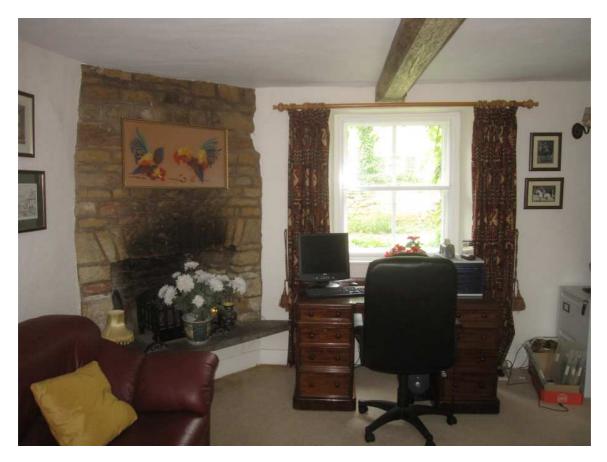
The south room (parlour) of the front block, with corner fireplace

The front doorway now leads into the central entrance hall, with the staircase. To the S is the parlour, separated from the stair by an oak stud partition. Splayed, smallersize fireplace and chimneybreast set in the SW corner; roughly dressed ironstone, with a flat lintel of roughly shaped stone voussoirs. Fixing holes indicate that this masonry was originally covered by a chimneypiece, of timber or higher quality stone. Transverse ceiling beam with chamfers and decorative stops: a shallow raised section of truncated pyramid shape, half-round bar; and fairly long run-out stop. This chamfer stop detail is found to both ends of the two ground floor beams and the two first floor beams in the front block.

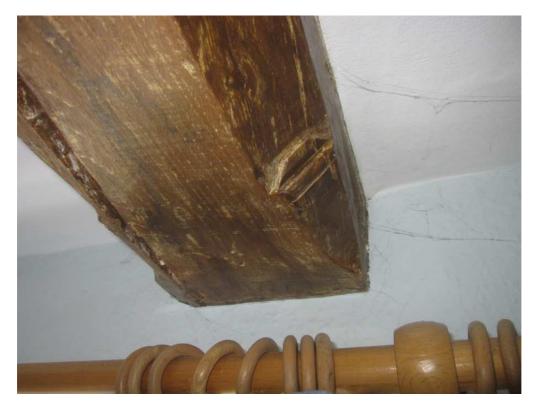
Chamfer stop to ceiling beam

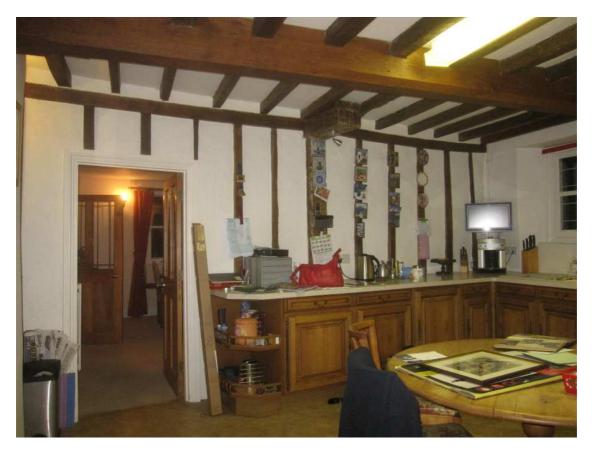
The kitchen of the rear wing, looking west to the timber stud partition

The kitchen in the rear wing has another large stone fireplace, with oak lintel. This lintel has a small, rough chamfer without stops, so may be re-used. The lintel has several burn marks and some possible graffiti of scratched straight lines. To the left, a bake oven of ironstone was found during alterations of 1987. A stud partition divides the rear wing from the front block: plain, often rather thin, oak studs fixed to a top plate; some original mud infill was found during works in 1987. The beam from the front block protrudes into the kitchen, with a cut-off end. The beam is supported on a larger post in the partition. At the SW corner, the wall cuts back at 45° at the junction of the rear wing with the front block, with a tall, narrow cupboard recessed into the wall, with splayed reveals inside from the former window here. Two modern transverse beams to the ceiling replace two earlier beams. The W one was set below ceiling level, forming a partition. To the W, the oak ceiling joists are c50mm wide by 75mm deep, but the centre and E sections have older-looking joists, c90mm wide by 75mm deep. The doorway in the E gable leading to the modern conservatory is an insertion of 1987, as shown on earlier photos.

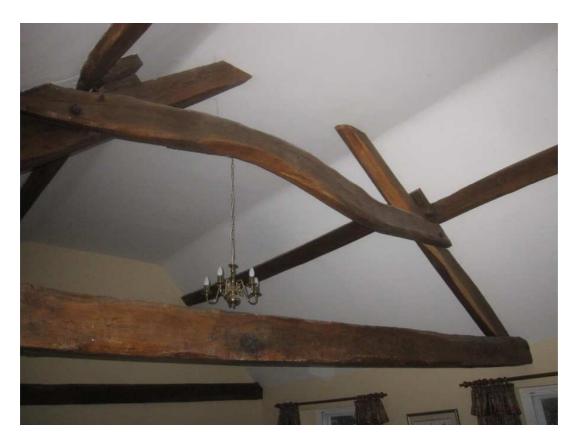
Roof truss of the 18th century outbuilding

The attached outbuilding roof has two trusses: of oak, straight tie-beams and irregular S-shaped collars crudely lapped to principal rafters. The joints have large, round-head bolts with large, square, threaded nuts, and also a large-head nail. The apex joint is of bridled form, fixed here with an oak peg, not an iron bolt. Staggered purlins are set simply on the backs of the principal rafters. In the roof void, it can be seen that quite a number of original oak rafters (c75 x 50mm) survive, fixed to a narrow ridge board. The blocked window to the S gable of the house is also visible.

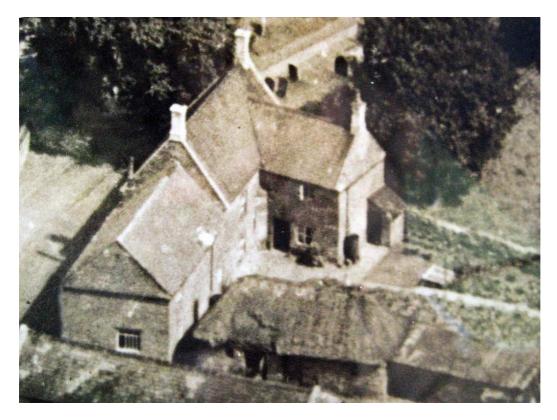
Earlier aerial view from south-east, with thatched outbuilding to yard

A black and white aerial photo of around mid-20th century date shows the main outbuilding, set quite close against the SE corner of the current house. It was of a single storey, stone-built, with doorway or window openings of normal width and a hipped, thatched roof. Abutting this to the E was another single-storey outbuilding with a low-pitched roof. A colour aerial photo, probably dating shortly before the alterations of 1987, shows the main outbuilding with a flat roof of corrugated iron, a central 2-part stable door set between two good-sized windows, with a small window to W and E. The eastern outbuilding has a flat roof and probably walls of rusty corrugated iron. These outbuildings have subsequently been replaced by the current brick-built garage. The 1886 map also shows a small projection to the E gable of the house rear wing, recognisable as a brick-built privy on the pre-1987 aerial photos.

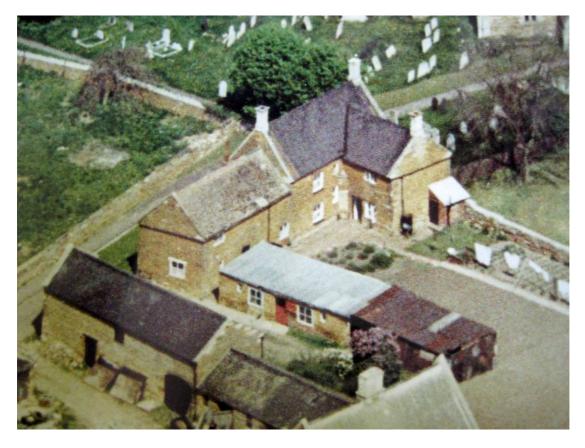
Later aerial view

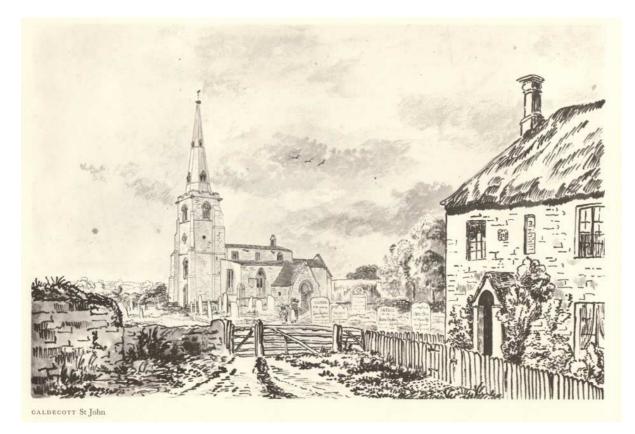
Drawing of c.1838-9, showing front door in original location

now of Welsh slate, but the house roof was originally of thatch, as seen on a drawing of c1838-9.¹
