Lyddington Manor History Society
Historic Building Survey

Home Farm
39, Main Street
Caldecott, Rutland

HISTORIC BUILDING SURVEY REPORT

HOME FARM, 39 MAIN ST, CALDECOTT

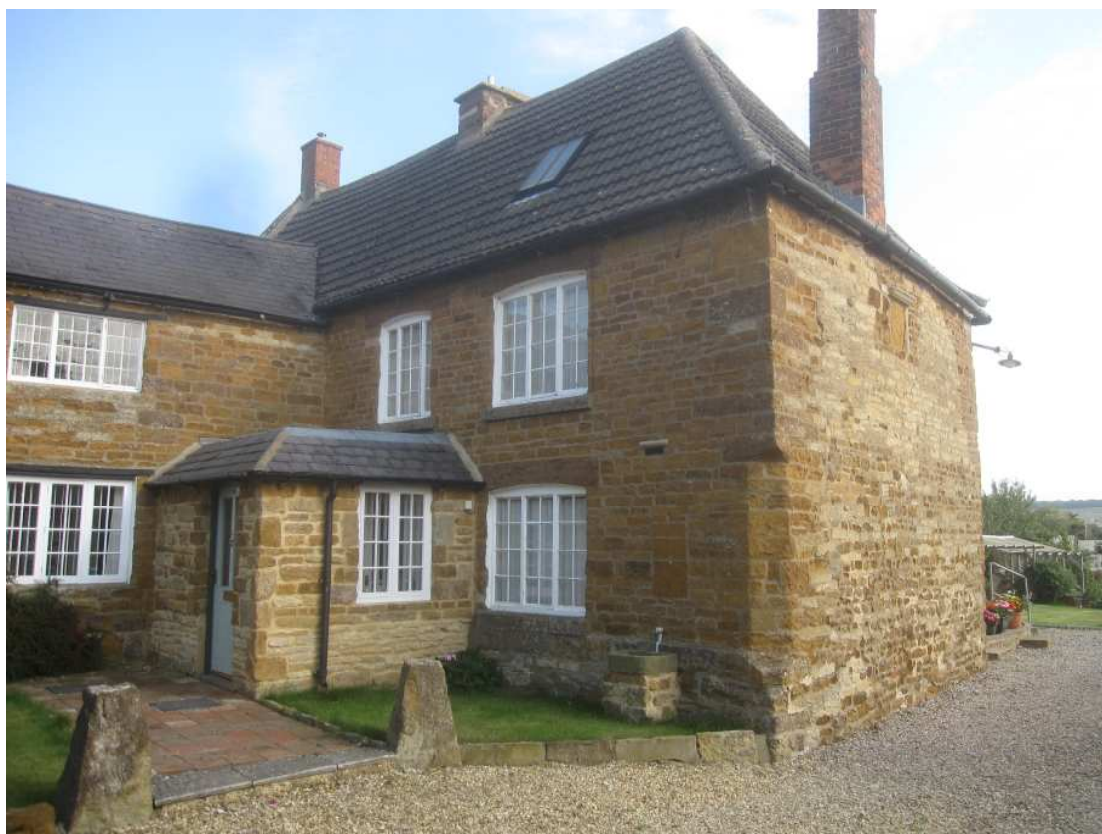
The N front of the main range has walling of well-squared, coursed ironstone, with good ironstone quoins to the NW corner. The corner is chamfered, to give better clearance for carts entering the yard. There are 3 windows, one to the ground floor and two to the first floor. All have deep segmental-arched lintels of brownstone in a single piece, with timber casements of 19th century style. To the right on the ground floor is a small rectangular window opening, blocked with ironstone. There is a square, rubble plinth. The rest of the north front is blocked by the north range and a modern porch.

The W gable of the main range has different walling, of limestone with some ironstone rubble, to the main area, except towards the corners. It is evident that the walling with limestone is older, and the ironstone is a later re-facing. The gable is blank, except for an eroded ironstone tablet near the top, with a cyma-moulded limestone cornice over it. It is probably a re-set date-stone. The stone of the cornice extends to the left, rather oddly. There is a tall single-flue stack of late 19th/20th century date, with a broader stack base of rubble stone to the centre of the range.

View from the north-west

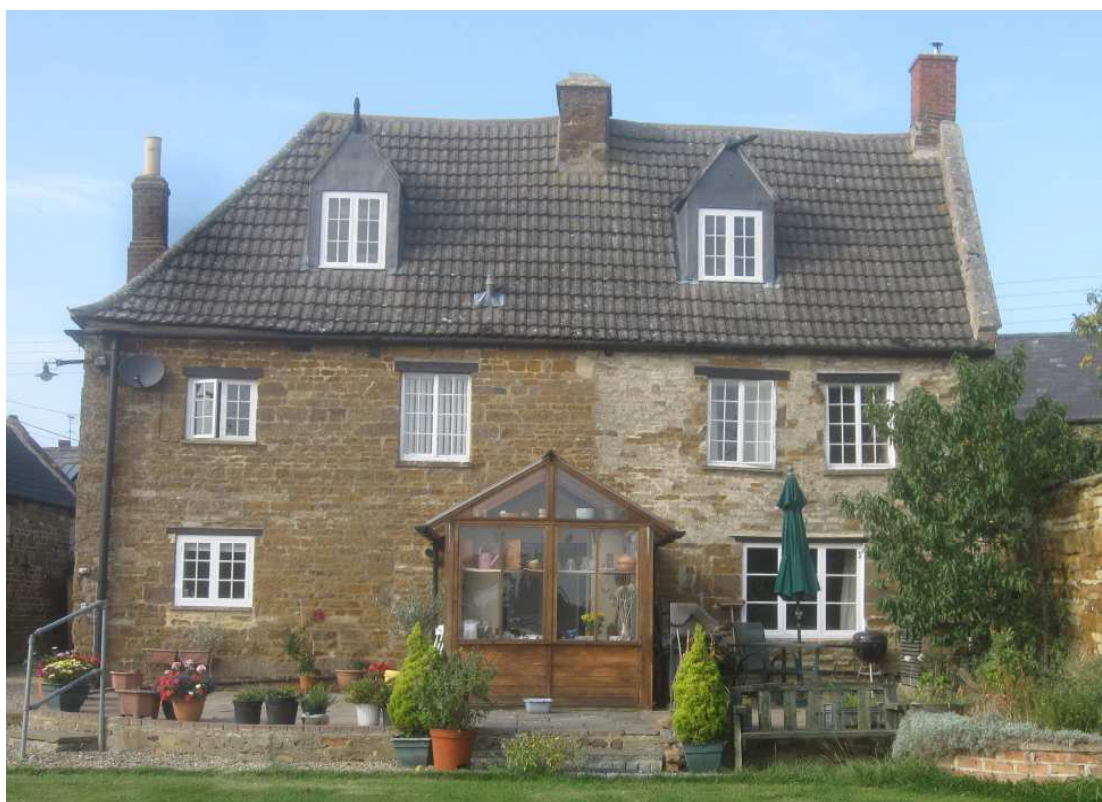
The S side of the main range has walling of two types. To the W there is well-coursed ironstone, and to the E more irregular limestone, with areas of ironstone. There is an irregular joint where the two types meet, indicating that the ironstone is a later re-facing. The first floor has 4 timber casement windows. Joint lines in the masonry show that there were previously 4 windows set symmetrically below these to the ground floor, but a window to the centre W has been lost and a wider single window to the E has replaced the two windows here. There is a modern timber porch.

The rear south side

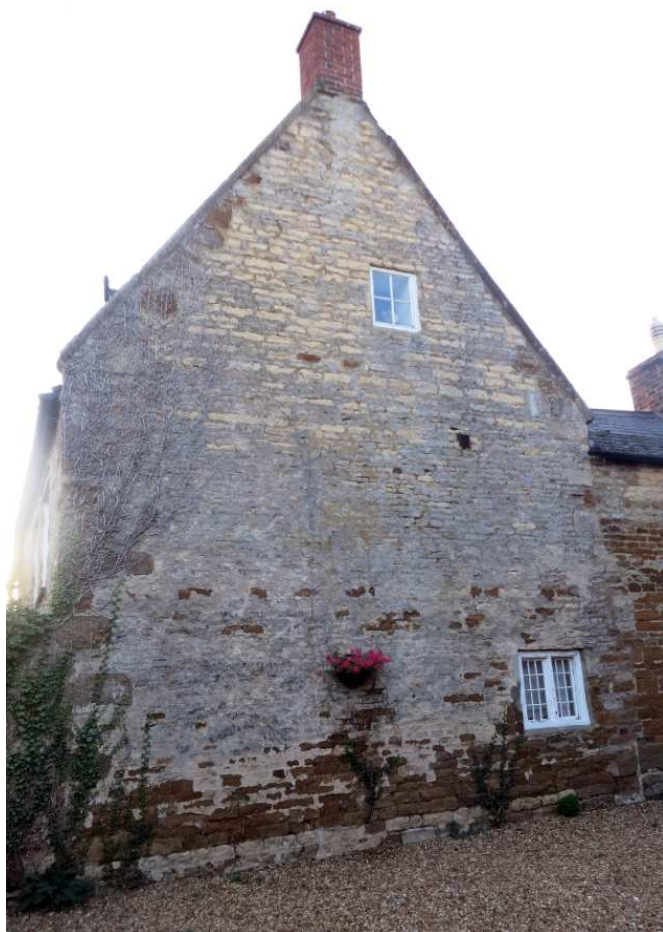
The E gable of the main range, which faces over the adjoining property, is of coursed limestone with only a little ironstone. 19th century casement window to ground floor and attic. Plain kneelers with gable parapet and seating for a single-flued stack, of rebuilt brick. Only a few quoins remain at the NE corner, where the north range abuts.

The east gable of the main range

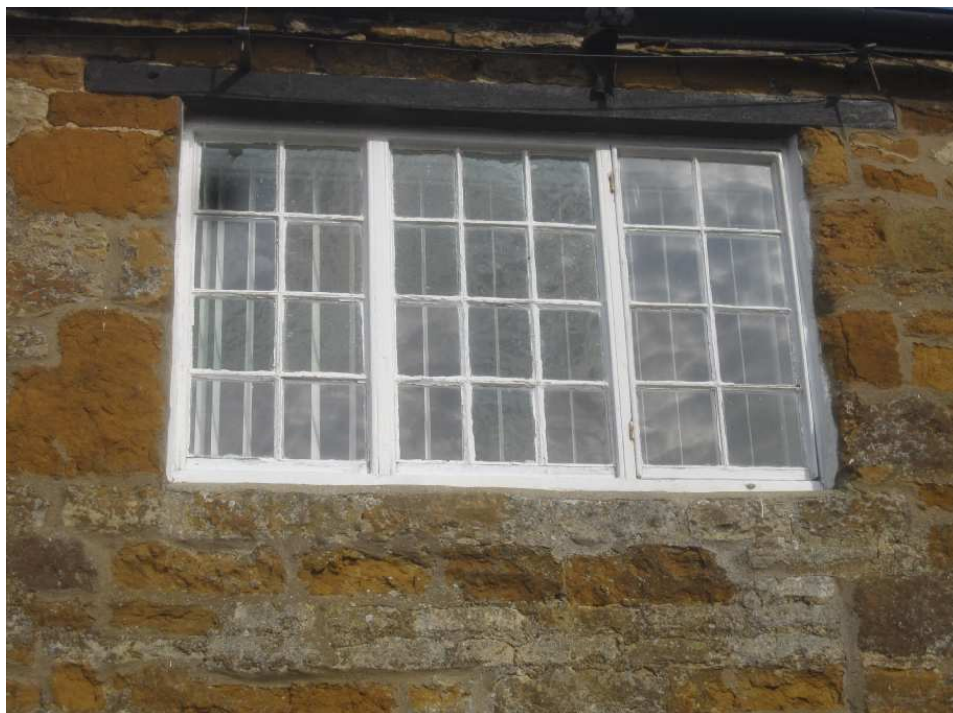
The north range front gable has well-coursed ironstone, though the upper gable is rendered. Ground floor casement window with segmental arch lintel of brownstone, here with a central keystone, rather than in a single piece like the lintels to the main range. Similar window to 1st floor, though the lintel is rendered. Plain kneelers and gable parapet, the roof at an angle of only around 35-40°, indicating that it was probably built for pantiles or Welsh slates, not Collyweston or thatch.

A fine set of casement windows, of which many survive, was fitted to both ranges around the early 19th century. A stable was also added to the barn at this time, with unusual curved principal roof trusses and rare black-glazed pantiles.

Casement window of c.1800 to the north range

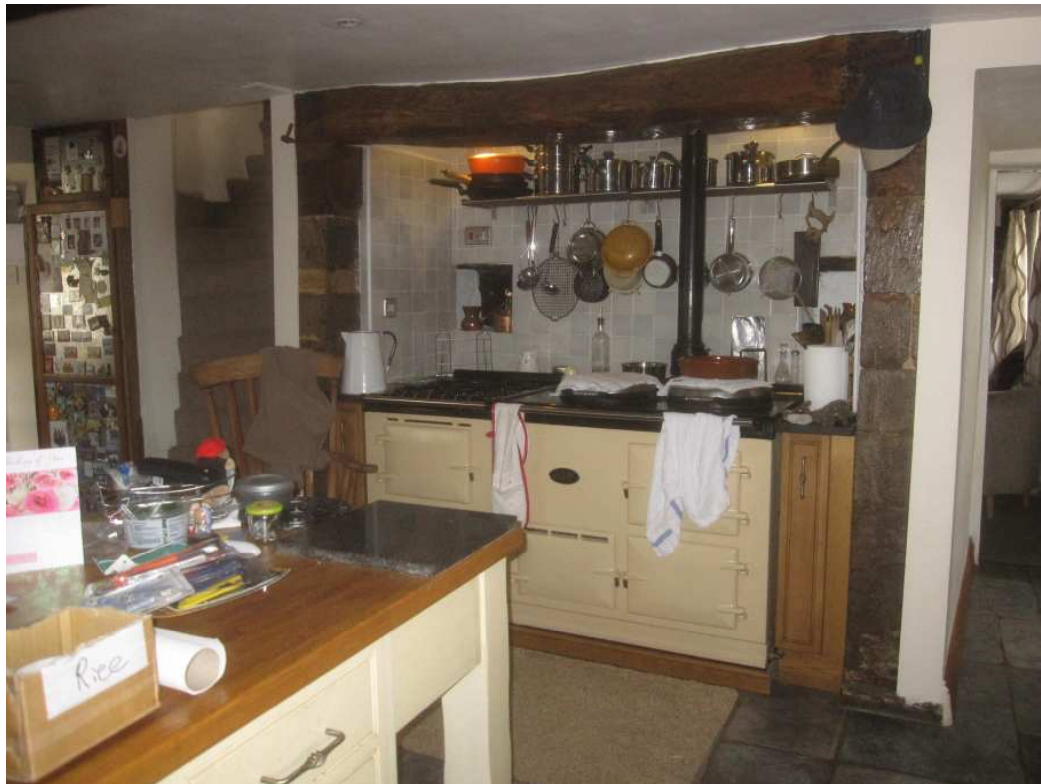
The main range W room has an unusual arrangement of ceiling beams: transverse beam with shaped stops to S end (but no chamfers to N), to which a spine beam is morticed and twice-pegged, with plain-cut chamfer stops. The spine beam has good ogee stops at the junction with the transverse beam, with the W end concealed by a later chimneybreast. Inglenook fireplace with ironstone cheeks to both sides, the angle beam cut out and a modern one inserted at higher level. Winder stair beside the stack.

The west room of the main range, with inglenook fireplace

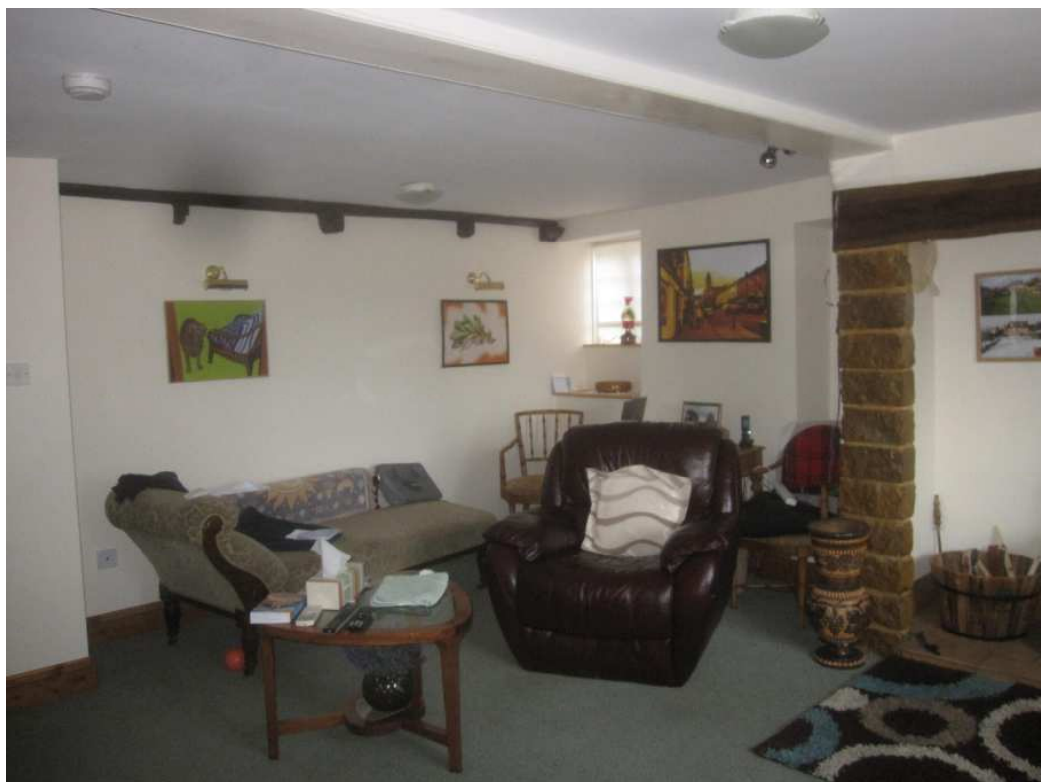
The main range E room has a re-worked inglenook fireplace and cased spine beam. The N wall has a timber like a wallplate, supported on 4 irregularly shaped corbel timbers – this presumably supported the floor joists. An inserted partition here was removed after 2006.

The east room of the main range, with corbelled timber plate to north wall

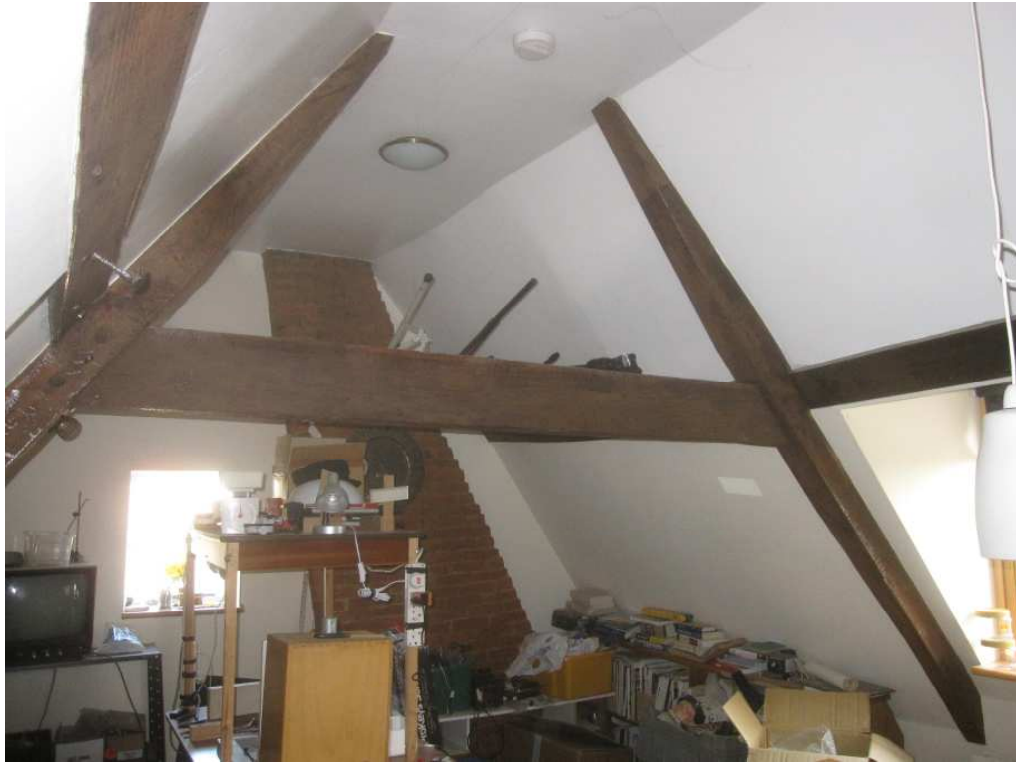
The main range has an attic floor set within the roof. A good quality roof structure survives in very complete state. Two A-frame trusses, set either side of the central stack. Although the principal rafters go down to attic floor level, they do not connect to tie-beams. The two ceiling beams are set to the E of the trusses, with the N end of the E beam visible where it is bedded into the wall top, 225mm E of the truss. The trusses have well-squared oak, with only very small chamfers. Tenoned collar, tenoned purlins, apex of trusses not visible, but no ridge (rafters have bridled apex). Well-squared oak rafters, tenoned to the purlins. A regular row of pegs which fix the lower rafters is visible to the purlins. Purlin scarf joints have double pegs visible, though the joint cannot be seen. Truss T2 to the W is set in the location to receive the hip rafters (ie offset to the W). The hip rafters receive a purlin at the W end, which

also has a row of pegs for the rafters. It is clear that the roof is all of one date and was made to suit the hipped end. But the roof structure is probably of later date than the attic floor beams, with their 17th century style chamfer stops.

The eastern A-frame truss to the main range

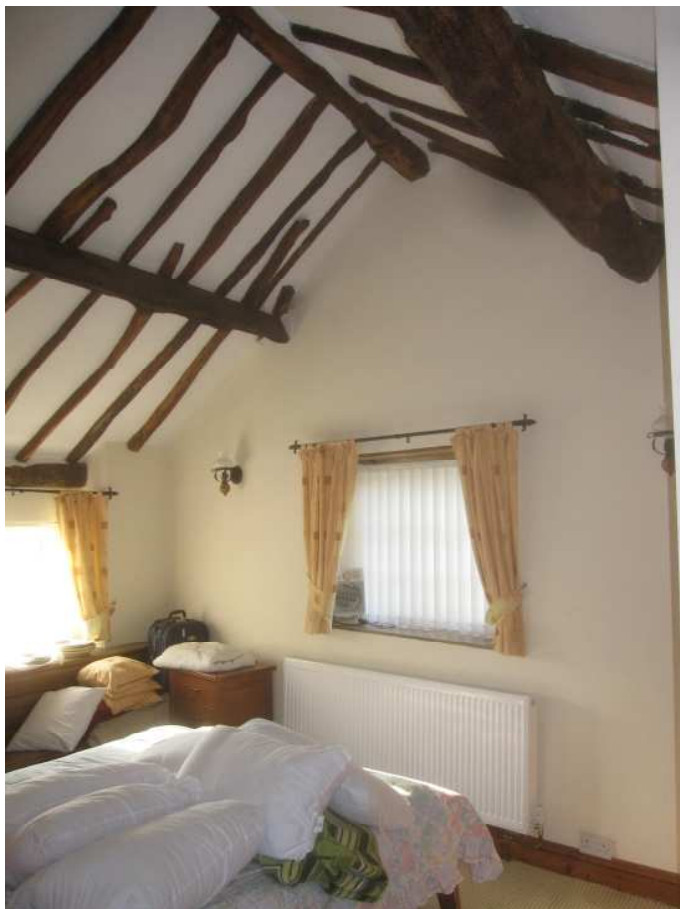
The N range has a Victorian cast iron fireplace to the S room. The original roof structure survives, open to the N room and ceiled to the S, of quite crude construction. Big, rough purlins and a crude ridge span N-S, bearing onto the central crosswall. Rafters are of irregular pole type or re-used, lapped crudely over the purlins. The timbers in the roof space are still white-washed. In the roof space, it can be seen that the crosswall and chimneybreast are of brick. A partition of poles and reed/plaster separates the S end of the N range roof from the main range

The irregular roof structure to the north range

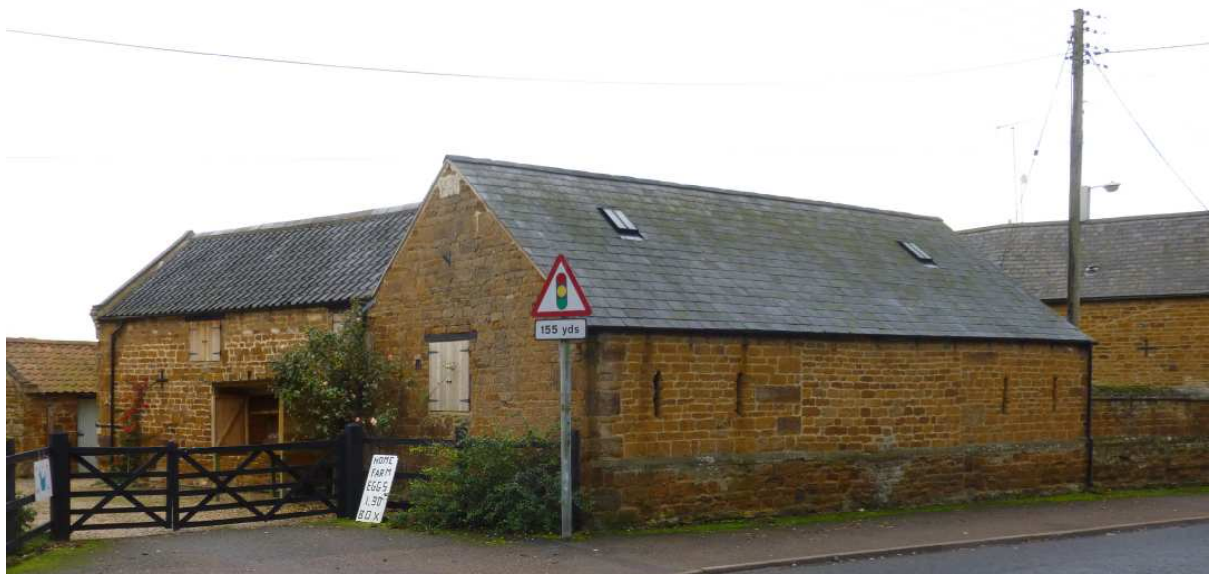
Two stone-built outbuildings are located to the NW of the house, forming an L shape. These were briefly inspected in 2006-7, before conversion to domestic use. There is a further outbuilding to the S of the L-shaped range, with stone walls and an open N front with timber posts.

The N outbuilding, set parallel to the road, was formerly a barn. The front N wall has the jambs of a large central barn doorway for cart access and a threshing floor, now blocked. Either side of this, symmetrically placed, are two ventilation slits. This front N wall has a chamfered plinth, which is also present in the stonework of the blocked-up doorway. The E gable has a limestone date-stone: MDCCXII (1712), with another date-stone to the W gable: 1712. The roof and gables have clearly been reduced in height, with a covering now of Welsh slate at around 35°. Inside, there were two or more old tie-beams, but the upper roof structure was modern. This building was clearly a well-built barn, probably thatched and dating from 1712. Beyond the quoins of the barn's NW corner, the N wall continues along the street frontage, with a slight kink to follow the road line. The first section, up to a wide gateway, also has a chamfered plinth, of the same type as the barn wall. To the W of the gateway, the front boundary wall continues right up to the adjoining building. On the 1800 enclosure map, an outbuilding range extended right across this NW part of the plot.

The outbuilding range, from north-east

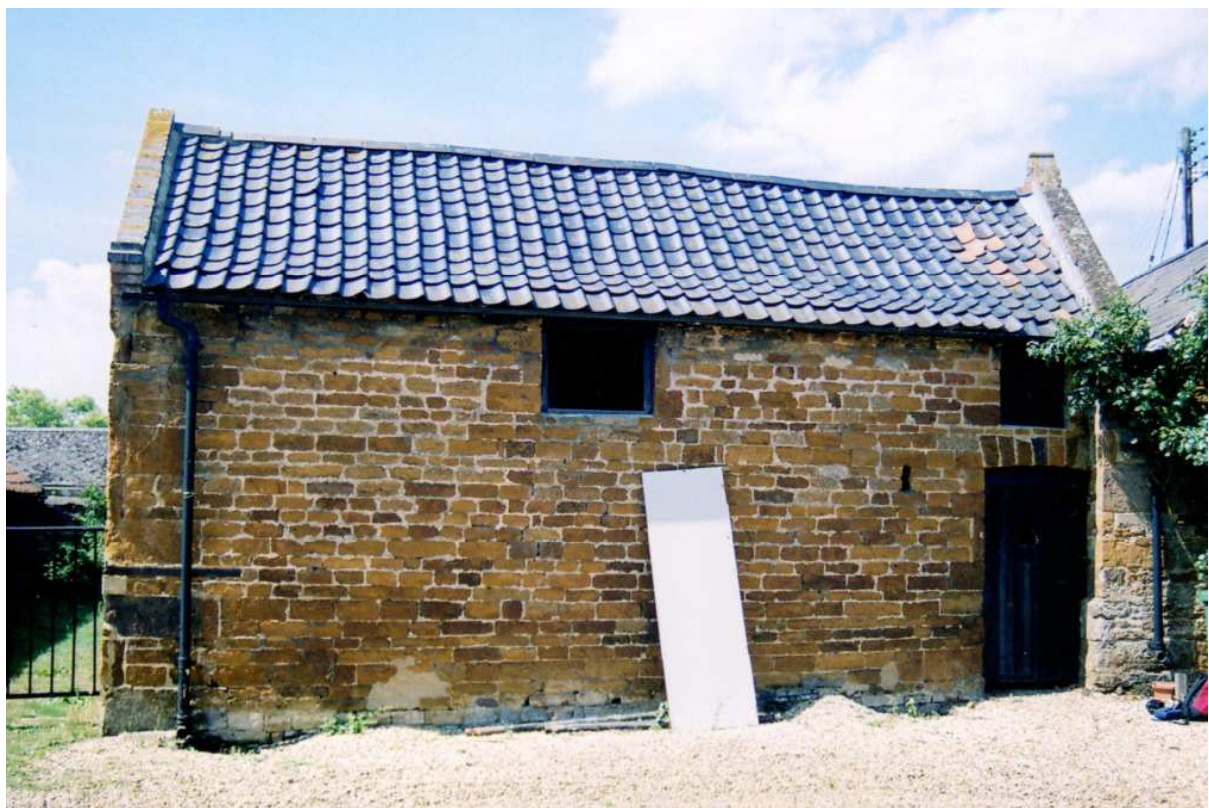
The S outbuilding abuts against the N one, being a later addition. It has E and W walls of stone, but the S gable was rebuilt in brick. The front E wall has a standard size doorway to the N, with an arch of ironstone voussoirs, and two hatch openings at upper level. The rear had two boarded doors with brick arches and loft doors over. The original roof structure survives, of unusual type: two trusses with curved principals, tenoned to tie-beams. The tie-beams are probably older, re-used beams of C17-18 date, as they have ogee chamfer stops. Lapped collars, fixed with a single threaded bolt and square nut. The apex has yoke pieces nailed to either side, which support an ash pole ridge. Rough purlins are supported on the ends of the lapped collars. Rough pole rafters. The roof is set at a pitch of only around 35°, and is covered with black-glazed pantiles – probably the original material, as the pitch is too low for thatch. Such tiles are found in East Anglia, but rare in this area. This building is not shown on the 1800 enclosure map, so must date from the early 19th century. Its form, with doorways and loading hatches above, suggests it was probably a stable.

The rear outbuilding in 2006, before conversion

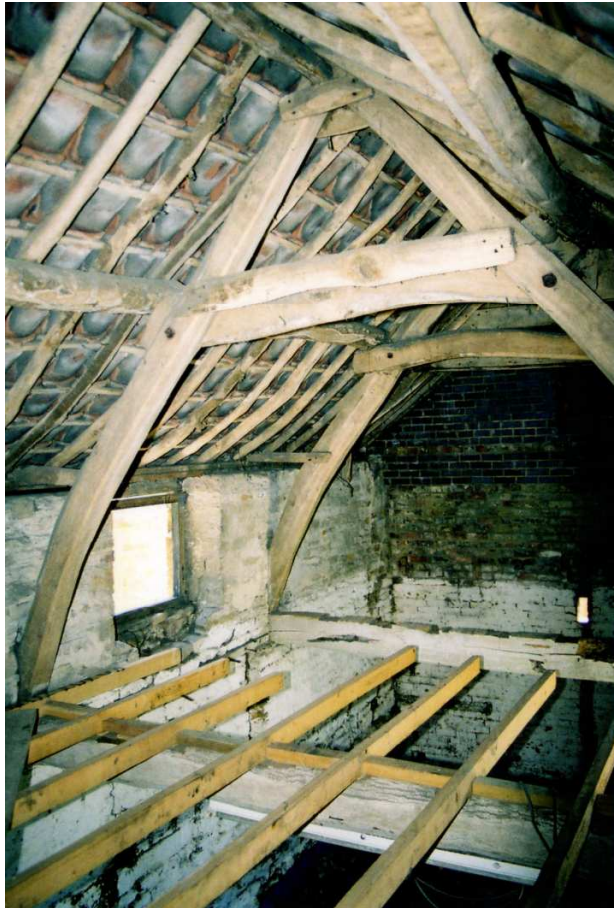
Curved principal roof truss
to south outbuilding in 2006

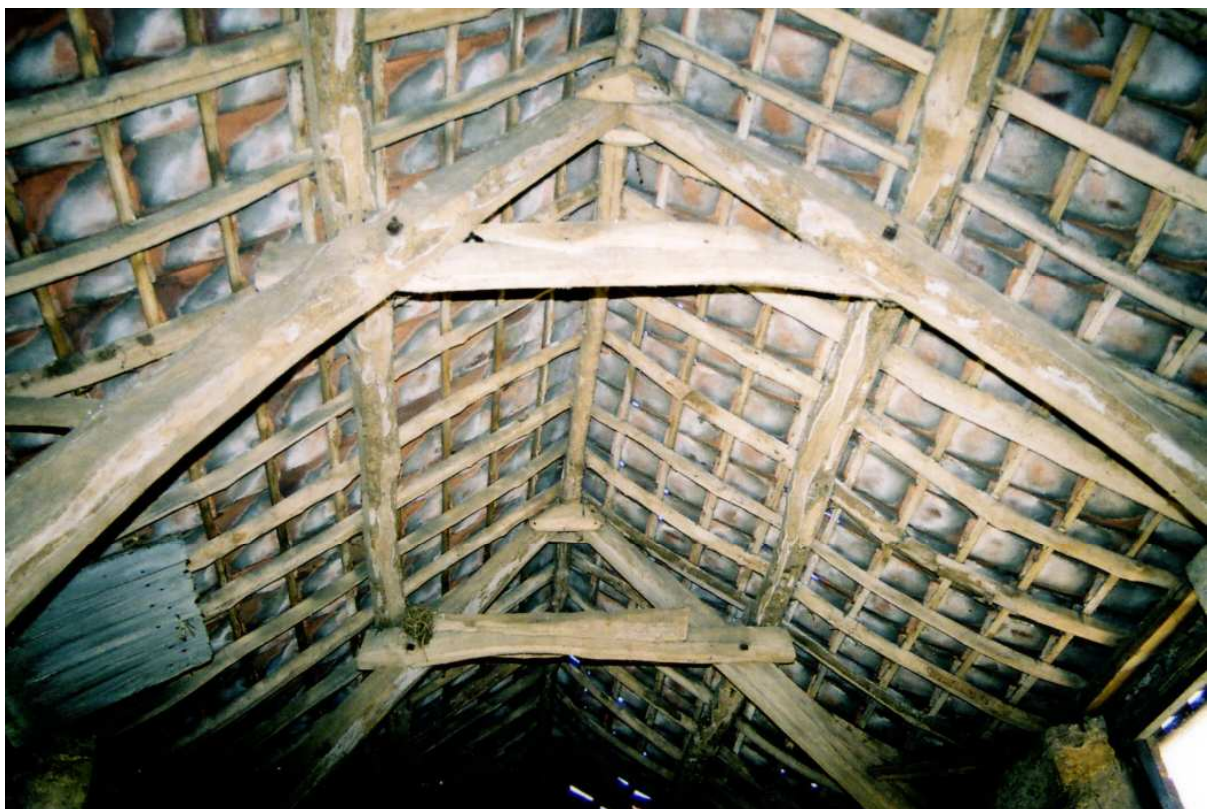
Apex to south outbuilding roof

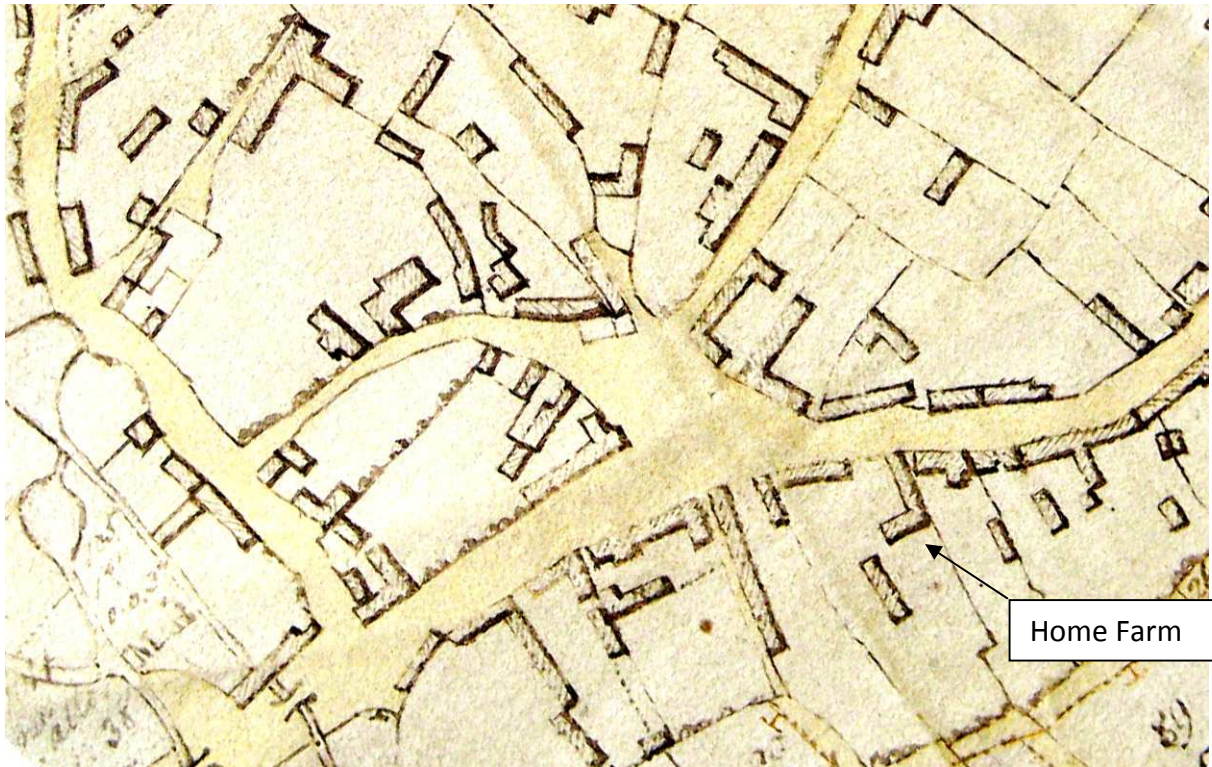
Caldecott Enclosure Map - 1800

The 1800 enclosure map shows the house with an L-shape, as existing. There is an outbuilding to the N (extending W beyond the barn, as noted above) and another large outbuilding SW of the house. The 1886 1st edition OS map shows the L-shaped house, with a porch to the S side and another small projection to the W gable. The farm buildings now form a courtyard, but the large outbuilding to SW has gone. A further outbuilding is set some distance further S on the plot.
