Lyddington Manor History Society

Historic Building Survey

2 Main St

Lyddington, Rutland

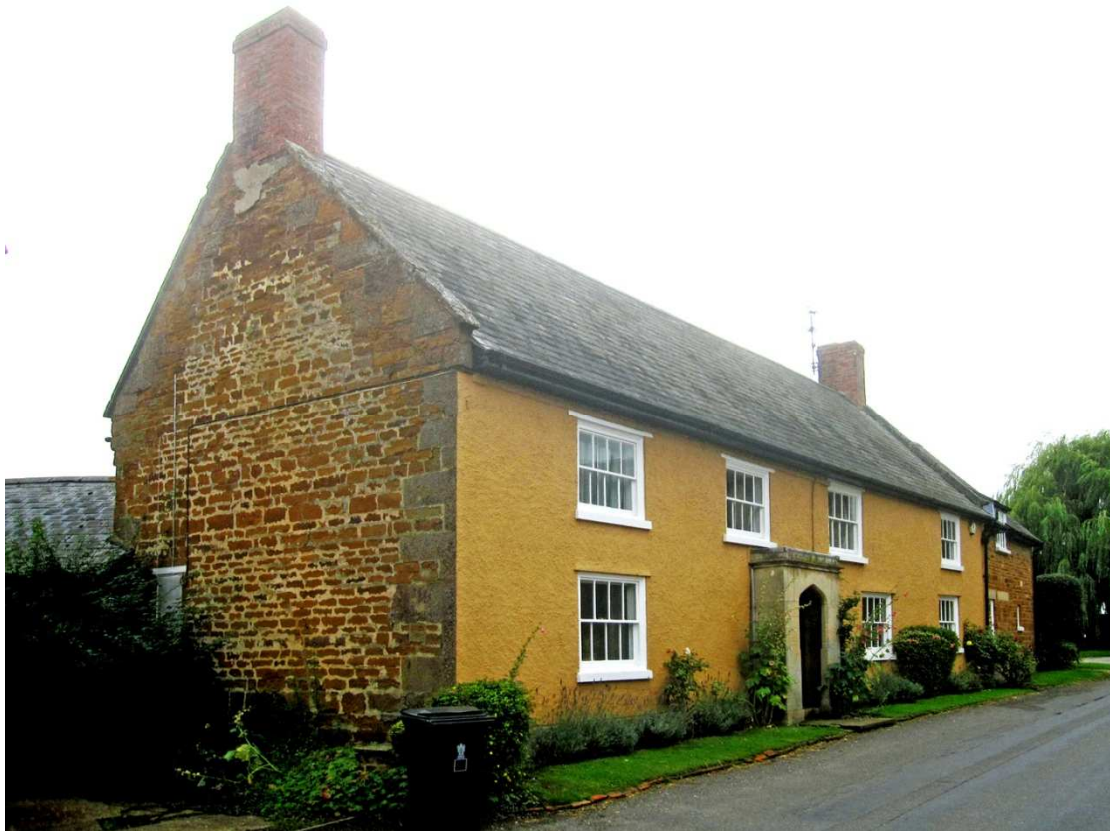
N gable has good quoins, small ground floor window offset to E. Upper gable shows the raking line of gable before roof raising; the gable parapet and plain kneelers may have been added when the roof was raised, as the roof seems to have no verge parapet on an old photo of c.1910. Two-flue brick stack.

View from the north-west

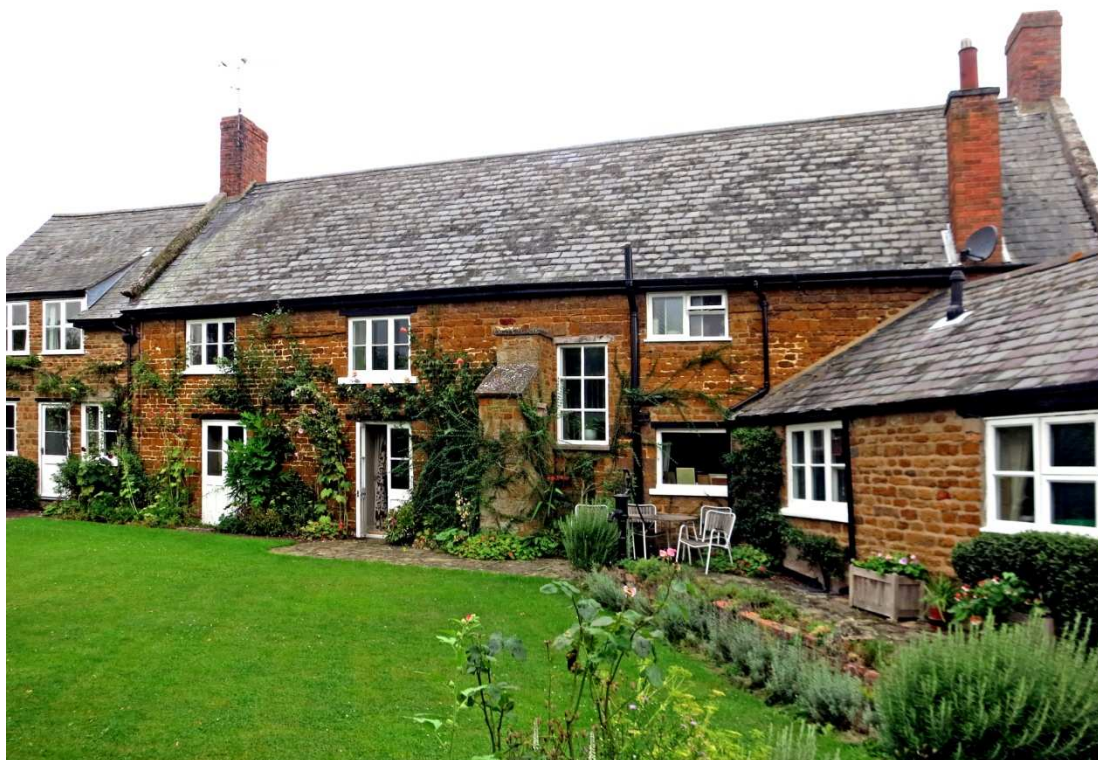
The rear E side is partly blocked by the former outbuilding which abuts at the N end. Well-coursed ironstone, corbelled courses at the top where the roof has been raised. At the S abutment to the outbuilding, there is only a partial straight joint, with no full quoining. The openings are rather irregularly set, with two 3-light timber casements to the first floor towards the S, two French window openings below, a large modern buttress, a tall modern stairs window and two modern windows to the N. Modern brick stack to NE.

The rear east side

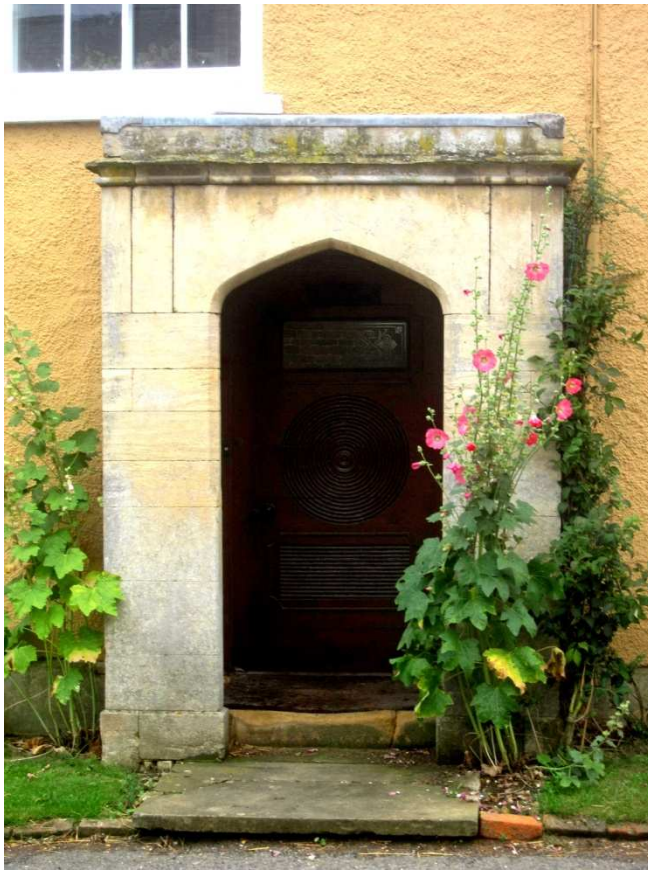
The W front is rendered, with large, irregularly placed sash windows. Porch of limestone ashlar, chamfered 4-centred arch, cavetto-moulded cornice and block parapet. Plain, square plinth runs along the whole front, of the same limestone ashlar. Inside, the porch has a front door and timber panelling to reveals and ceiling – flush panelled, reed-moulded panels to lower and upper level, central large circular reeded panel, glass to door upper panel. Unusual detail, probably c.1820-40. The sash

The front porch

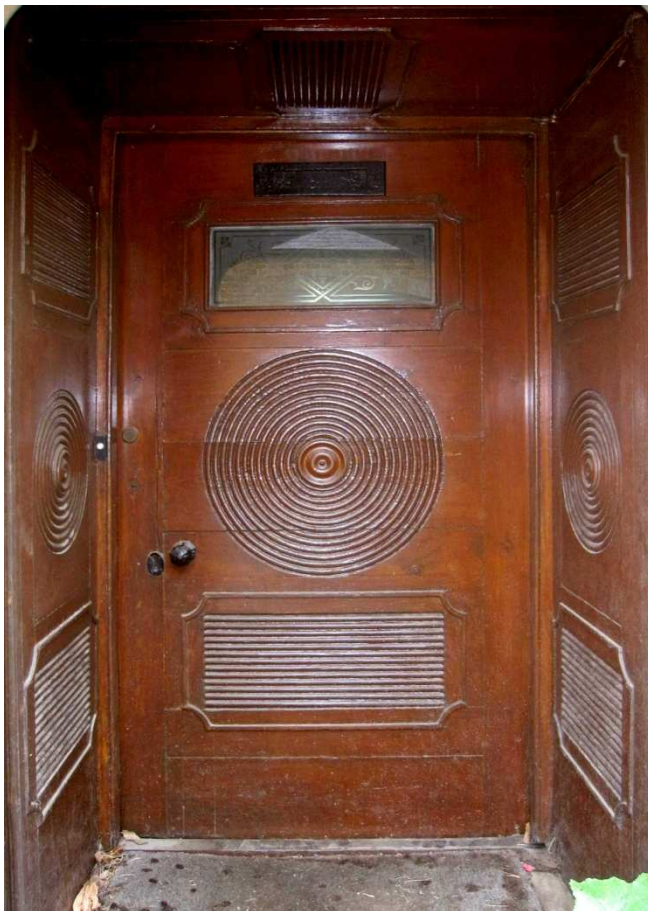
The front door and panelling

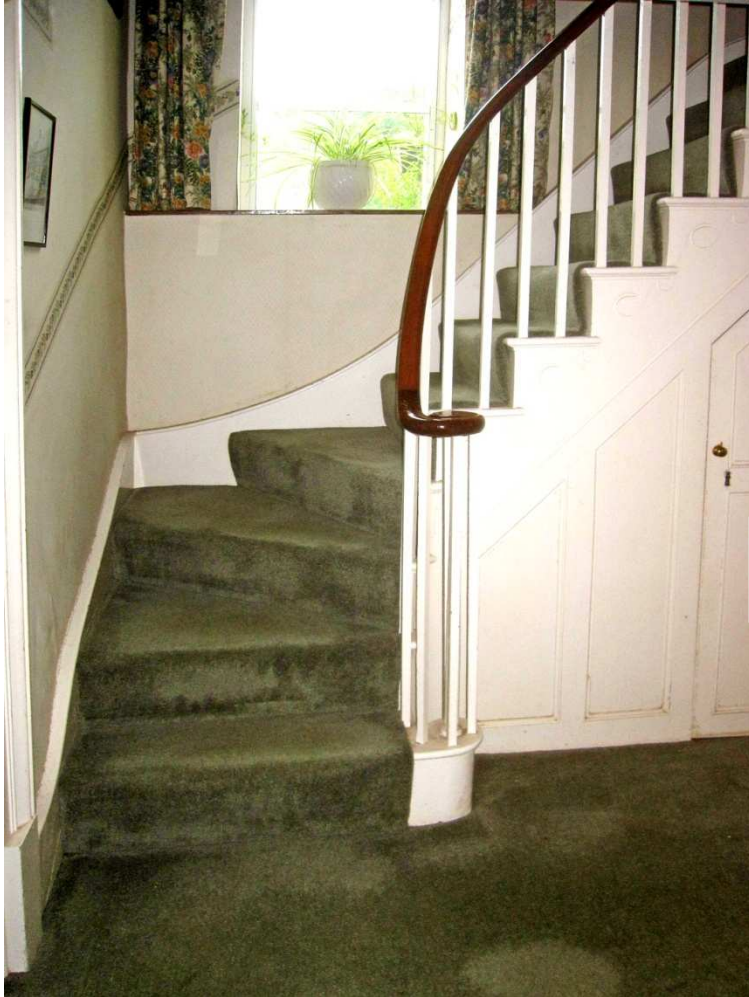
Central hallway with stairs at rear. Staircase with sweeping mahogany handrail, stick balusters, cut-string stair with scrolling pattern to tread ends, curved panelling to the inner return – all typical of early C19. The N room has a partition running N-S to the E side, forming a corridor. Old joists span W-E onto this partition, which must date with this placement of the joists, as they could not have spanned across the full width of the building. Fireplace in chimneybreast to N wall, of brownish marble, highly fossiliferous, thought to be from Derbyshire; flat marble slabs, with unusual mantelshelf, of doubled form with rolled front edges. Is this a later 20th century insertion? One would expect a fireplace for a kitchen here. Panelled cupboards to either side of the fireplace, and panelled linings to the interior of the sash window. In the SW corner of this room a section of wall steps out in thickness, and has a pronounced ‘batter’ to the internal face. At ceiling level, there is a short angled projection, boxed in. This is very likely to be a cut-off cruck blade, especially as these are often found in association with thick, battered walls.

The staircase in the entrance hall

The house underwent major alterations again in the early 19th century. Large sash windows and a high quality doorway and front porch were added. A fine staircase was added to the front hall, probably blocking the former cross-passage.

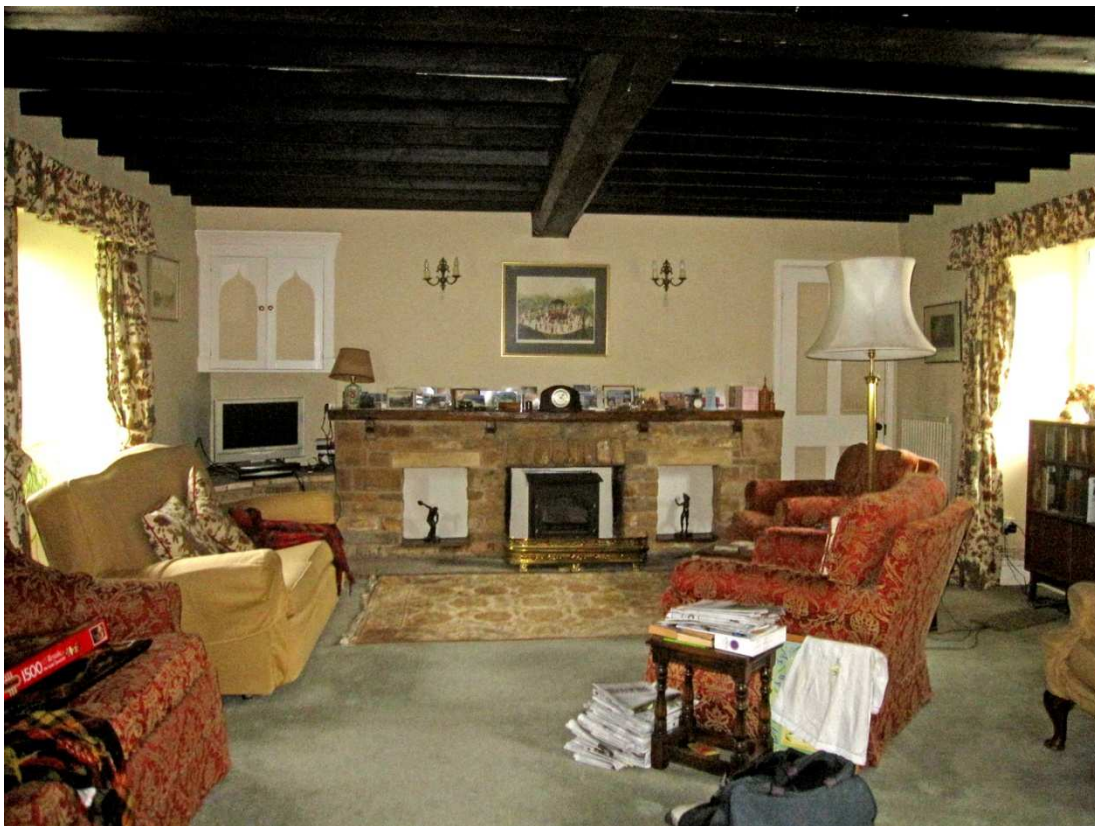
The S end now forms a single, long room, but a cross wall has been removed. The N part formerly had a large fireplace, removed in the 20th century. Large stone-built chimneybreast is visible in the entrance hall, with plaster stripped; this shows that the chimneybreast is not bonded into the front wall, so it appears the front wall is earlier. The spine beam to the N part has a scarf joint with iron strapping, which indicates the presence of a former chimneybreast. The fireplace is said to have been of stone, and

was relocated to Bay House, Lyddington. The S part had a fireplace set flush in the wall thickness, now with a modern fireplace front. The spine beam above has ogee stops, of 17-18th century type. Floor joists to both rooms however are of fairly thin profile, so it seems the floor structure was re-worked in the mid-18th century or later.

The south room, looking south

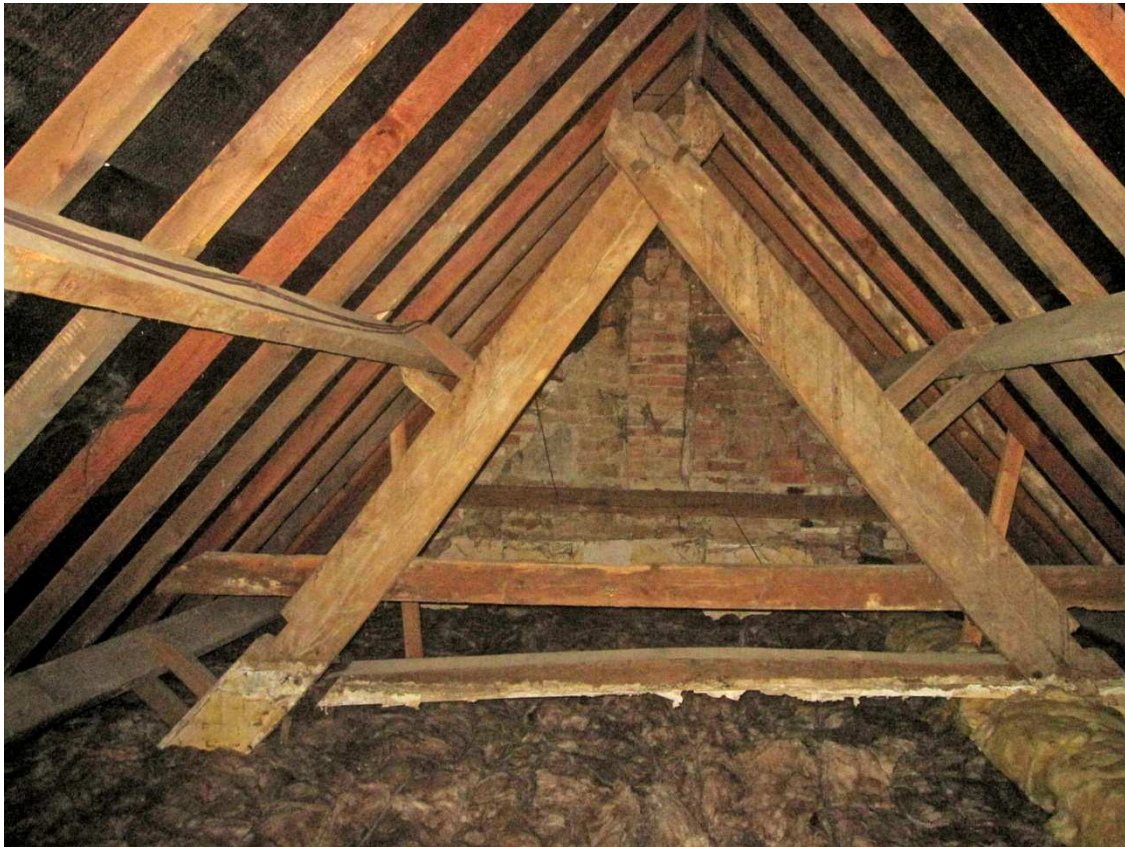
The roof structure has all been replaced, with the exception of a single old truss, towards the S end. This truss is of A-frame form, with heavy principal rafters and a thin, tenoned collar. The collar is morticed with two closely-set pegs. The design was over-ambitious, and one side of the collar has broken away, so a further softwood collar has been added. The apex has a half-lapped, scissor crossing to take a horizontally-set ridge, with two large skewed pegs. The purlins were only 115mm wide, trenched into the back of the principals, and fixed with a single spike nail, not a peg. The timbers are of neatly sawn oak, all unchamfered. This roof structure design is an odd combination of newer technique with cruder, old-fashioned detail. Tree-ring dating has found that the three timbers which form the truss were felled in 1745-50.

Truss T1 from the north

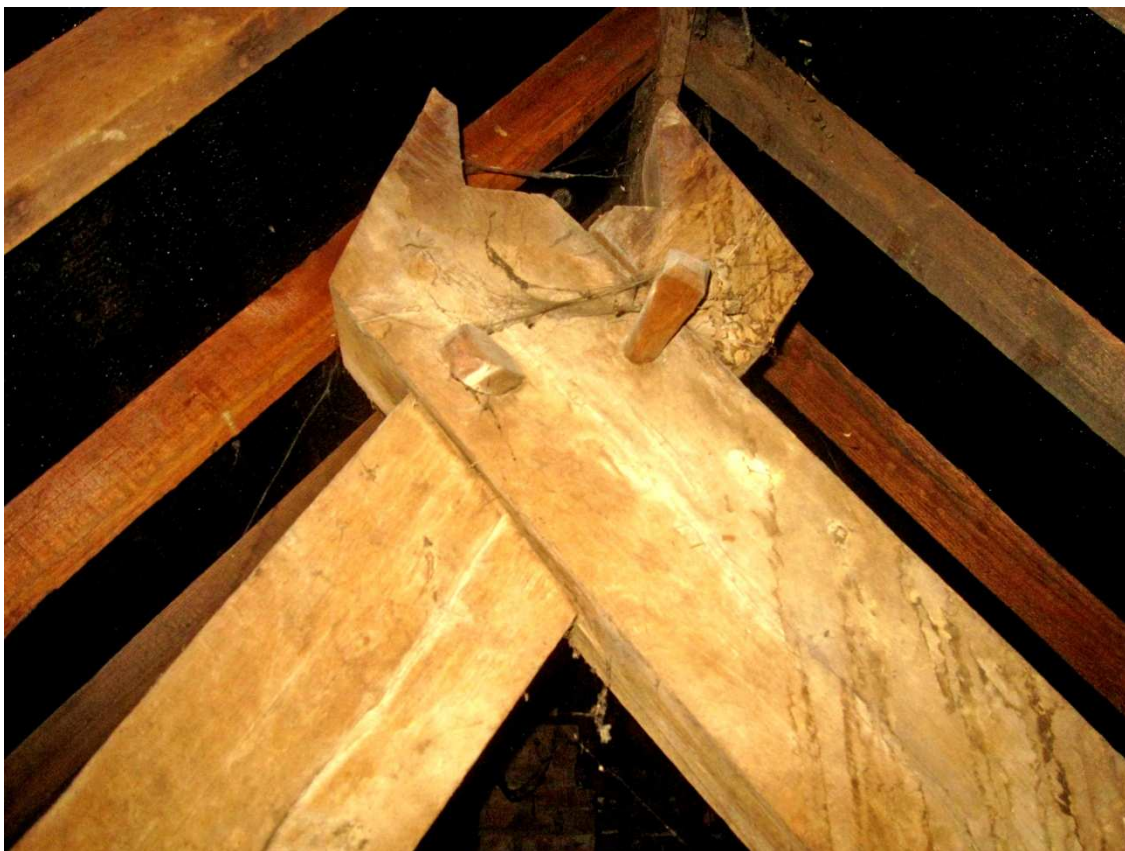
Scissors apex with skew pegs to truss T1

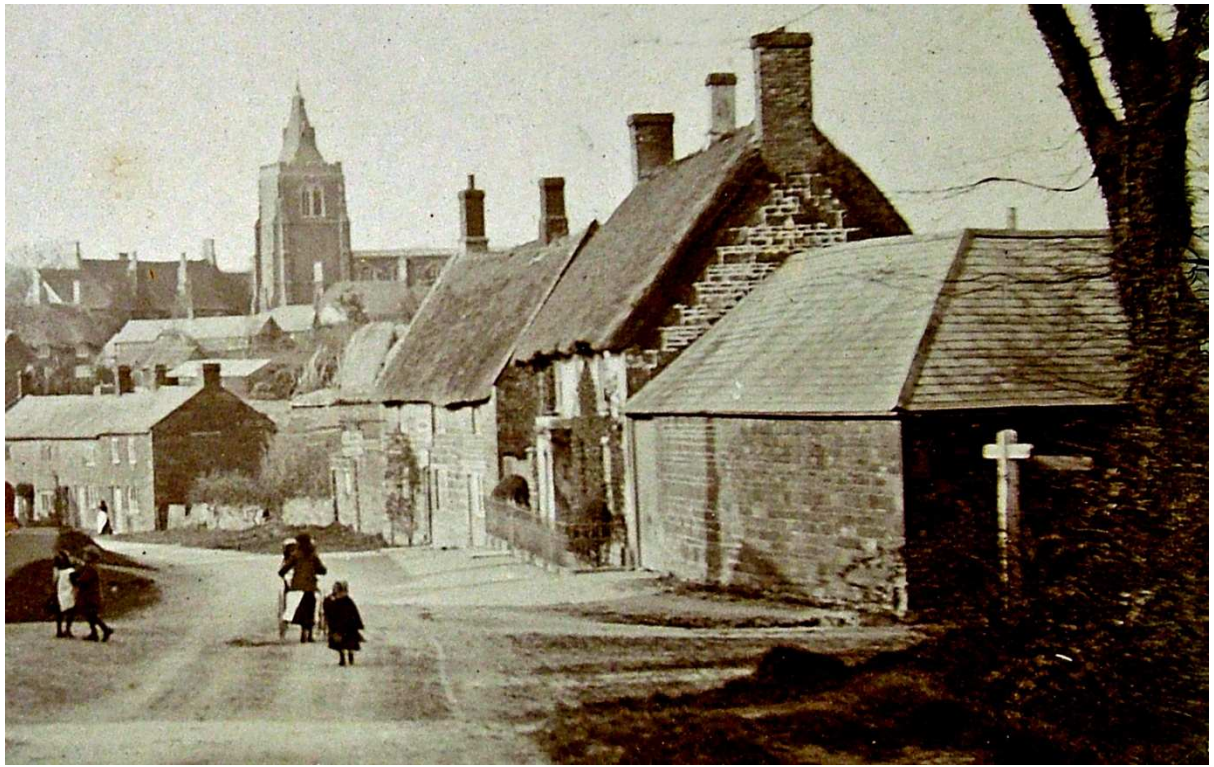
windows (7 in total) are wide, 4/4 panes, no horns, moulded timber architraves and block cills – also earlier C19. Old photos of c.1905 and c.1910 show the house with a thatched roof, raised slightly over the 1st floor windows. There was also a single-flue stack to the centre, probably of stone ashlar, and a set of front railings.

Photograph of *circa* 1910
