Historic Building Survey

6 & 7 The Green

Lyddington, Rutland

HISTORIC BUILDING SURVEY REPORT

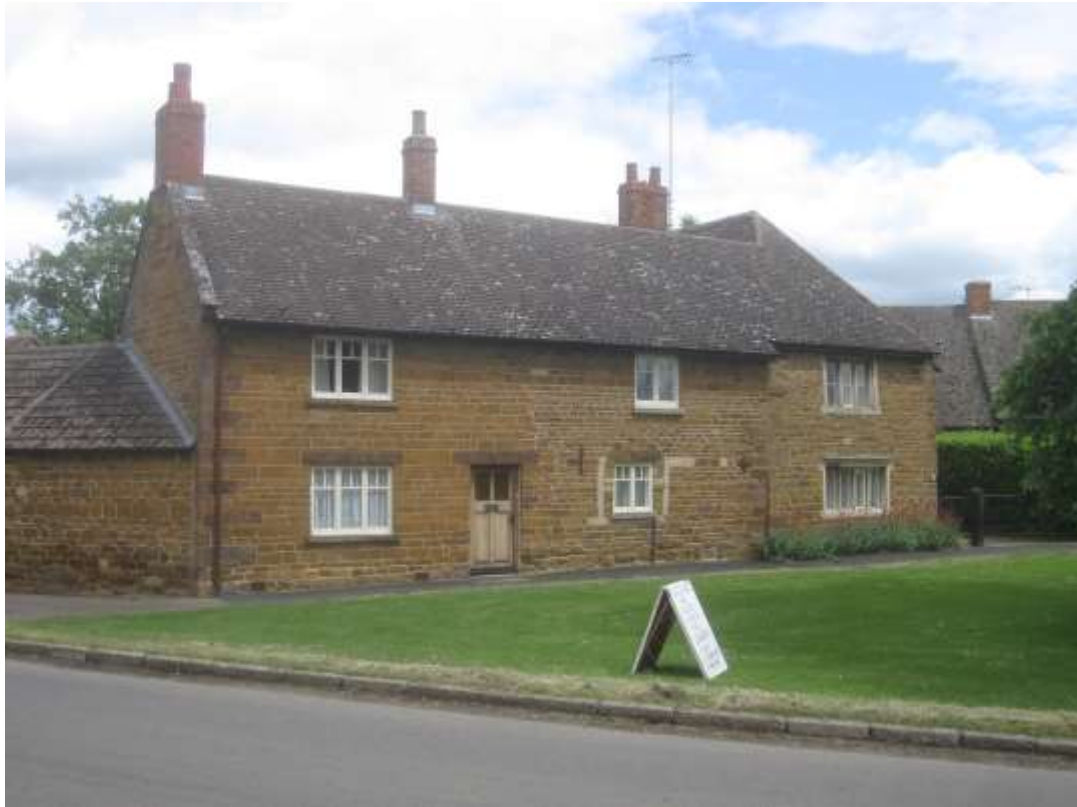
View from south-west

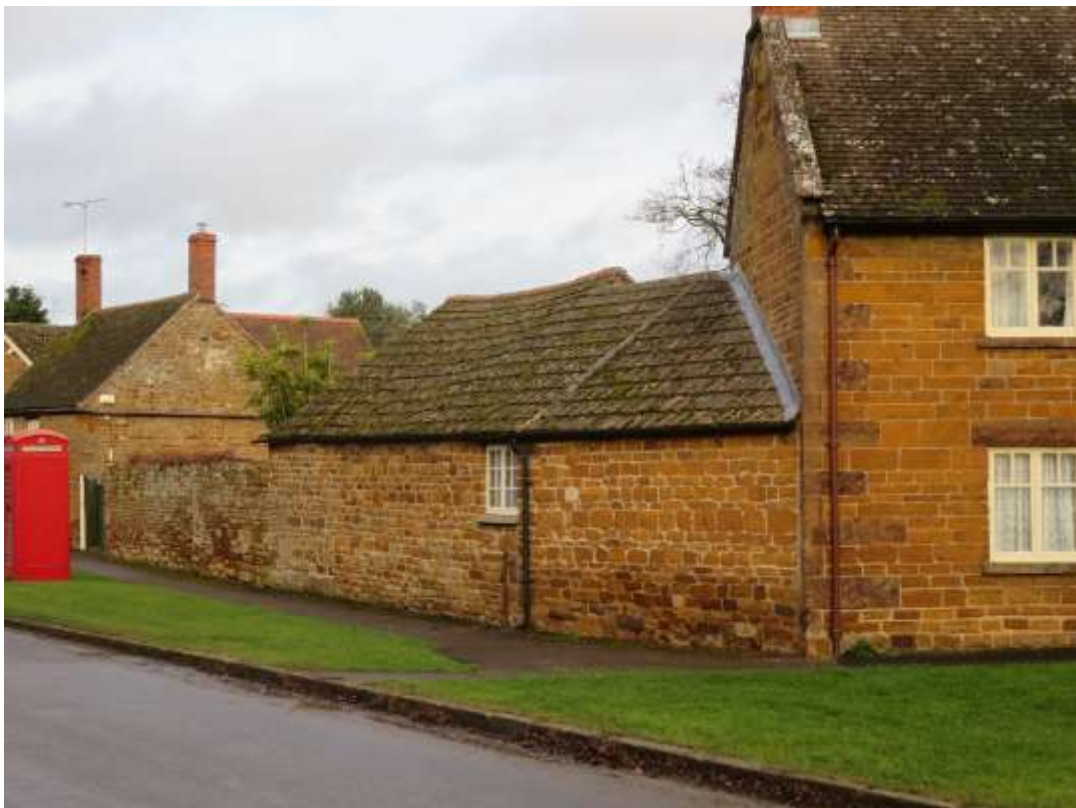
Outbuildings to north of No 7

No 7 has a range of two outbuildings which abut to the NW, running around the splayed corner. The splayed section seems to be a later addition, but the straight section to its NW, probably reduced in height, contains the remains of a chimneybreast on its S gable wall. Beyond this, two further sections of lost outbuildings are delineated by straight joints, and shown on the 1886 map, running up to the yard gateway. Beyond the gateway, the house at No 26 (Rowan Cottage) is now a separate property, though the 1886 map shows it as part of the same plot. In the middle of the yard was a T-shaped building, not shown on the 1848 map, of which some brick-built parts remain.

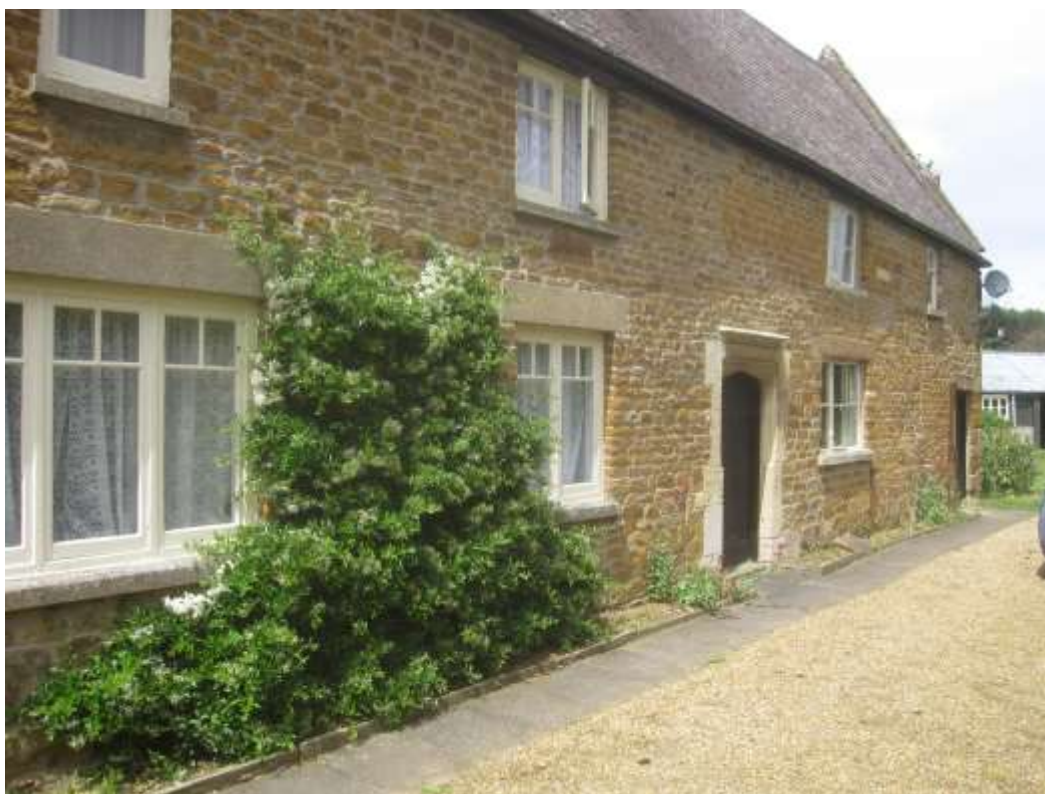
The east side of No 6

The E side has coursed ironstone walling, slightly more irregular than the front, with an area of patching in well-squared blocks above and N of the doorway. Fine central doorway of Ketton stone, 4-centred arch head, cavetto/chamfer moulded jambs, high rounded stops, cavetto-moulded cornice. The head has little weathering and has probably been replaced, before the 1913 Henton photo, where it appears brighter than the other stonework. See below for the original timber-boarded door. To the S of the doorway, there are now two large ground floor windows, with a large and a smaller window to the first floor. These are all post-1913 insertions. The Henton photo of 1913 shows that there was formerly a single 3-light window to the ground floor here, of timber, but with a cavetto stone cornice, indicating that it originally had stone mullions. Directly above this was a fine stone dormer window, a 3-light mullion, with a cavetto hood mould with dropped ends. The dormer gable had moulded corbels and a parapet coping. In the upper gable the photo shows a large recessed panel surmounted by a cornice, with what appears to be a clock face in its centre. To the N of the doorway on the ground floor is a 3-light timber window with a flat ironstone lintel, which has keystone ends, supported on jamb blocks with sloped abutments; central opening casement on pintle hinges. This looks of around early 19th century date. Directly above on the 1st floor is a similar 3-light window. The former sloped sides are visible, indicating this was an eyebrow dormer in the thatched roof, before this was raised and replaced. At the N end, tight against the gable end, is a doorway with a flat ironstone lintel, the S jambs being only of rubble – probably an early 19th century insertion. Between the doorway and the 3-light window is a blocked opening of a former window. Single light modern window to 1st floor above.

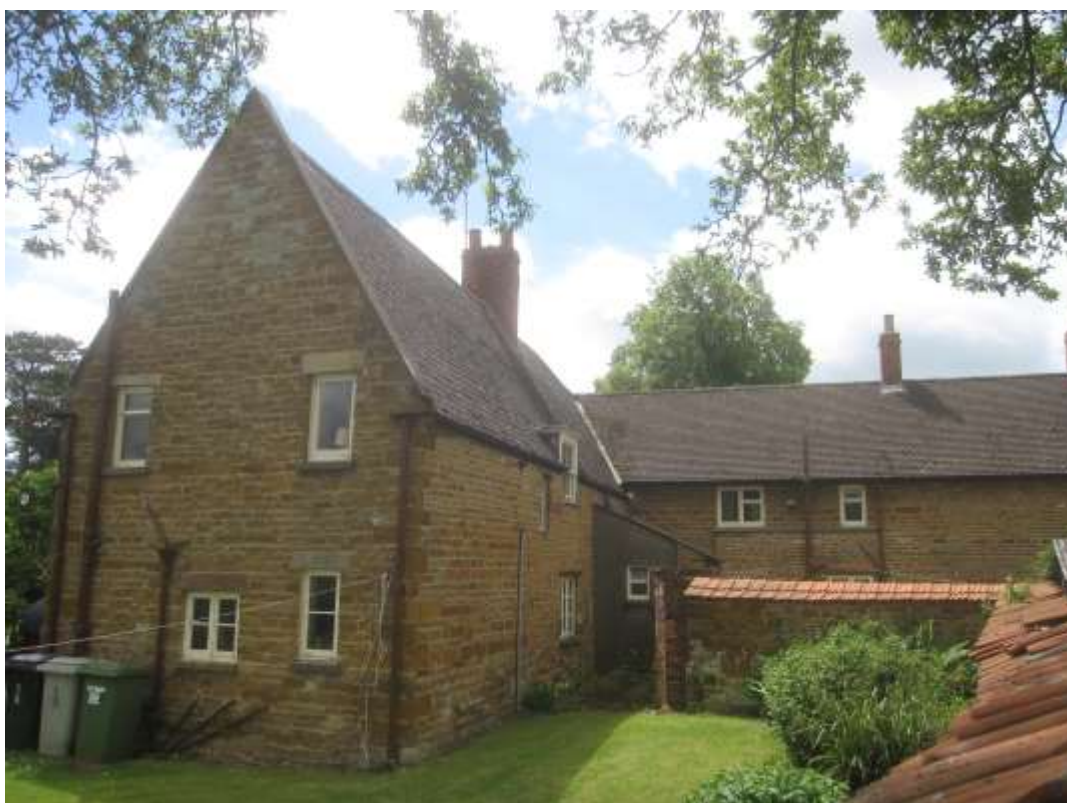
View from the north

The N gable has good ironstone quoins and kneelers, with the remains of an ironstone coping to the parapet. There may have been moulded corbels before the 1950s re-roofing. Ground floor has central 2-light timber window with flat ironstone lintel. Another modern inserted window to ground floor, and two to 1st floor. No evidence is now visible of a former attic window.

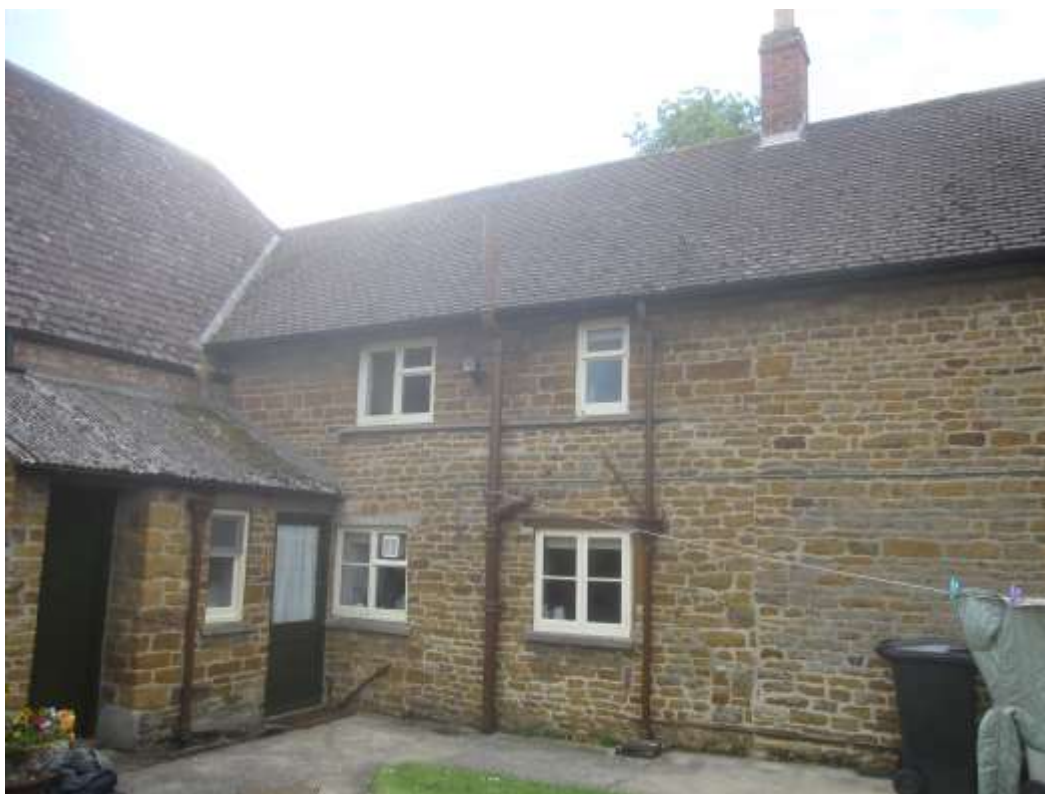
The rear north of No 7

The rear N wall has irregularly coursed ironstone to the E, with a joint line where it meets the rebuilt W part. The upper part of the E wall, above an offset, is also more regular, a later build. There is a small, fairly modern lean-to extension in the internal corner with No 6. W of this, the window was formerly a doorway. There is another window on the ground floor to the W, and two windows above. The W part is blank.

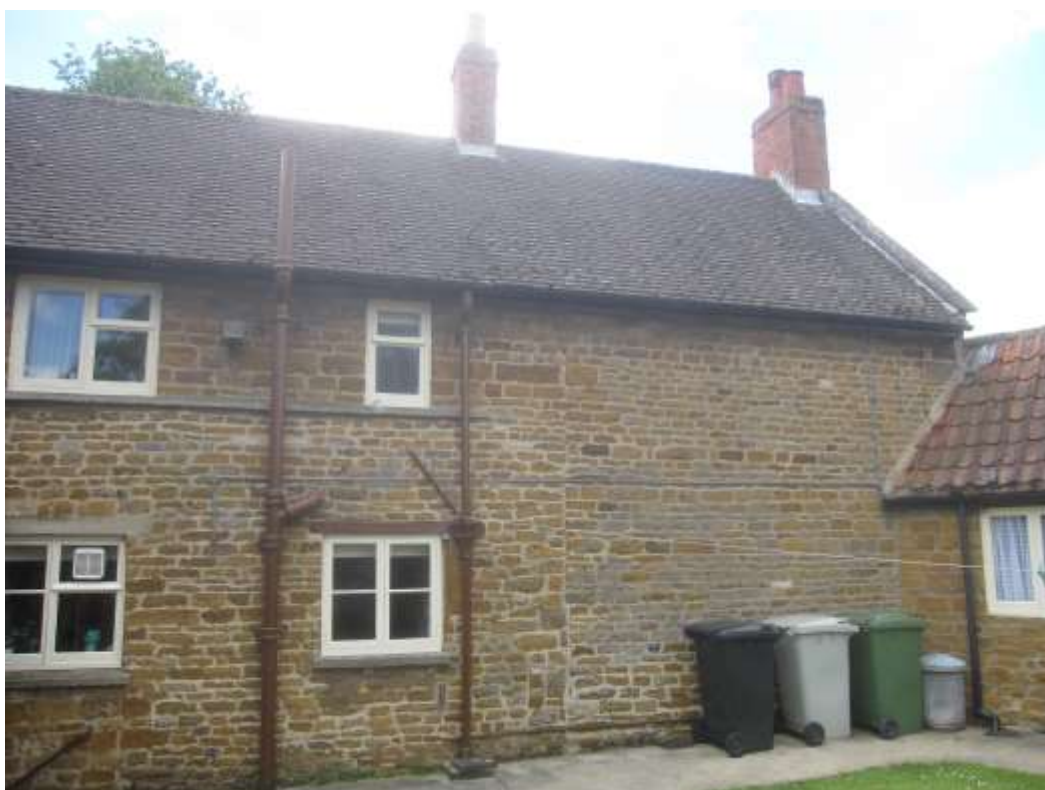
Rear north of No 7, west end

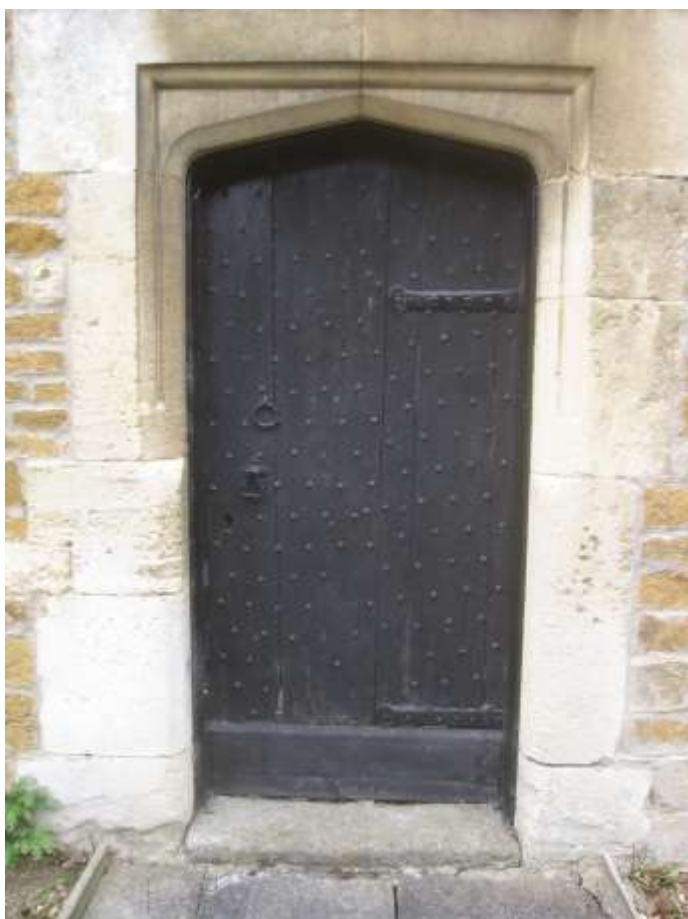
Original 17th century door to No 6

The oak-boarded front door needs special mention. It appears to be the original 17th century door, surviving complete with its hinges. An extremely rare feature is that the door was designed to fold in half, like a window shutter. The door is of double-boarded construction. The front boards are vertical, some of tapered form (which allowed maximum use of timber). The back has continuous horizontal boards, rather than the usual ledges. The front boards are mostly jointed with overlap rebates, with bead and astragal moulding, though the central hinged joint is square-edged. The front has large-head nails, closely but irregularly set. Strangely, very few of these can be seen clenched over on the inner side, so the fixing together of the front and back boards is quite sparse. Two thick, short strap hinges with rounded ends, on stout iron pintles, are set into the masonry surround – all probably original. A notch cut into the door below the pintles allowed the door to be fitted, or taken off for re-fitting. There are no holes for a previous set of hinges. The rear boards include a few narrow boards. The central flap joint has three big flat hinges, fixed with nails, with large knuckle joints. The door latch has a drop handle with shaped back plate, now fixed with slot-head screws. Inside, there is a plain latch bar and hasp. The latch may have been renewed or at least re-worked, though it is probably in its original location, set on a thin, slanting and recessed piece of boarding. Just below the latch is a timber lock case. It is plain, now fixed with slot-head screws, and is in working order, complete with key. However, it is probably a later replacement, as there is a blocked keyhole above the door latch. Lower down, there is an early door bolt, of plain round section, fixed with two drive-in hasps. The half-fold in the door is not set in the centre – the outer part is rather wider than the inner one.

The reason for this highly unusual feature may be that wider clearance was desired in the small entrance lobby, against the central chimneystack, so that the open door did not partly block the doorway leading into the north room. The only other reason would be that the front door could be half-opened, instead of fully opened, but this would serve little purpose. No other examples of this feature have yet been identified.

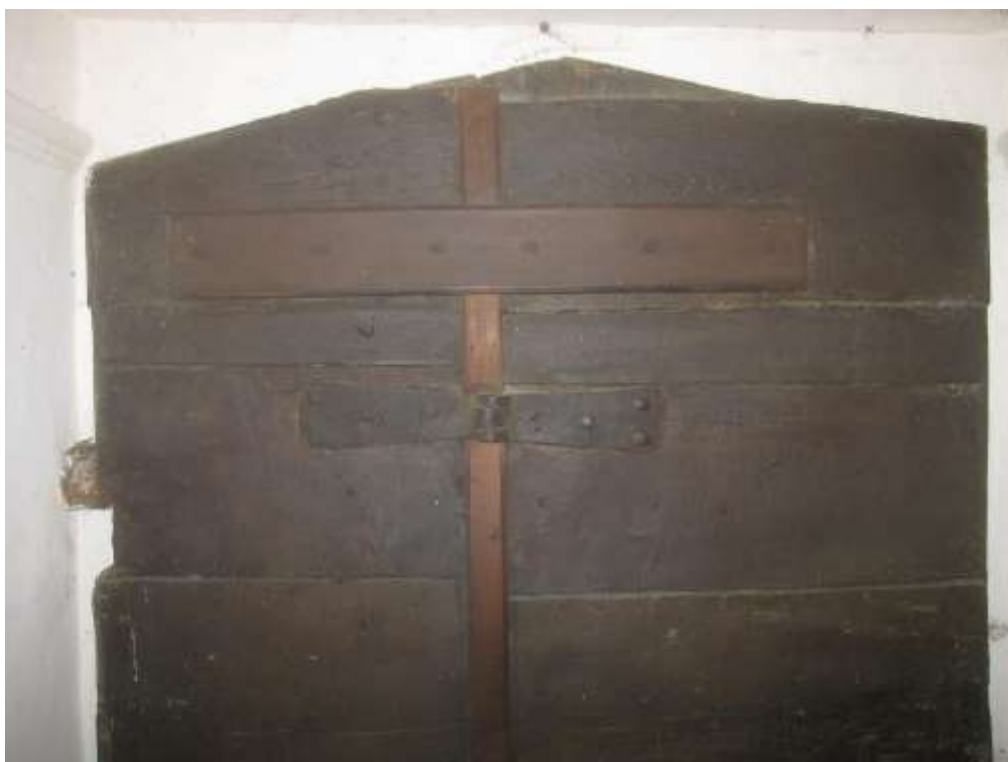
Rear face of door to No 6, with centre-folding hinge

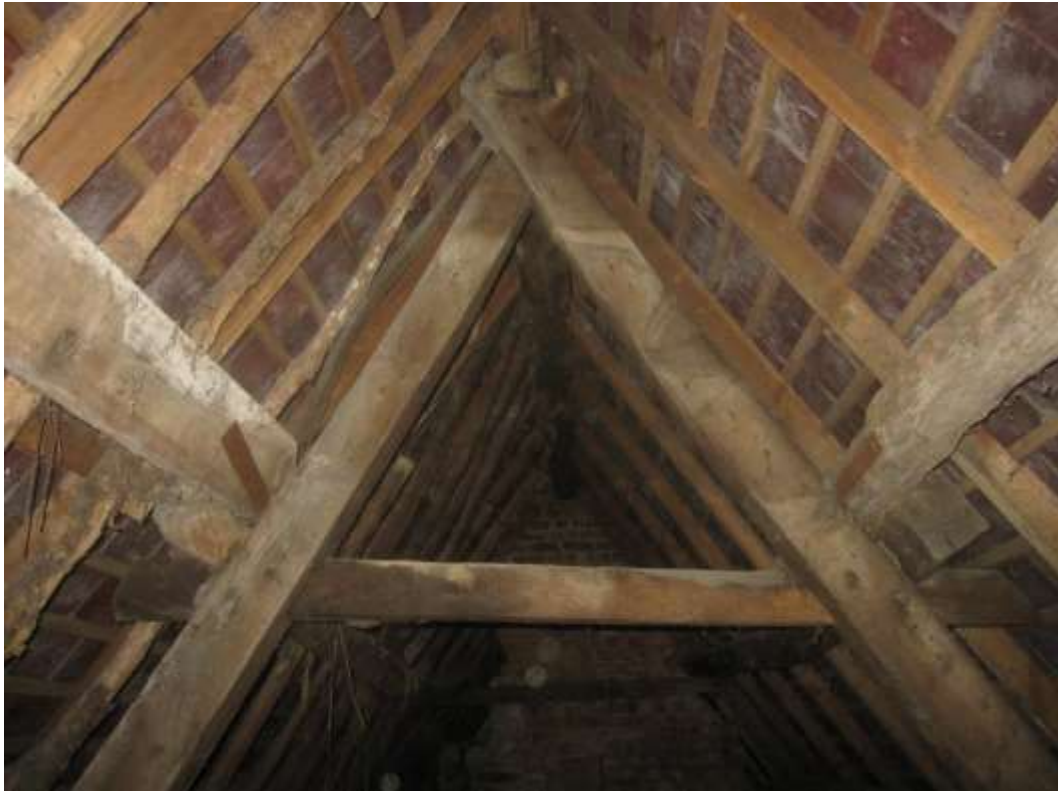
Truss T1 to No 6, north side

The main roof structure survives to the N of the central stack, but has been largely replaced around the 1950s to the S. The N part has a single truss T1, set centrally between the stack and the N gable. This is an A-frame truss, with lower and upper collars, both plain-lapped and pegged. The principal rafters (tree-ring dated to 1755 as below) are fairly slender and very neatly squared. Scissors apex with seating for square-set ridge. The pegs are mainly square-shaped to their heads. A few carpenter's marks, of short (c.20mm), neatly chisel-cut type, are visible, though there were no marks to the W principal/upper collar joint. Set on the back of the principals, the lower purlins to the S bay are both bead-moulded on their lower corner. A peg with a pointed tip, which fixes the purlin to the principal, can be seen to the E side. The upper purlins to the S bay are notched into the collar. All four purlins to the N bay are rather crudely set above the S purlins, which have square-cut ends, without any jointing for an earlier, more neatly-set N purlin. Quite a number of ash pole rafters survive, fixed to the purlins of both the N and S bays. There are also thatch battens of split ash poles, and some surviving straw/hay rope and old twine, used for fixing timbers and the thatch.

Tree-ring dating samples were taken in 2014 by Robert Howard of Nottingham Tree-ring Dating Laboratory from the roof timbers. Two samples from the principal rafters of truss T1 retained complete sapwood and gave a precise felling date of 1755. The roof structure was evidently replaced at this date.

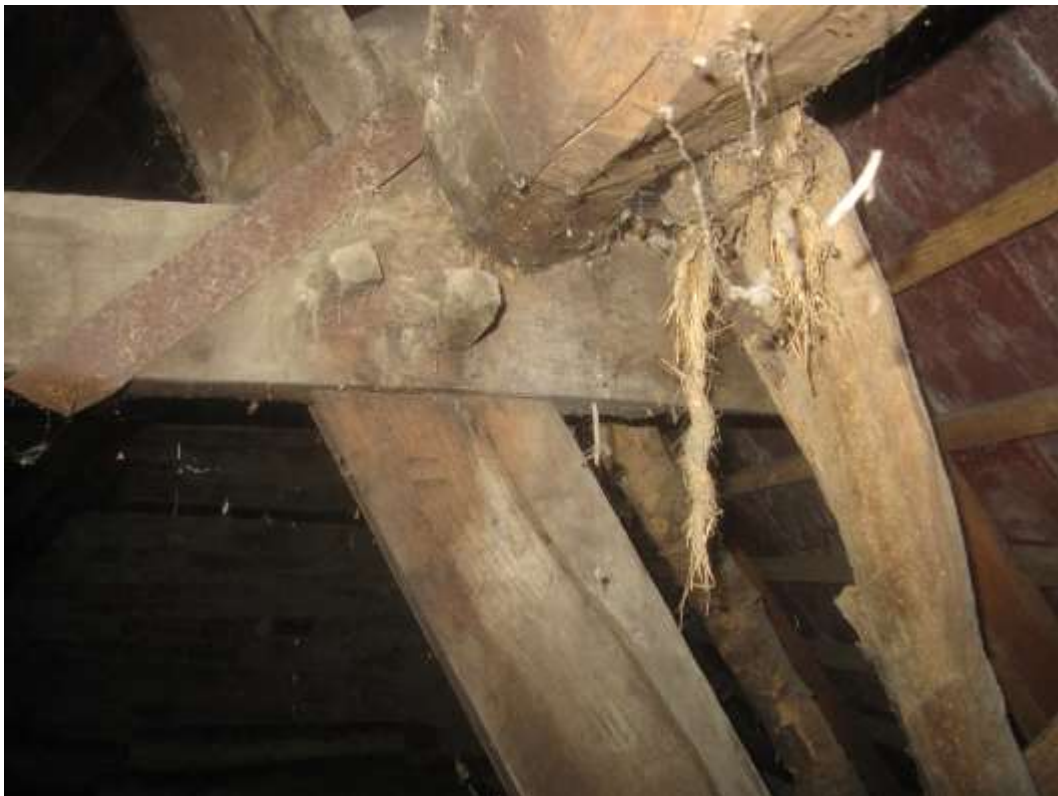
Detail of lap-jointed collar to truss T1

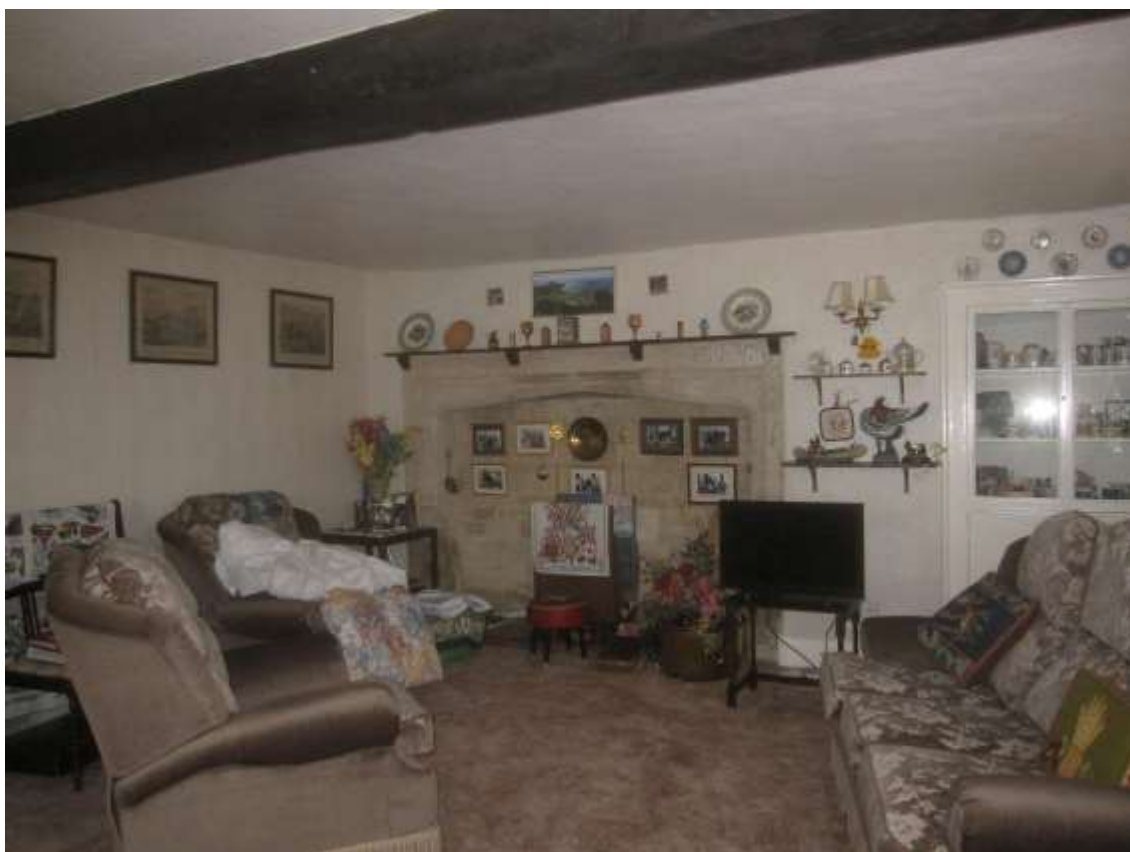
The former parlour to No 6, with moulded stone fireplace

The central front door led into a small lobby, leading into rooms to left and right. The S room is now part of No 7, with the doorway to No 6 blocked off. It has a large, impressive fireplace of Ketton stone, offset towards the W. 4-centred arch, ogee and cavetto mouldings, high rounded stops. The outer surround has been hacked back, so any cornice/mantel projection has been lost. The fireback has been built up and the flue closed off. Transverse beam, chamfered, no stops.

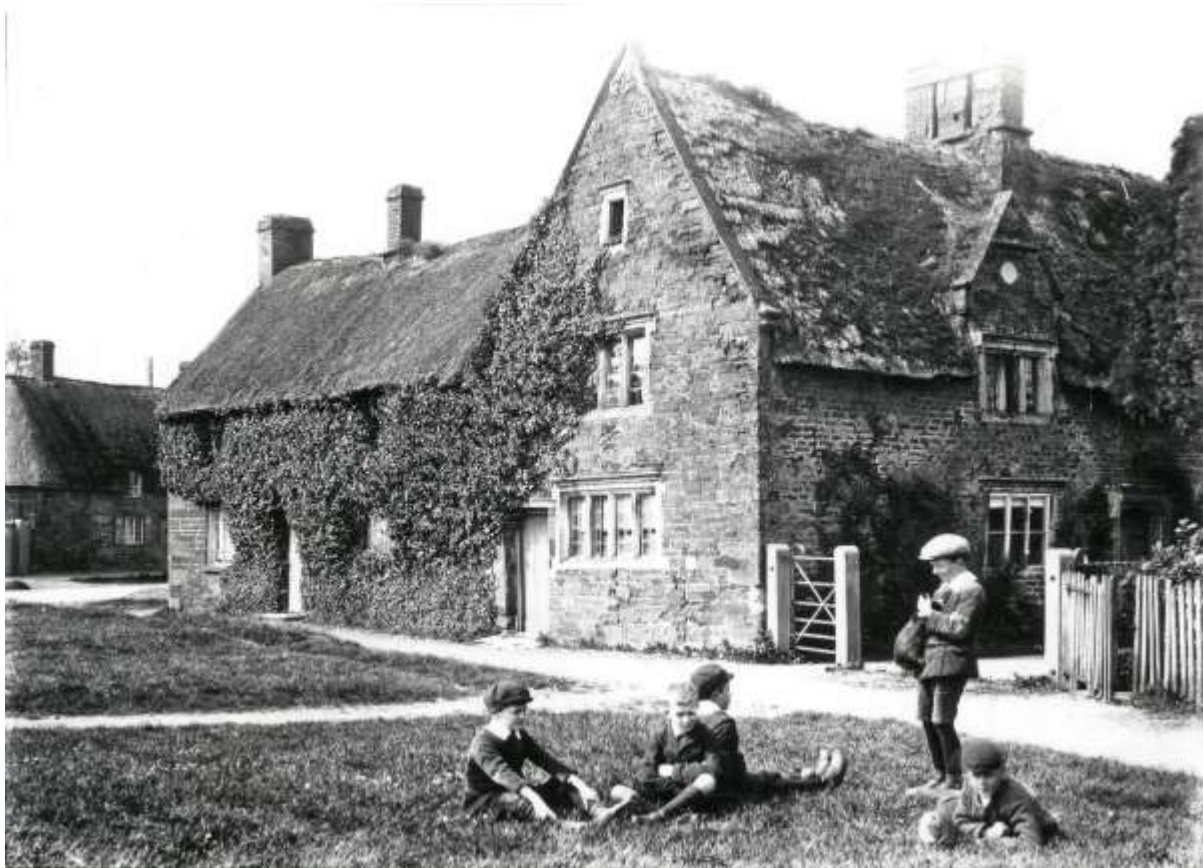
Henton photo of 1913, with lost gable and dormer to No 6

The central chimneystack was rebuilt in brick as a 2-flue stack around the 1950s. The Henton photo of 1913 shows it was originally a fine 2-flue stone stack, with chamfered plinth and two ashlar slab stalks. A third flue (for a bedroom fireplace) had been added to the W, in brick.
