**Lyddington Manor History Society  
Historic Building Survey**

**Avalon, 58 Main St  
Lyddington, Rutland**

## HISTORIC BUILDING SURVEY REPORT

### AVALON, 58 MAIN ST, LYDDINGTON

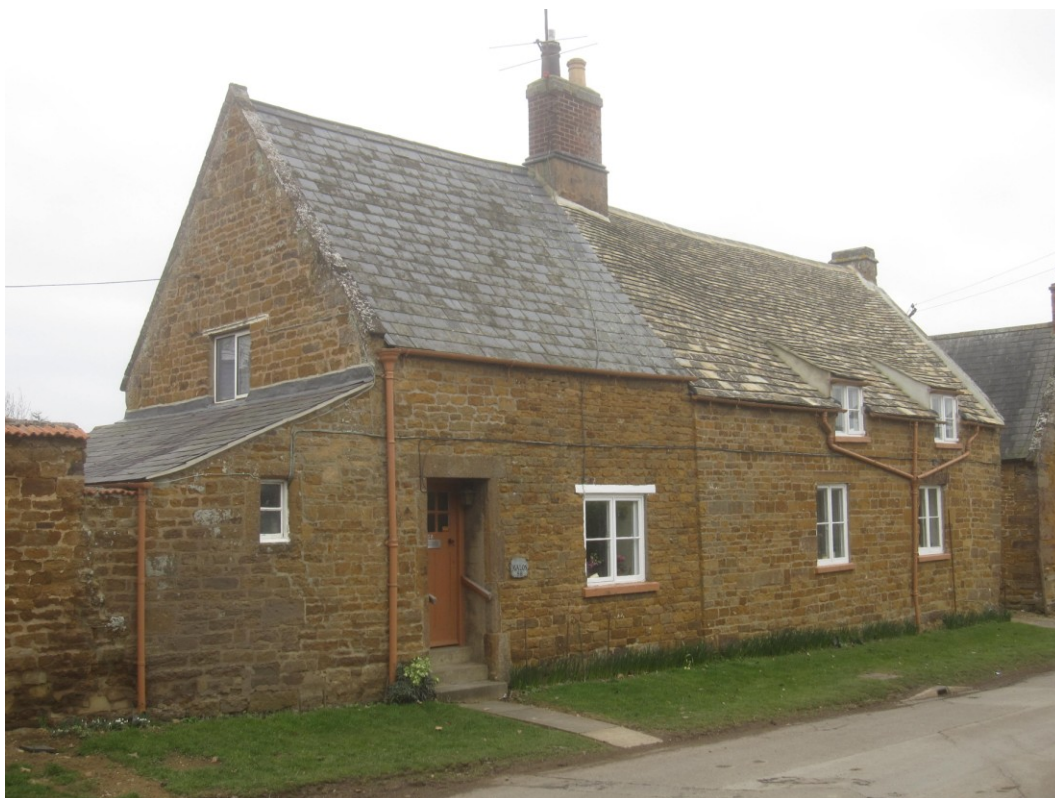
The N end of the W front has coursed ironstone in regular, fairly thin courses, which looks like a later re-facing. This stonework abuts against the southern two-thirds of the W front with a straight joint and is set back slightly. Doorway to N with ironstone plain flat lintel and tall, thin jamb stones – probably of C19 date. Timber casement window to S with timber lintel and stone cill. The masonry runs on into the block to

the N with no straight joint or quoins. This is now a single-storey extension, but was clearly an integral part of the earlier building. The stonework now has some larger blocks, and a small single-light window with plain-chamfered ironstone surround. Beyond the single-storey extension, the wall continues further N up to the plot boundary, with various irregularities but no clear straight joints. There is a blocked doorway with good quoins – no lintel externally, but an old oak lintel survives to the E face. Good quoins to the N end, against a stone gate pier of the adjoining plot.

View from the north-west

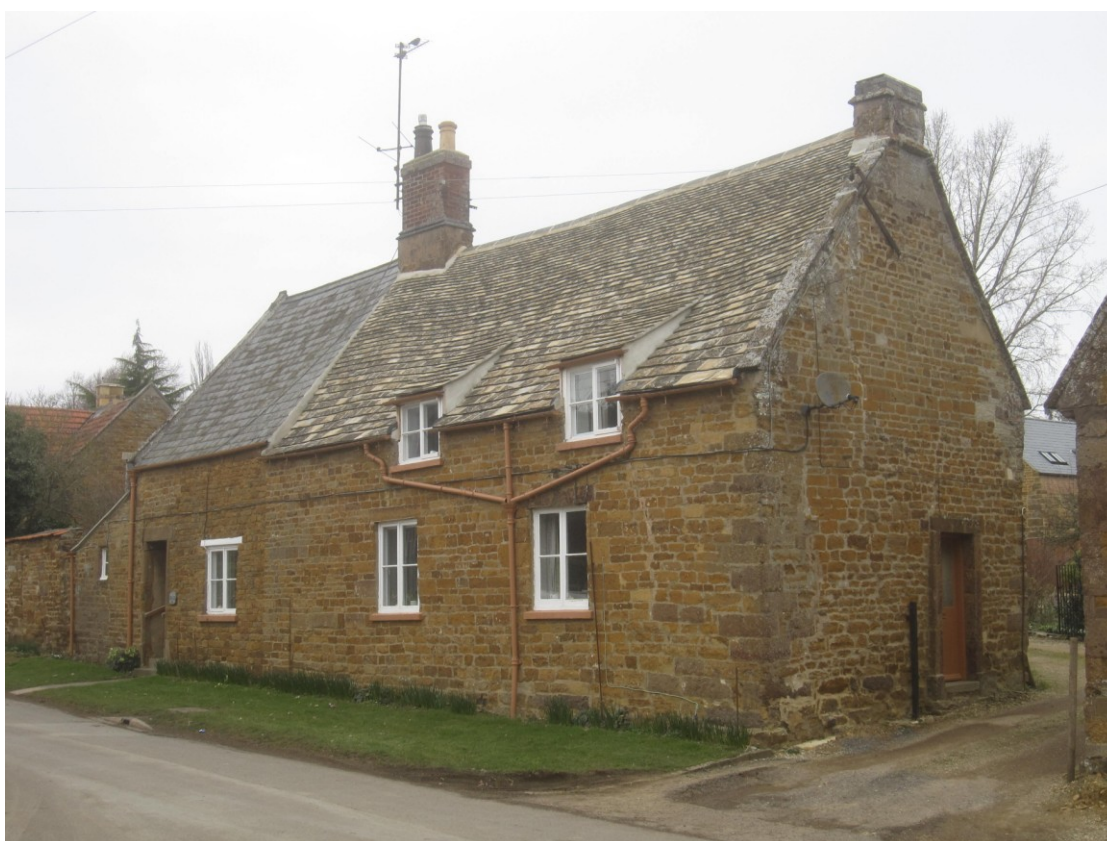
The S section of the W front has coursed ironstone, with some courses of rather larger blocks. There are no quoins to the straight joint with the N section. A little S of this junction, there is another straight joint and small offset to the lower part of the wall, probably from rebuilding an outward leaning section. Two ground floor windows with plain flat ironstone lintels, ironstone jambs and 2-light timber casements. Two half-dormers to 1<sup>st</sup> floor, with plain sloping roofs of Collyweston slates and rendered cheeks.

The S gable has good quoins and a coped gable parapet with plain kneelers. The lower parts have irregular coursed ironstone. The SW corner and the upper part of the wall have been rebuilt/re-faced, with better-shaped blocks. Ironstone doorway with plain, projecting surround, plinth blocks and flat lintel – probably of late C18 or C19 date. At the top the gable coping has a seating for a 2-flue stack with good ironstone blocks and a chamfered plinth, though the upper part has been lost.

View from south-west

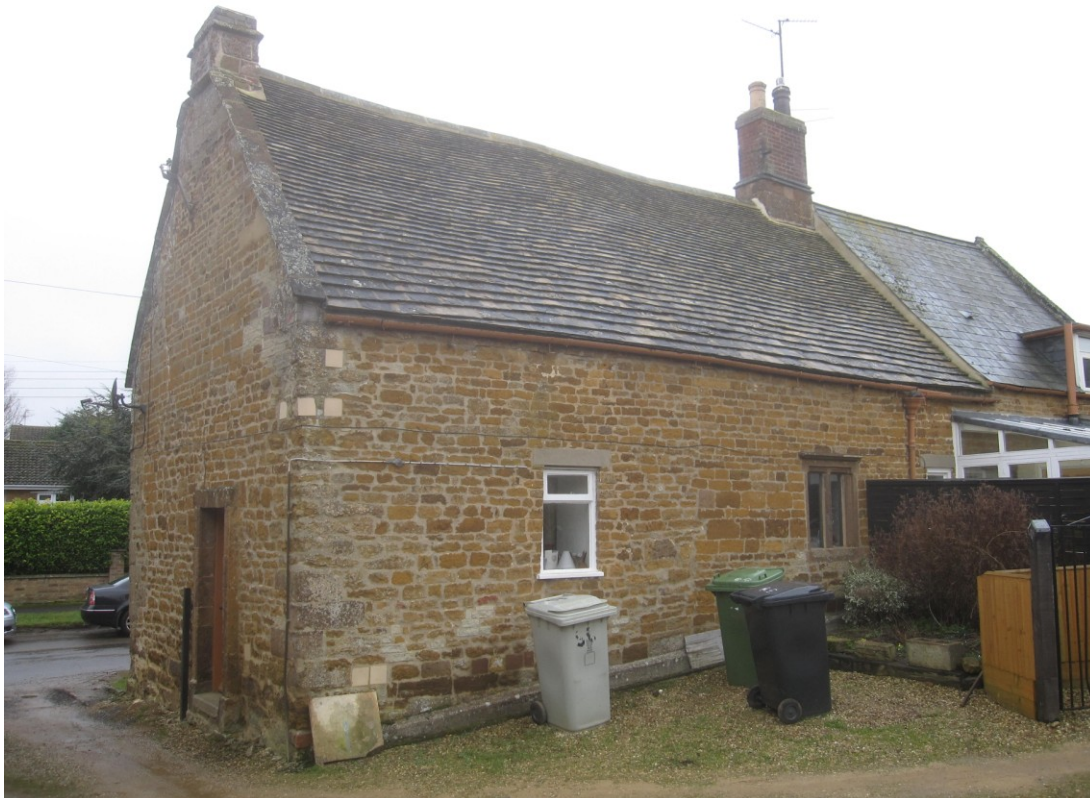
View from the south-east

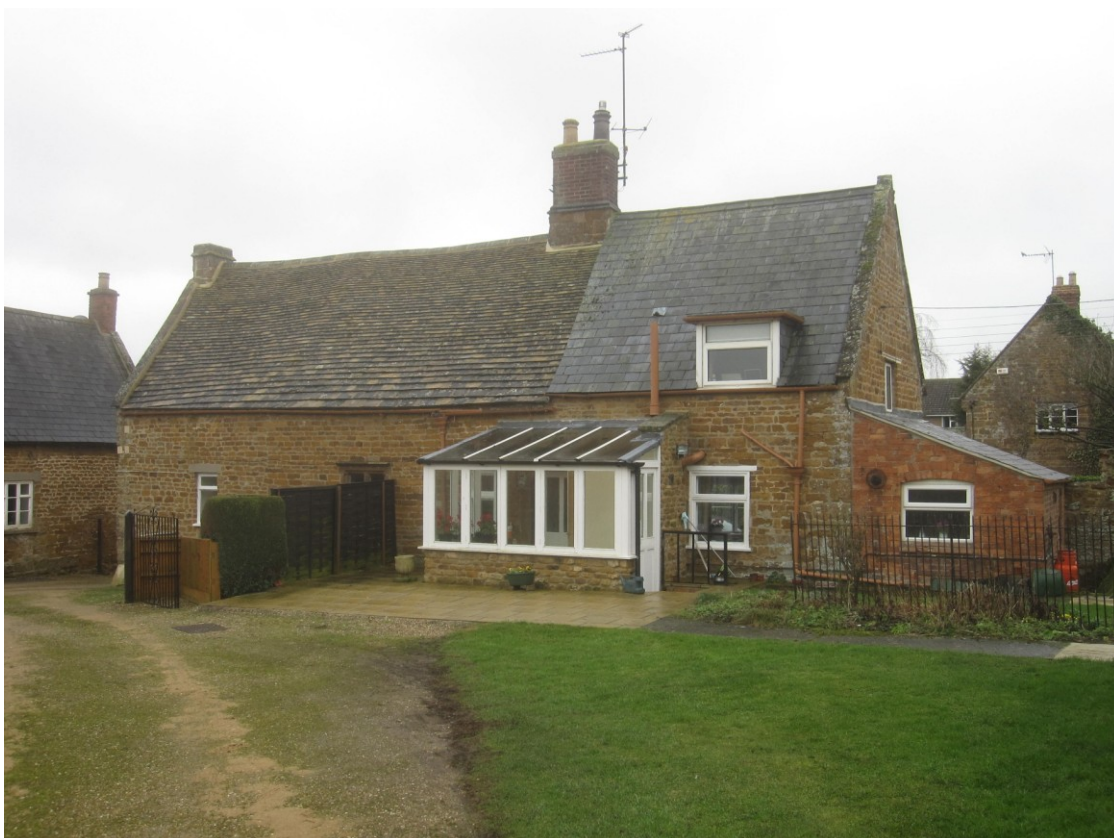
The rear E wall has rather irregular coursed ironstone to the S third, with a single-light window opening, a modern insertion. The central section has better coursed ironstone, and a 2-light ovolo-moulded brownstone window with cyma cornice. The mullions are quite tall, and the moulding returns to the head are left short of the jambs and central mullion. Another single-light window of modern appearance to the N, then a projecting modern conservatory. Inside the conservatory there is another stone doorway with ironstone surround, with a small chamfer and flat lintel. Slightly wider window with timber lintel to N of the conservatory, then good quoins to the N end.

The rear east side

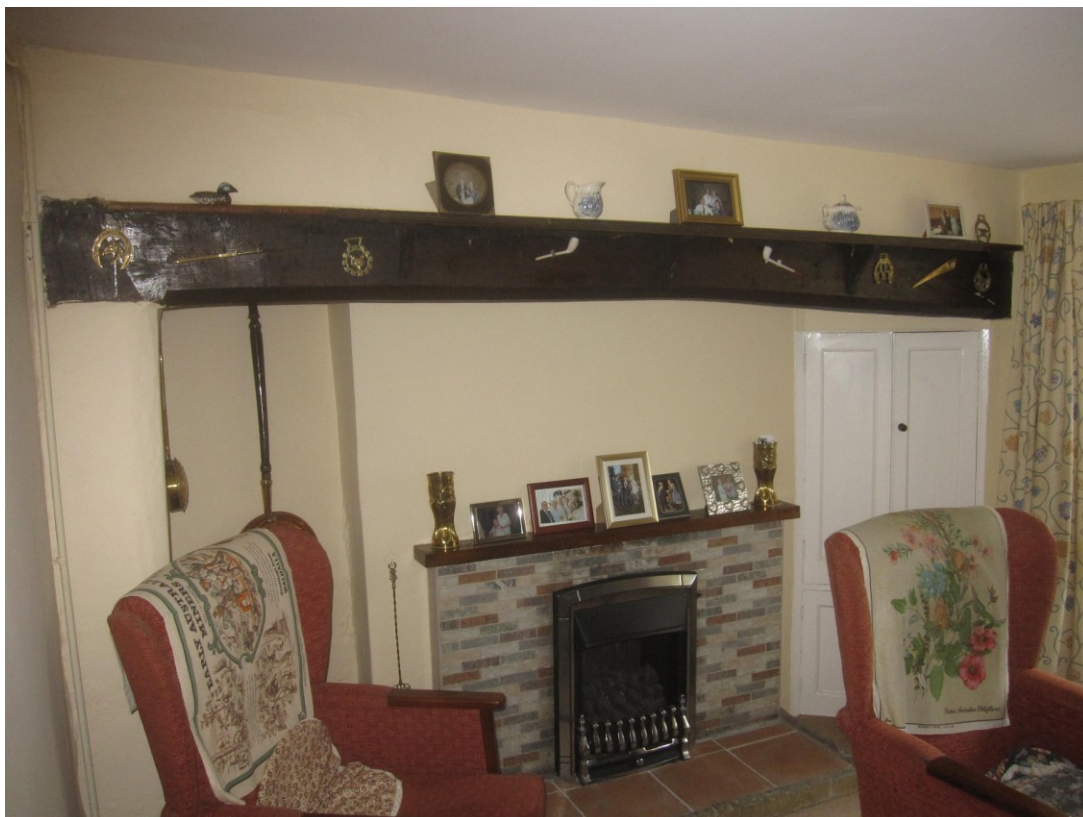
The N room has a wide inglenook fireplace with slightly cambered beam, chamfered with ogee stops. There is a bake oven in the left corner, now covered up. Transverse

Inglenook fireplace to north room

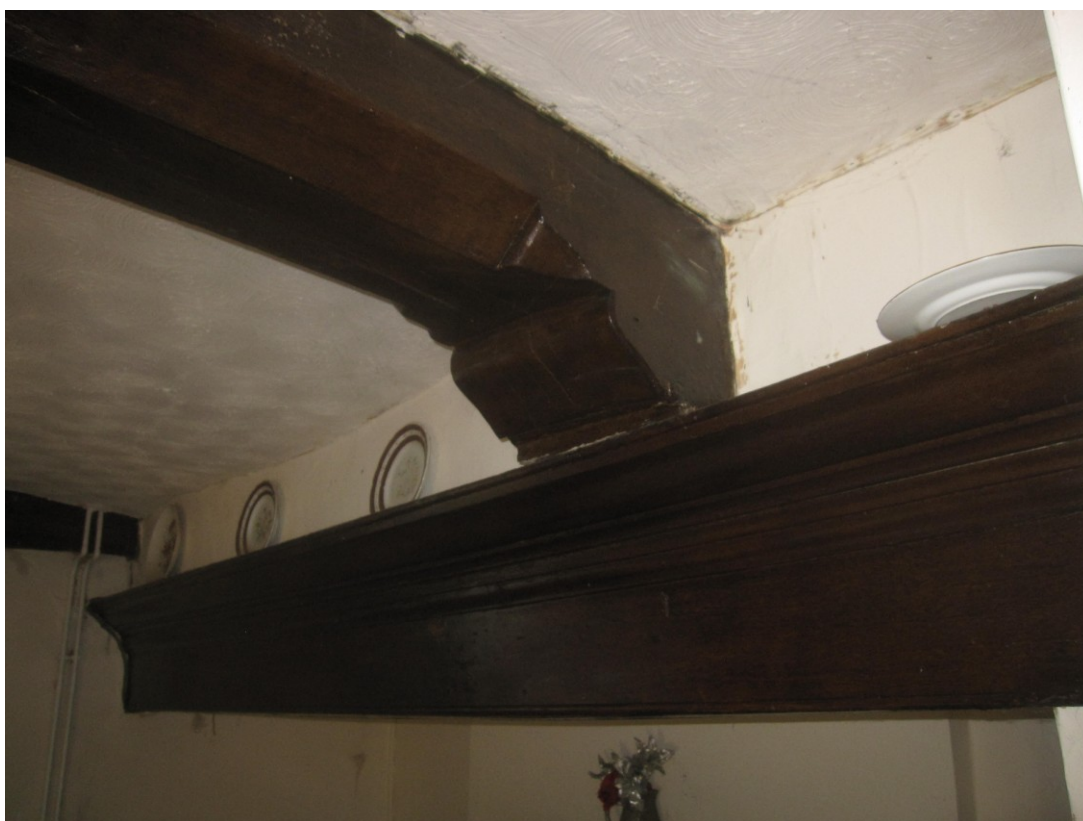
The central room has another wide inglenook fireplace, with high-set beam, cased in and with a cyma-moulded cornice. A spine beam with a fine ogee-moulded, corbelled N end, carved out of the solid, bears onto the ingle beam. The spine beam is chamfered with good ogee stops to the N end but no stops to the S. Against the W wall is an oak plate to carry the first floor joists, chamfered with ogee stops. The ironstone mullioned window to the E wall has plain chamfers internally (cf ovolo moulding externally). As on the outside, the moulding to the jambs and mullion is left short of that to the head. The S room has a spine beam with chamfers and straight-cut stops to both ends, which are set c.300mm away from the wall. There is a splayed chimneybreast to the SW corner, with modern fireplace. The window to the E wall is a modern insertion. This rear E wall is much thicker than other walls, and may well be of early date.

Ceiling beam to central room, with moulded corbel

Tree-ring dating samples were taken in 2013 by Robert Howard of Nottingham Tree-ring Dating Laboratory from the cruck truss T1, truss T2 and from the corbel-moulded ceiling beam in the central ground floor room. For truss T1, the re-set collar dated to 1388-1413, but other timbers could not be dated. The principal rafters of truss T2 dated to 1685-1710. The ceiling beam was found to be of elm, so was not dateable.

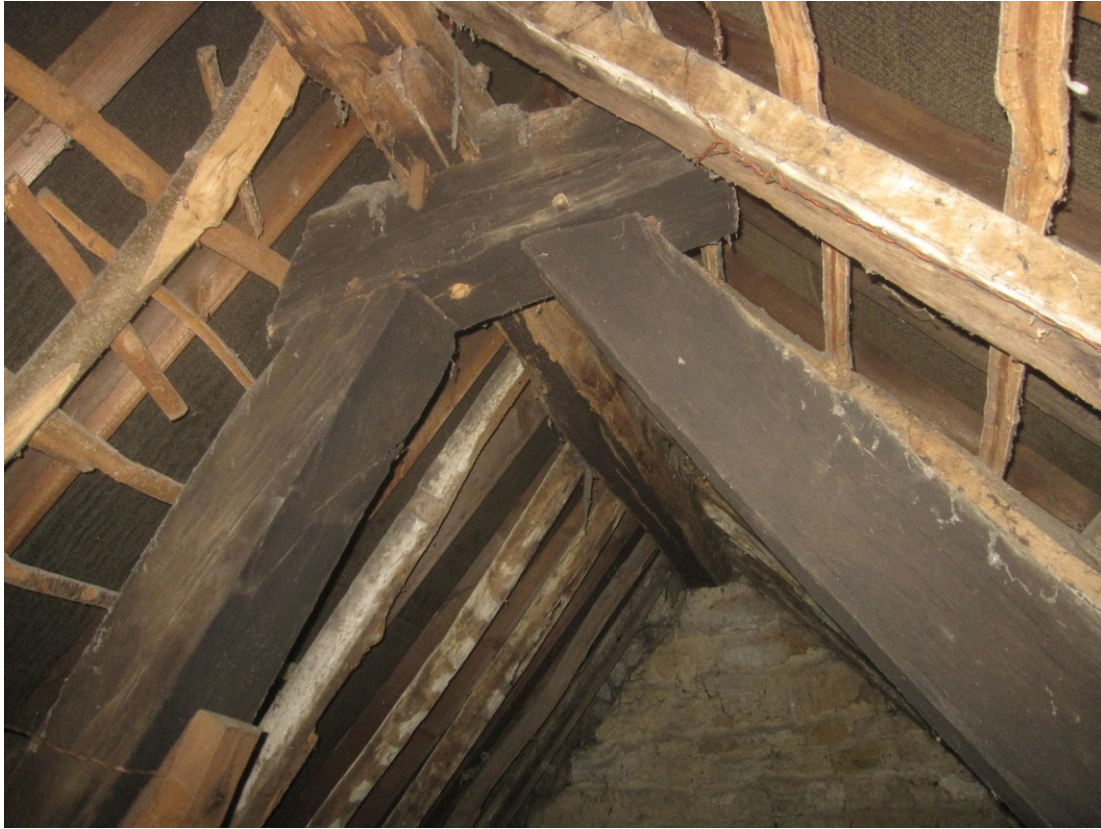
The N bedroom has a smoke-blackened roof truss (T1), visible only in the roof void, as it is boxed in at first floor level. Although no curving timber is visible, the truss is very probably of cruck form, as it has all the characteristics of the local, standard cruck construction. The truss has two principal blades, tenoned and pegged into a saddle at the apex. The blades are of fairly thick, squarish section (170/185mm wide by 150mm thick at later collar height), with saw marks only visible to the N face of the E blade. There are empty matrices for a dovetail-lapped collar, fixed with two skew pegs. There is now a collar set at a higher level, fixed with nails – perhaps the original collar re-used, as the S face seems to have some sooting. A ridge beam, with plain, splayed scarf joint, is trenched into the top of the saddle. There are two downwards pegs to fix the scarf joint, and a third downwards peg fixes the ridge to the saddle, passing right through it. The ridge beams to N and S of the truss are both smoke-blackened. Side purlins are carried on the back of the principals, but these have various peg holes from a previous use. No trenching is visible to the back of the principals, so the original purlins were probably carried on the projecting ends of the collar, in the normal local fashion. At the N end, the ridge has a splayed scarf with a peg hole visible. This indicates that the cruck structure originally extended for at least one further bay to the N, but was truncated when the current stone gable wall was built.

Smoke-blackened cruck truss T1, south face

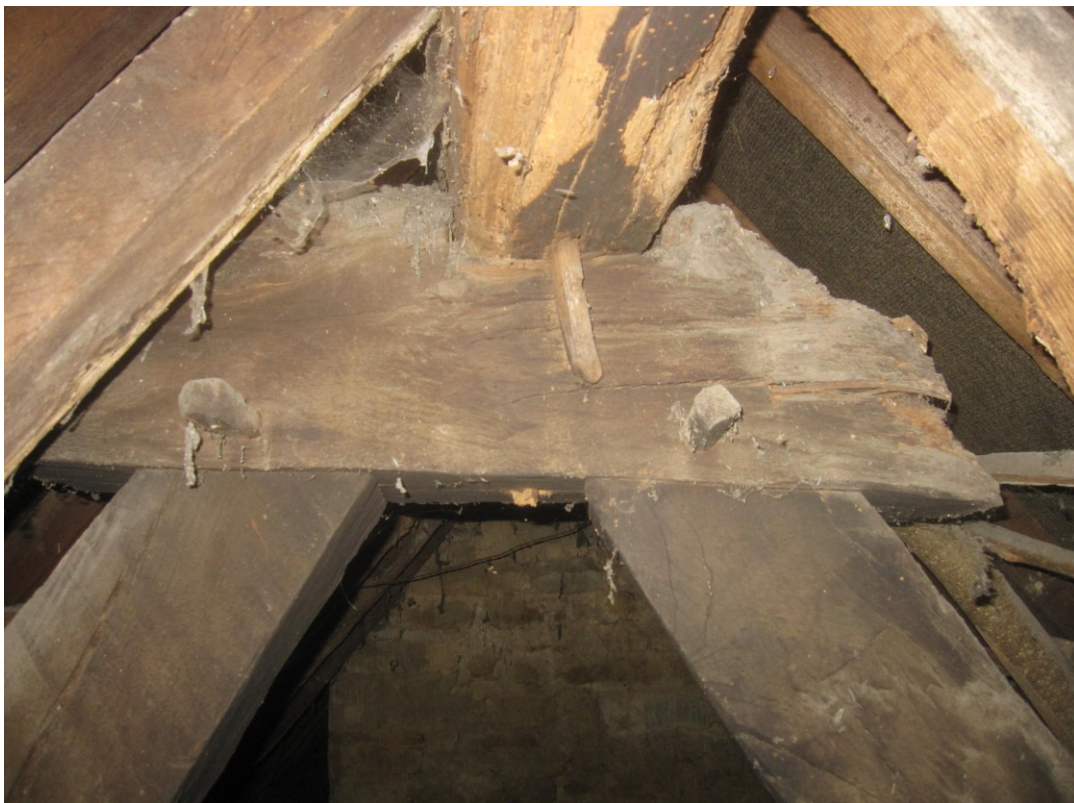
Apex of truss T1, north face

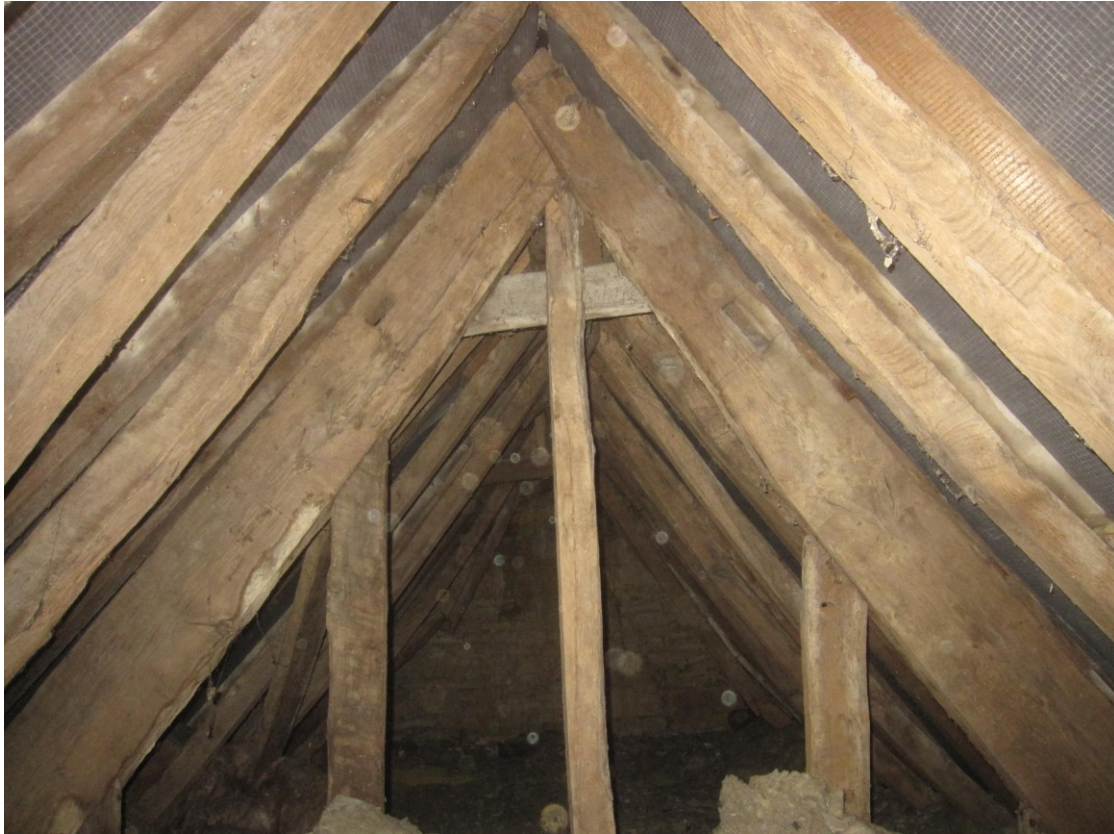
The roof over the two S bays is of different type. A single truss (T2) has large principal rafters, half-lapped at the apex, with no ridge. The truss is of A-frame form, but the collar is not visible, as it is set below ceiling line, in the partition dividing the central and S bedrooms. The truss was closed, with nailed studs and mud infill on nailed laths. Purlins are trenched into the back of the principal rafters, and have straight-splayed, pegged scarfs. The original rafter couples survive extensively, of squared oak (eg 75mm wide by 70mm deep), with small, knife-cut carpenter's marks at the apex. The marks are set out of sequence, with Roman numerals eg XVII. An unusual feature of the roof structure is the wind-bracing. One brace survives in situ on the E side, rising from the SE purlin up towards the top of the E principal rafter, tenoned at both ends, and passing inside of the rafters. The raking mortices to the principals show that there was a second brace on the W side of the roof, rising from the N purlin to the principal. But there were no corresponding braces on the other sides of the principal rafters.

Truss T2, north face

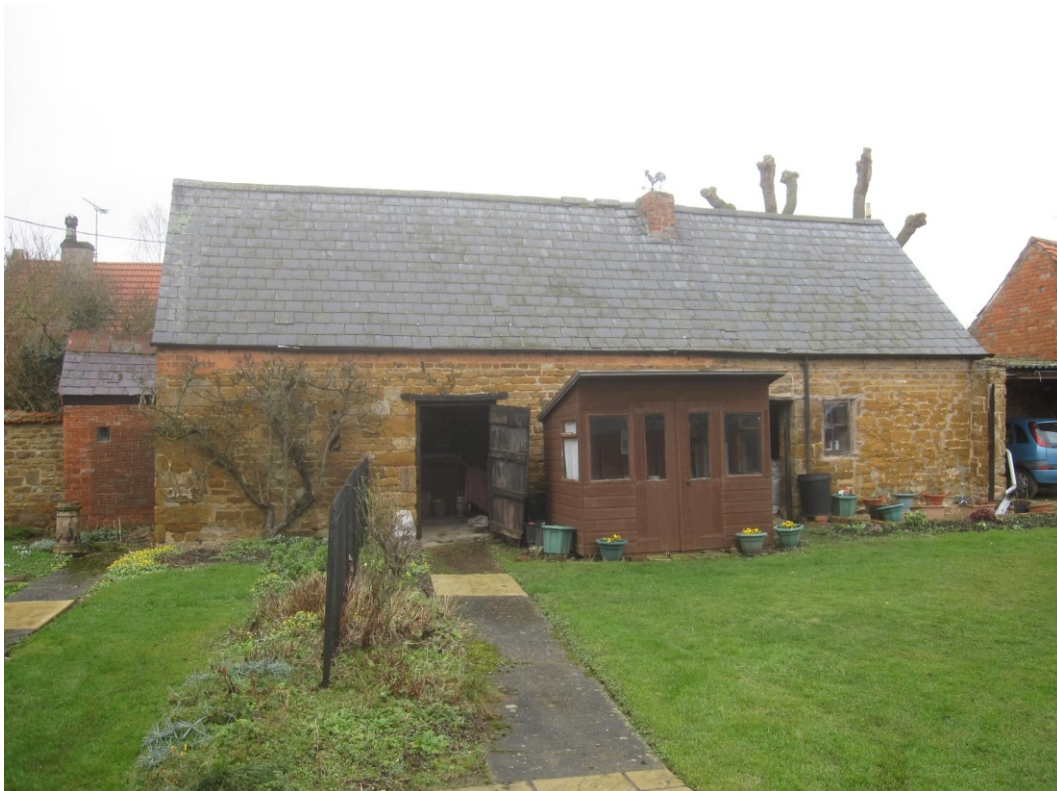
Against the N boundary of the plot is an ironstone outbuilding, single-storeyed with two pedestrian-sized doors to the front, along with a large and small window. There is no doorway to the rear wall. As the gable ends show, the building has been heightened in brick, and has a Welsh slate roof. Inside, a brick chimneystack and cross-wall have been inserted, for use as a laundry or brewhouse, with two copper-type boilers set either side of a fireplace. The brickwork dates from the mid or late 19<sup>th</sup> century, as does the softwood kingpost roof. Hanging on the S wall is a large iron pan, which is said to have been used to collect the blood when the building was used as a slaughterhouse.

Outbuilding to north-east of the house

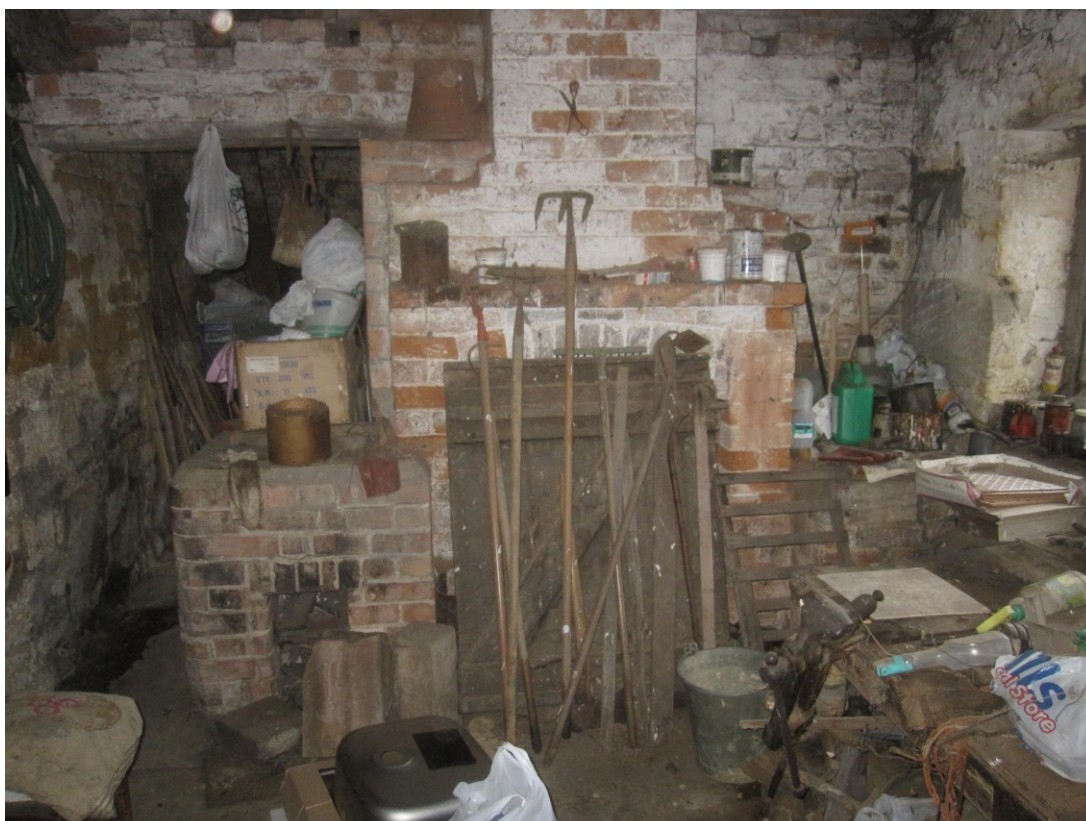
Outbuilding to north-east, with brick fireplace and coppers

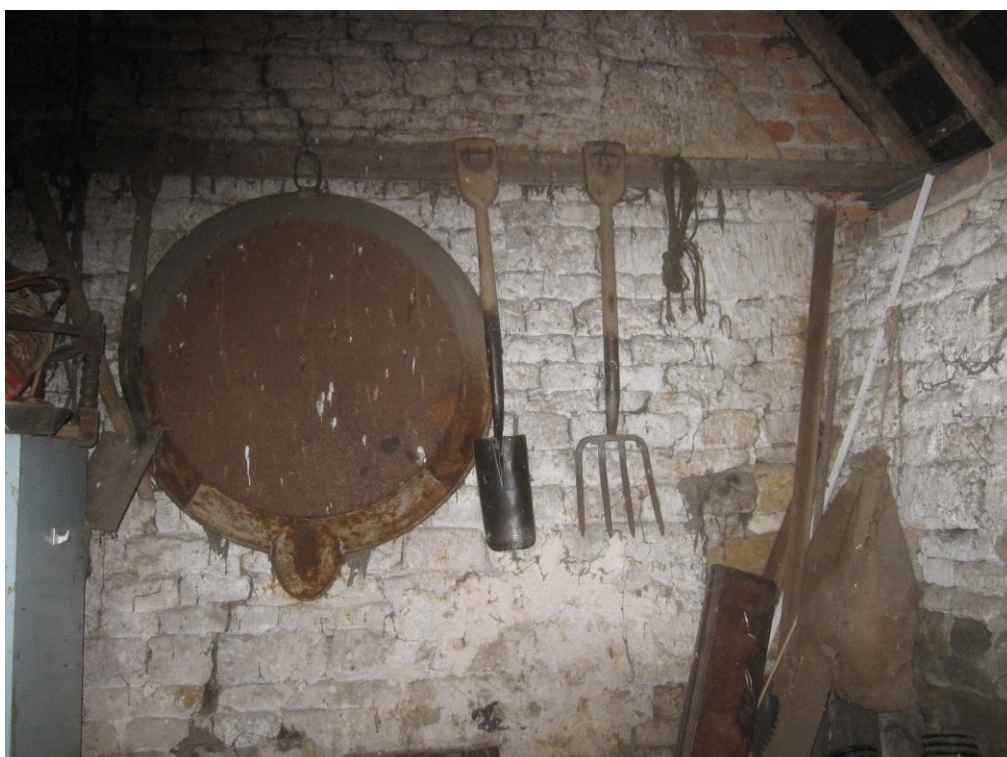
Iron pan in the north-east outbuilding

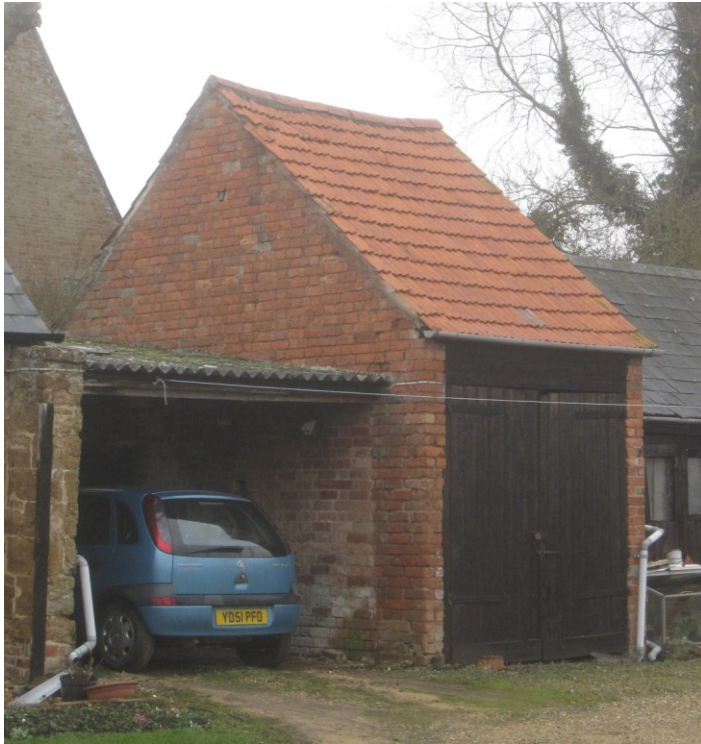
On the 1804 map, it can be seen that this range of outbuildings formerly extended further W and E. There is now a small brick privy to the W, and a free-standing brick coach house or cart shed to the E. Further E (also on the 1804 map) is a large ironstone outbuilding, currently being converted to domestic use. Survey drawings of 1991 show that the barn originally had a pedestrian-sized door to the front and rear walls, though a large barn-type glazed opening has recently been inserted. The outbuilding must have been re-roofed in the later 19<sup>th</sup> century, as it had the same type of kingpost roof structure as that in the laundry/brewhouse. A new range has recently been added to the building, running S from the original building.

19<sup>th</sup> century brick coach house or cart shed

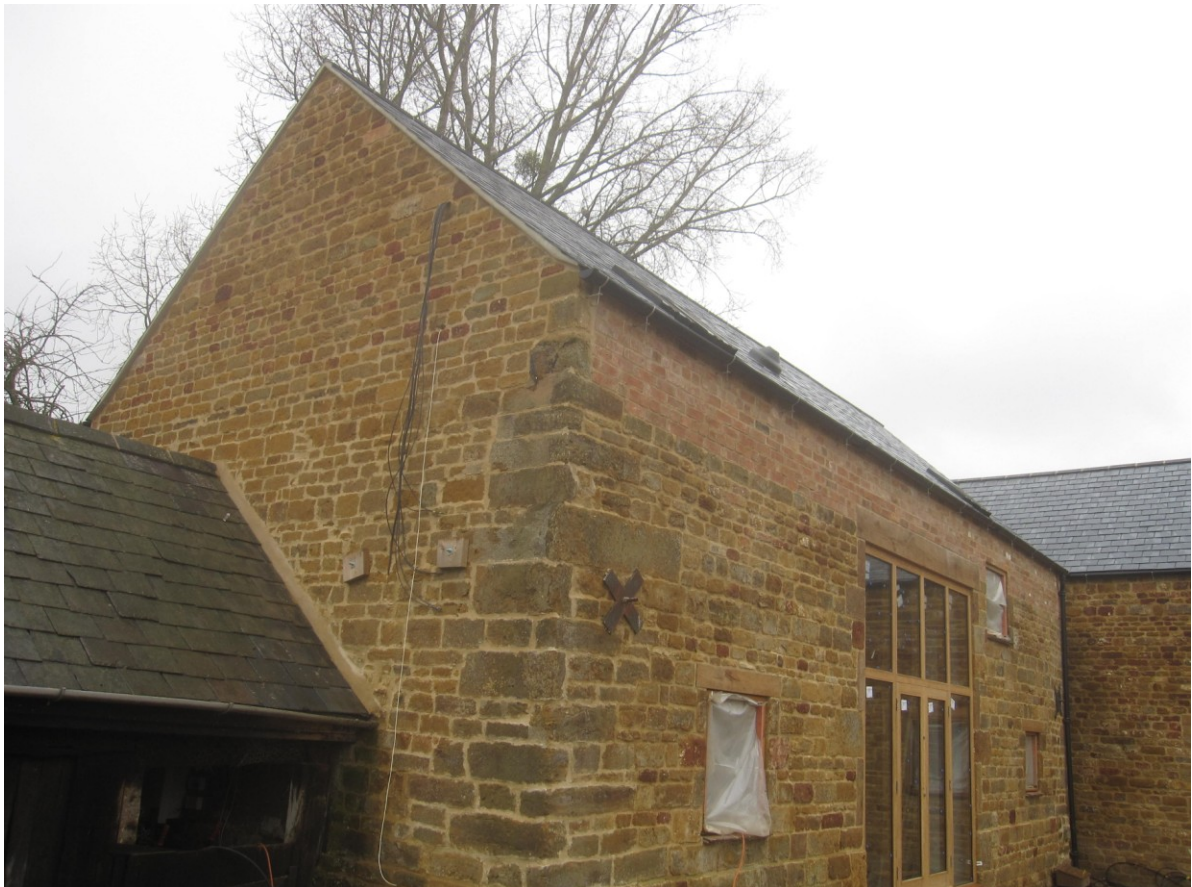
The eastern outbuilding, with recently inserted large opening
