**Lyddington Manor History Society
Historic Building Survey**

**Fern Cottage, 43 Main St
Lyddington, Rutland**

HISTORIC BUILDING SURVEY REPORT

FERN COTTAGE, 43 MAIN ST, LYDDINGTON

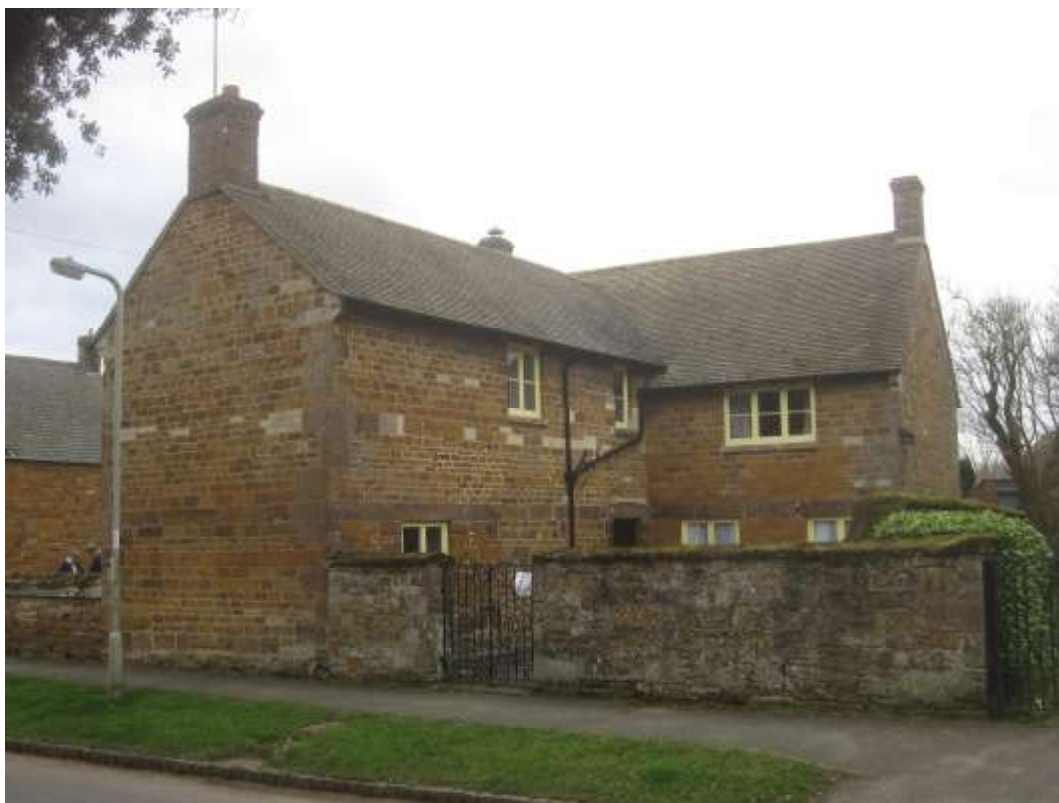
View from the north-east

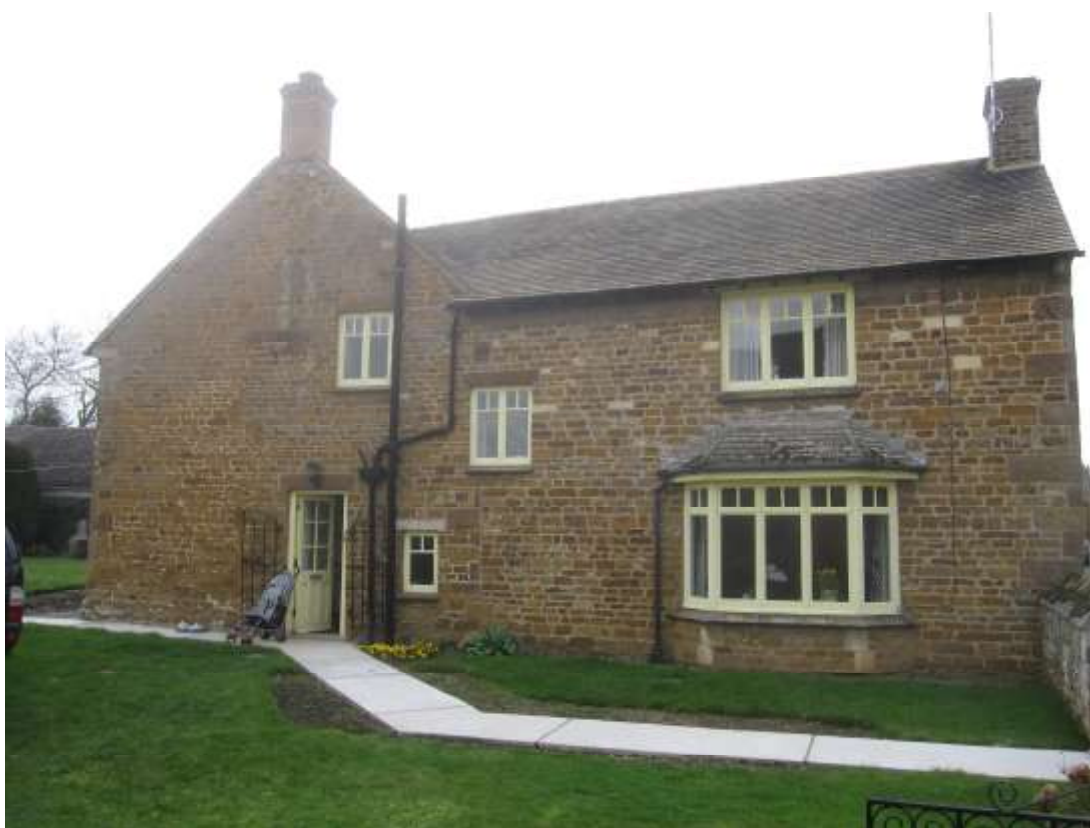
The main block S gable has a doorway, 1st floor window and gable kneeler all probably of 20th century date. The roof eaves to this range was also raised in the 20th century. There is a blocked window to the former first floor height with a characteristic large brownstone chamfered lintel – probably 19th century. The rear W wall has rather irregular masonry coursing in places, with an area of rebuilding above the S ground floor window. The two main ground floor windows have chamfered brownstone lintels of the same 19th century type as the S gable. At the N end is a small single window which has a highly unusual detail – a 2-light inner window with delicate ogee-headed tracery of alabaster. This is presumably a re-used feature salvaged from elsewhere. The first floor has two large dormer windows. The N gable is blank, and has the same ovolo-moulded kneelers as the front wing, from the 20th century roof raising. The front E wall of the main block has a brown/purple stone ashlar band at first floor level, like the front wing, but with finely jointed ironstone walling. The two ground floor windows here have flat lintels with a slightly projecting false keystone. Three 20th century brick chimneystacks.

View from south

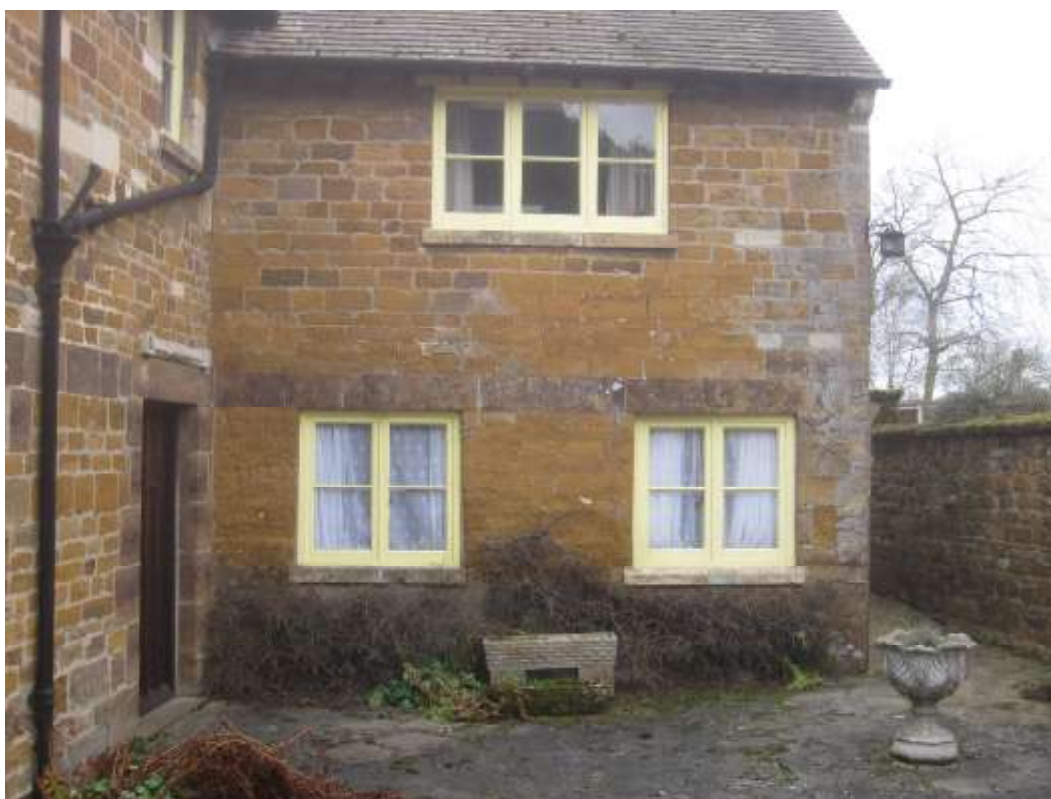
The east front of the main rear range

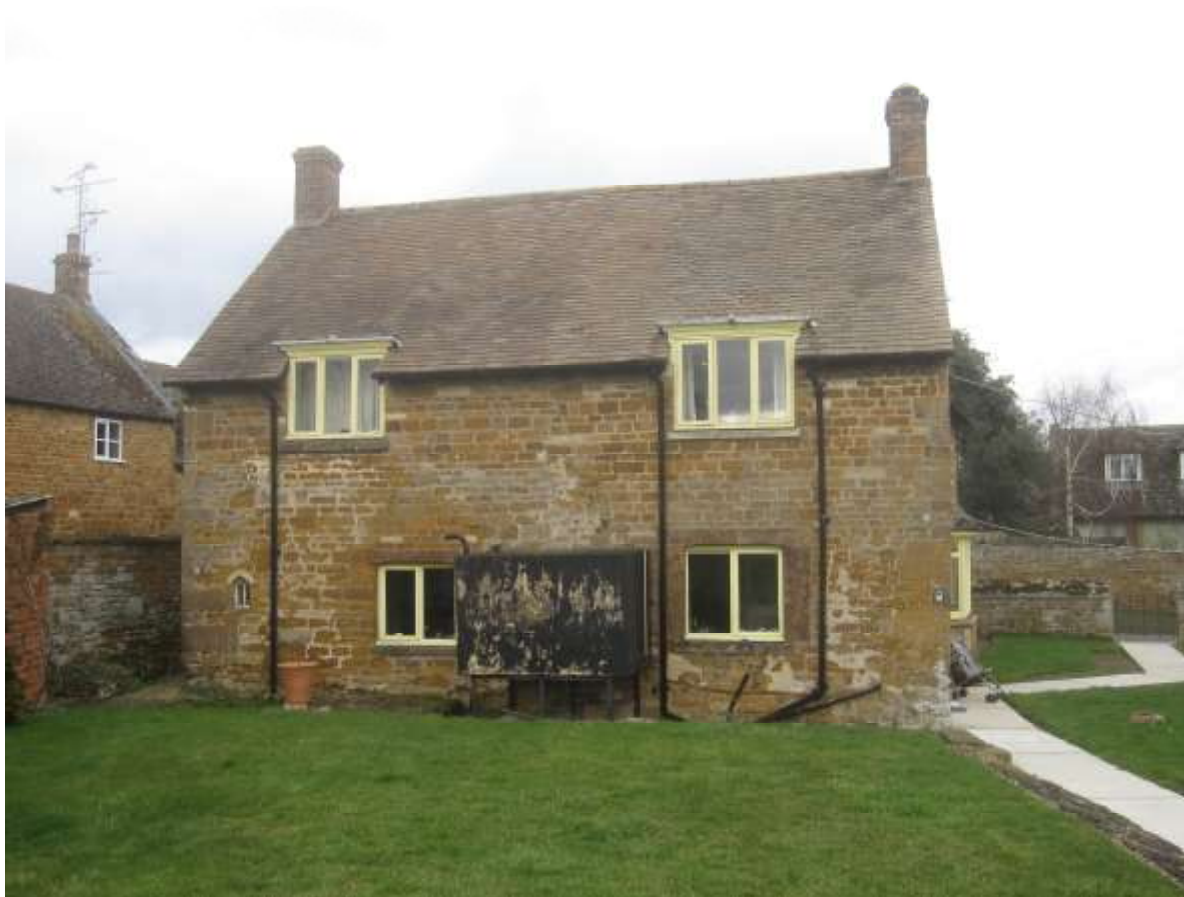
The rear west side of the main range

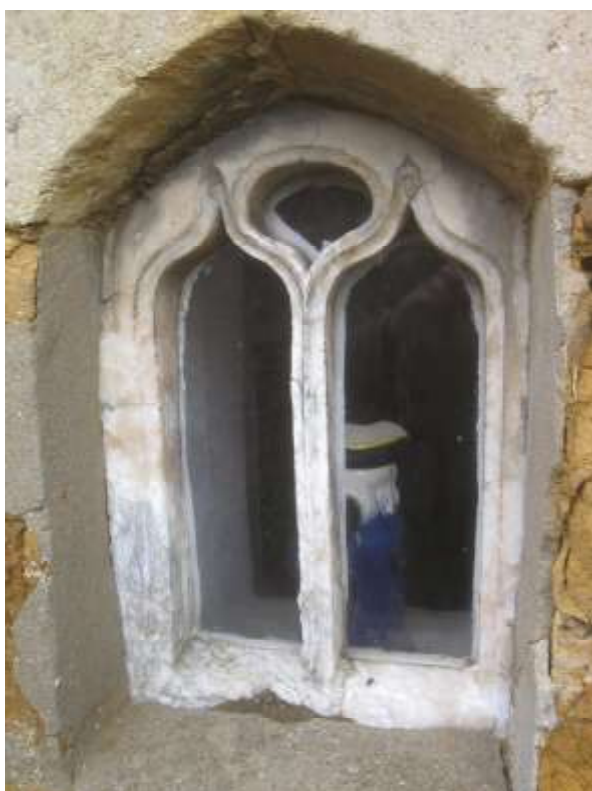
The re-used alabaster window in the west wall of the main range

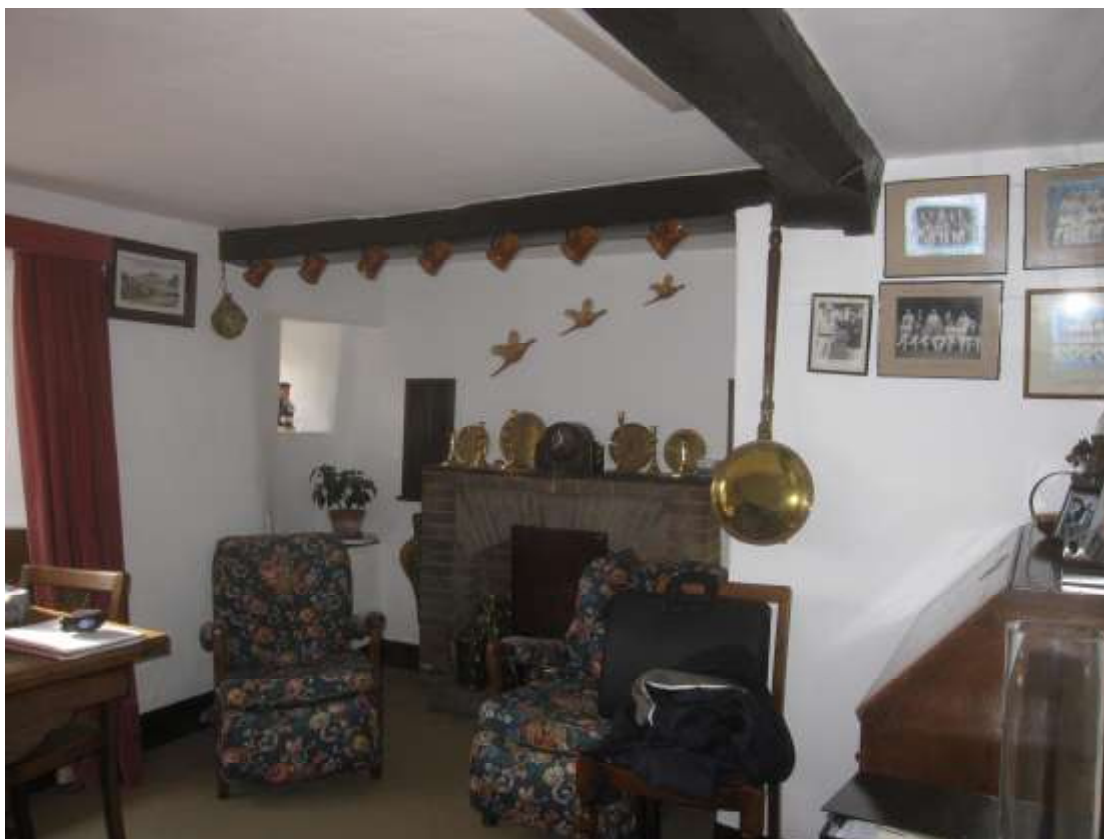
The N room has a good spine beam with finely formed ogee stops to the N end, at the inglenook chimneybreast, but no stops at the S end. The inglenook has a high-set beam, cased in boarding. A partition wall now divides the room, with a narrow room to the east. A rounded corner at the N end, beside the inglenook, is said to have been the location of a former winder stair.

The north room in the main rear range, with ingle fireplace

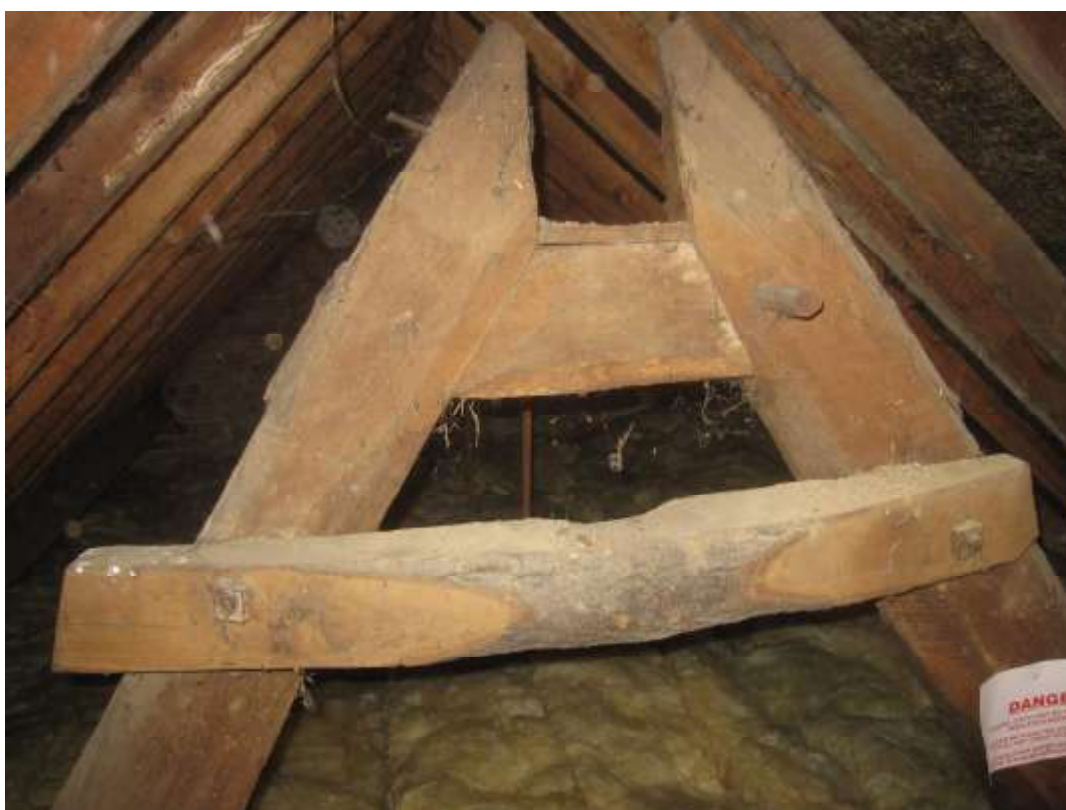
Single roof truss at centre of main block, of A-frame type with dovetail-lapped collar, probably of re-used timber. At the apex, the principal rafters are joined by a short saddle piece, and rise above this to hold a ridge beam, now missing. The purlins and rafters have all been replaced when the roof was raised in the 20th century. The S room has an irregular projecting chimneybreast, probably a later addition for a ground floor fireplace.

The apex of the roof truss to the rear range

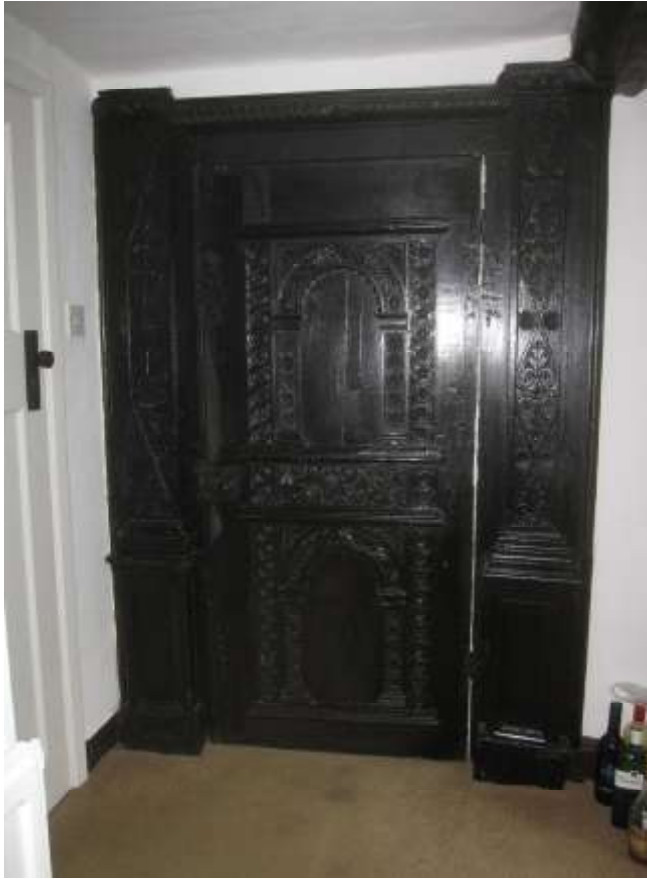
The door in the N room leading to the kitchen, with pilasters to either side, is made of re-set Jacobean panelling. The panelling is of very high quality, a very unusual feature which must have come from a building of considerable status, probably of earlier 17th century date. The door has two arched sections, one above the other, with intricately carved guilloche borders to each side. The pilasters have panelled pedestal bases, shafts with leaf and floral carving, and Ionic capitals. Over the door, between the pilasters, is a finely carved gadrooned cornice.

The re-set Jacobean
panelling in the north room
of the main rear range

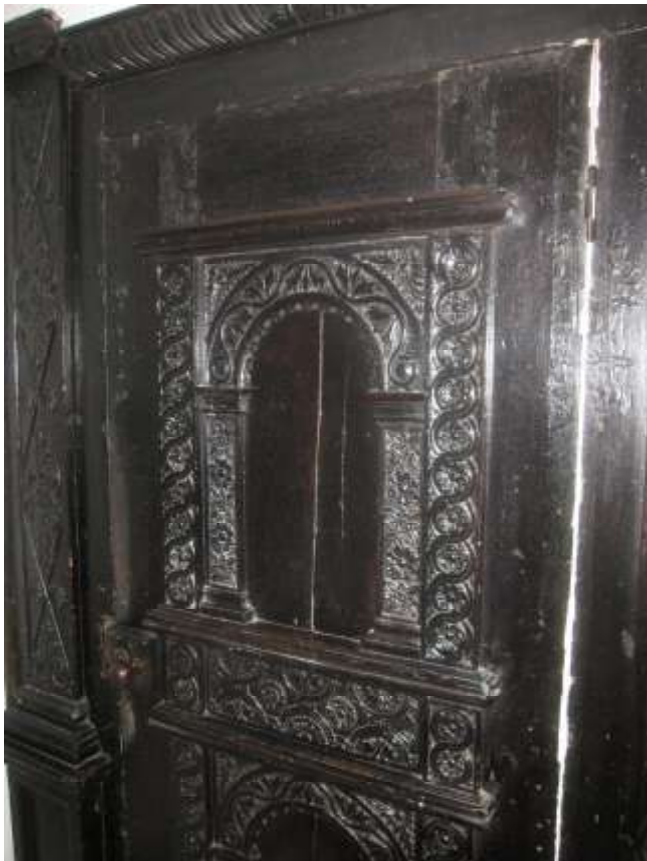
Detail of the panelling

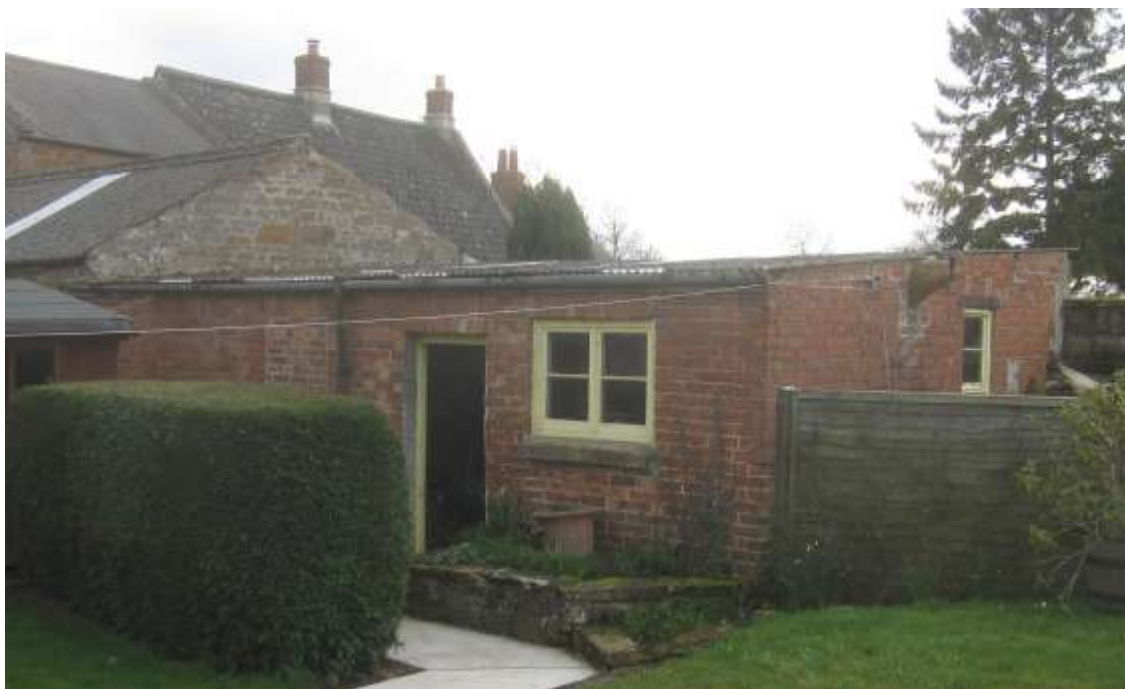
The 1886 map shows two very small houses at the SW of the two plots adjoining to the S. These survive as the ground floor only of a pair of brick-built 19th century cottages. Each cottage had a single room on the ground floor with a front door and window in the E wall, under flat brick arch heads. The rear W wall and S end walls are older, of stone. The front E wall and N external wall are of 9 inch brick, but the dividing wall between the two cottages (of which only the base course remains) was of half-brick thickness. The N cottage had a fireplace with chimneybreast on the N wall, though evidence for a chimneybreast to the S cottage is unclear. Brick-paved floors, modern profiled sheet roof, with no remains of the former first floors. .

The surviving ground floor of the pair of 19th century cottages at the rear of the plot

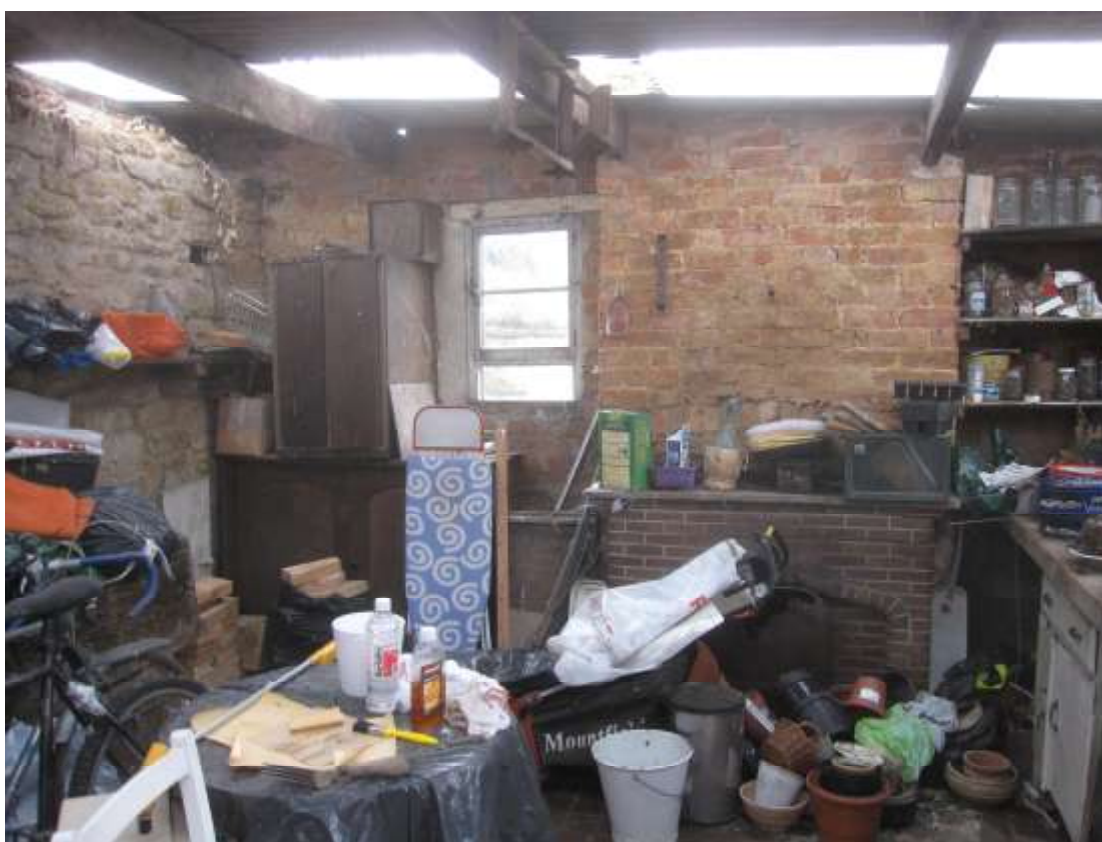
Interior of the west cottage, looking west

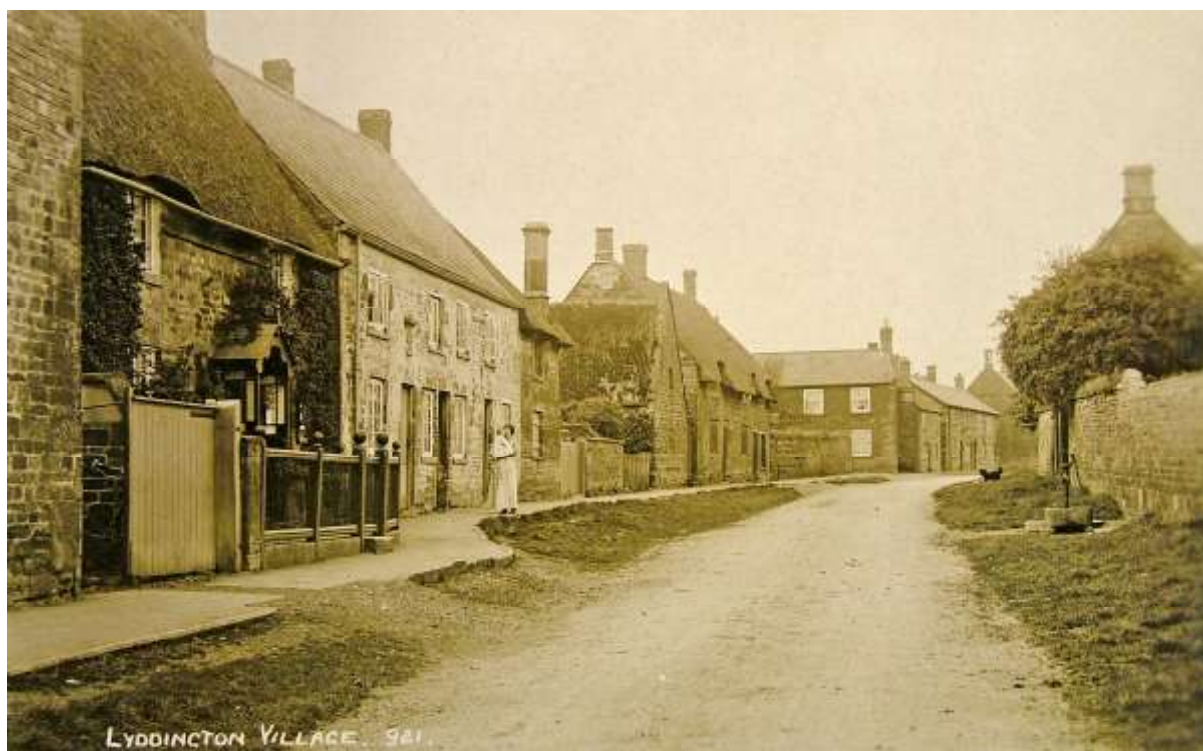
Postcard of c.1910 (RCM 0548), showing: No 41 with front porch; the pair of houses demolished in the mid-20th century; and the front wing of No 43 before the alterations

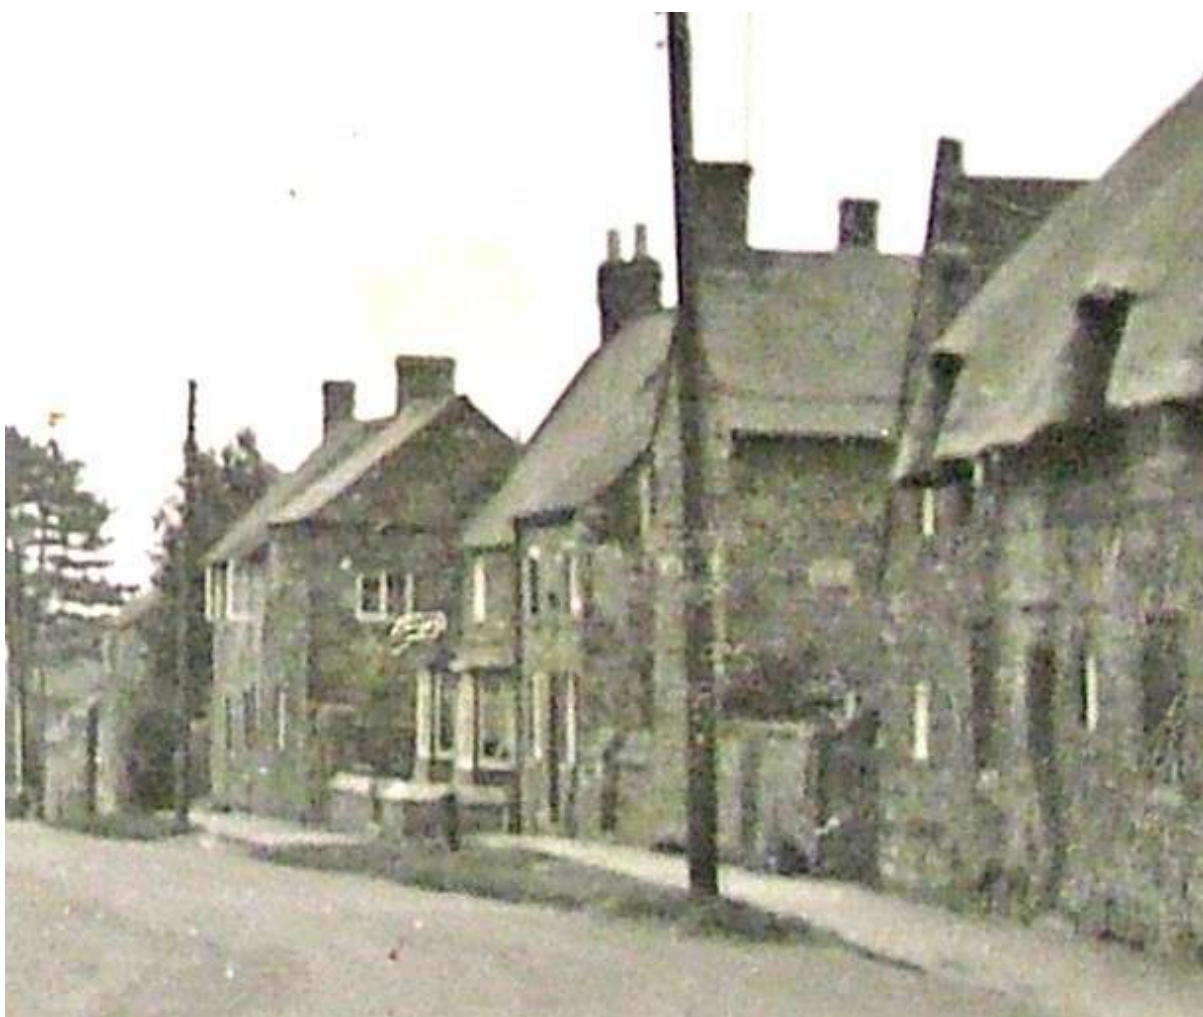
Subsequently to this, a photo of c.1950s date (after electricity poles had been installed) shows the southern half of the house pair as retained, with a gap to the north. The exposed gable end was presumably made serviceable as an external wall. By this time, the front range of No 43 (on plot 105 of 1804) had been replaced with a 2-storey block, with a gable to the street front and the roof ridge running W-E, with slated slopes replacing thatch. Bay windows have also been added by this time to the ground floor frontage of No 41.

Detail of the photo of c.1960, showing only the south half of the house pair still standing, with a gap and then the re-built front wing of No 43, with W-E slate roof and gable stack

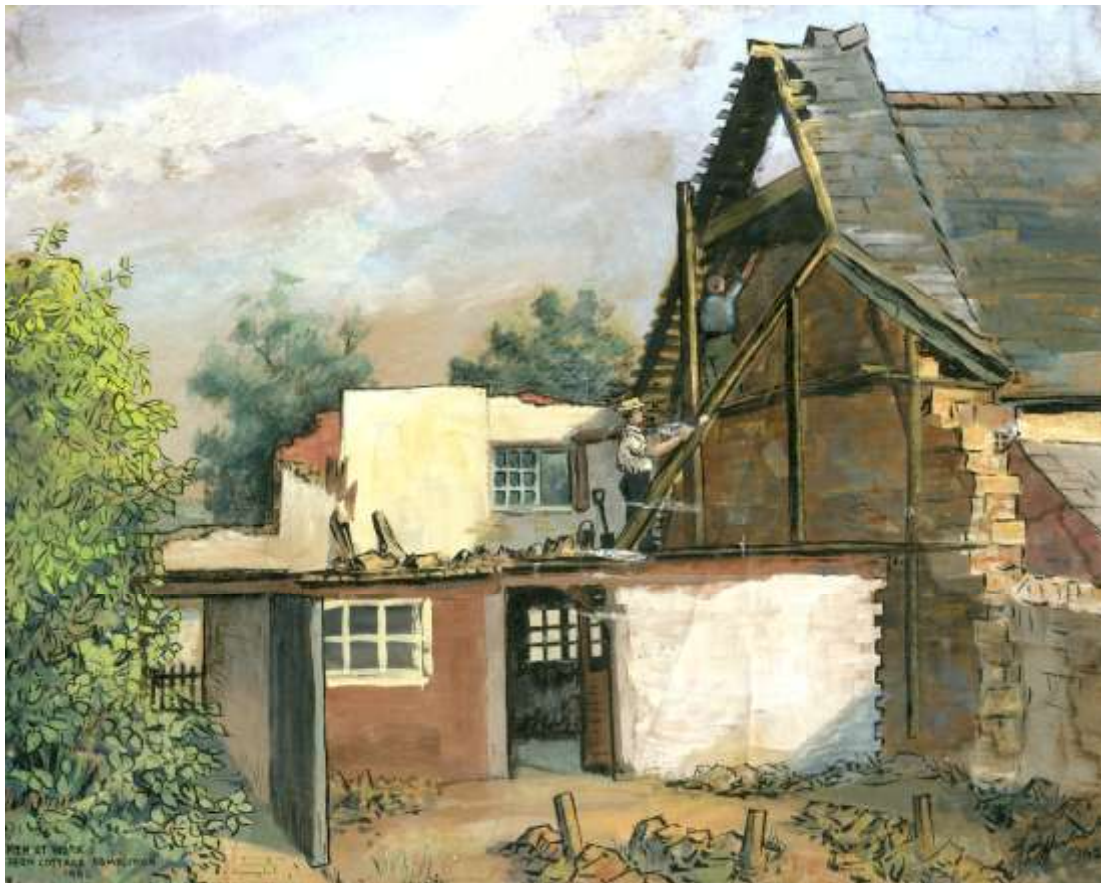
In 1962 the remaining half of the house pair on plots 79 and 80 was demolished, resulting in the wide gap that currently exists between No 41 and No 43, forming part of the garden to No 43. It is the demolition of this building which is shown on a painting which includes the title, in the bottom left-hand corner 'Men at work Fern Cottage demolition 1962'.

A painting entitled: 'MEN AT WORK FERN COTTAGE DEMOLITION 1962'

This shows the demolition of the south half of the house pair on plots 79-80 of the 1848 map. To the right is No 41, prior to the replacement of a rear lean-to with the current two-storey rear wing. This is now the location of the entrance drive to the south of No 43, Fern Cottage.
