**Lyddington Manor History Society  
Historic Building Survey**

**Home Farmhouse, 35-37 Main St,  
Lyddington, Rutland**

## **HISTORIC BUILDING SURVEY REPORT**

### **HOME FARMHOUSE, 35-37 MAIN ST, LYDDINGTON**

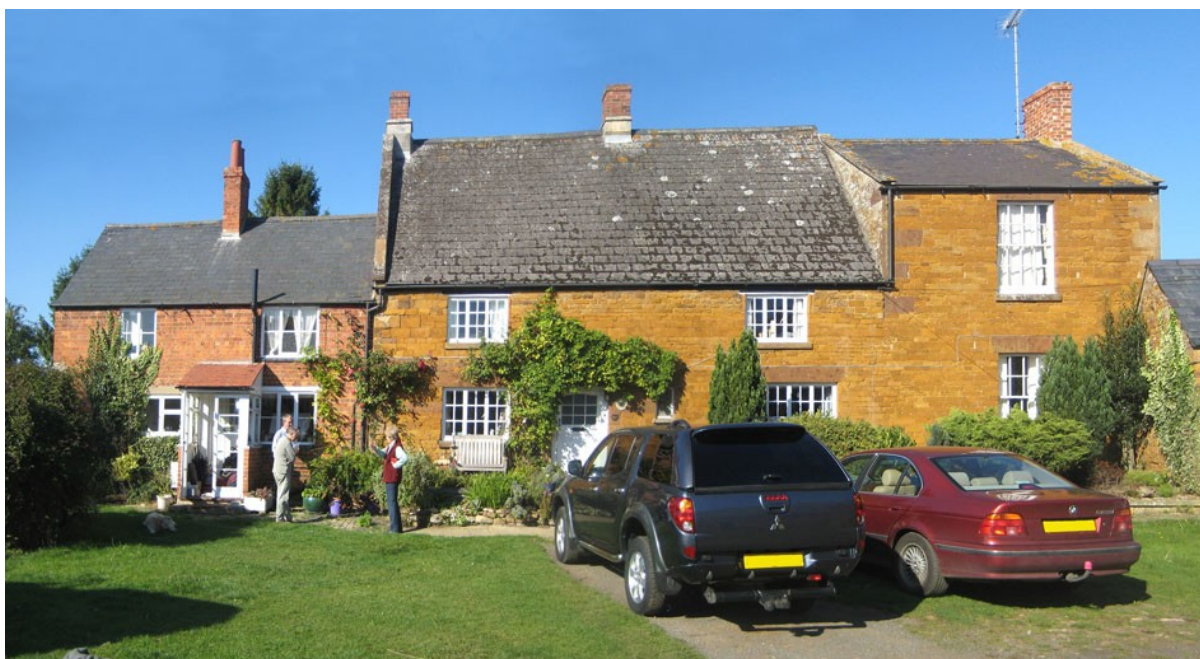
The east front

The E front of the main house is of 1½ storeys to the central and southern rooms, but the N end has been rebuilt with two tall storeys, under a roof of shallower pitch. The whole front has finely jointed ironstone, with no straight joint – the whole was clearly re-faced when the N end was rebuilt. At the junction with the N end at high level, a short section of straight jointed abutment indicates where the eaves of the central section has been built up, following removal of the former thatched roof.

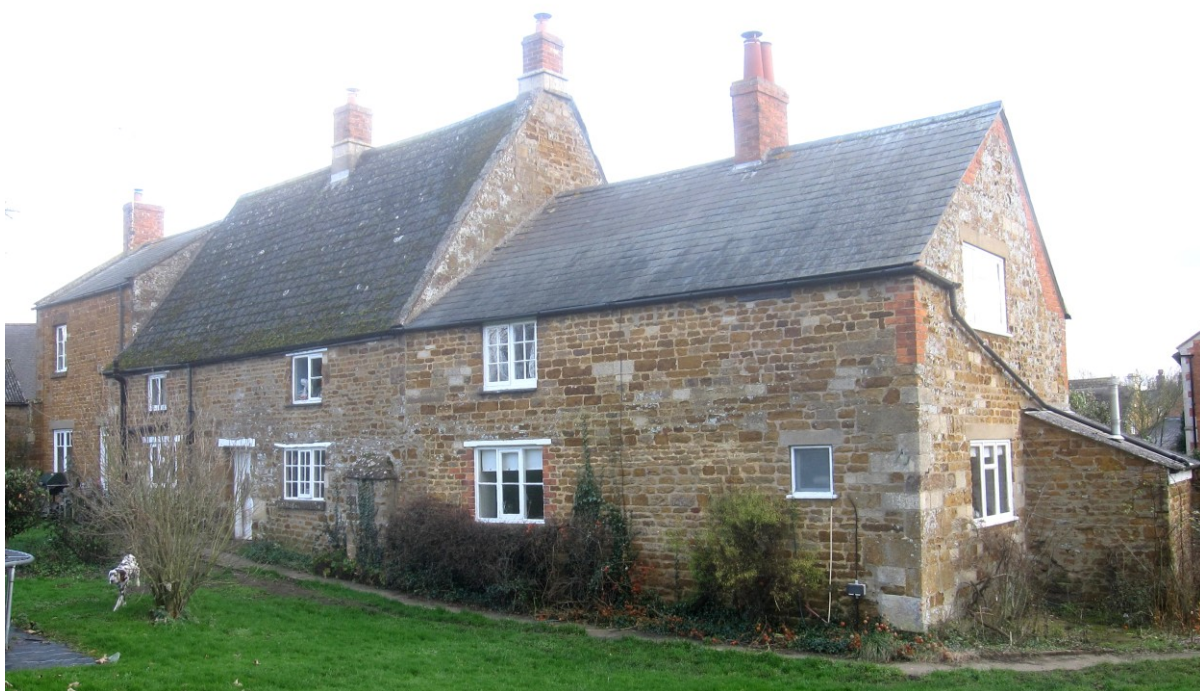
View from the south-west

The rear W side of the S section has coursed ironstone. A small window to the S has a concrete lintel and may be relatively modern. The larger ground floor window has brick patching to the jambs, so seems inserted. A straight joint with quoins marks the S end of the main block. Just N of this is an unusual projection, like a short buttress, with a well-formed coping to the top, in two courses of brownstone. This projection presumably houses a bake oven, set into the inglenook fireplace inside. The rear doorway is wide, with a timber lintel, chamfered and with step-stops. Timber lintels also to the four windows here. One window is of the same 3-light casement type as those to the E front. At the N end, the rebuilt wall steps inwards. Two tall window/French window openings to ground floor, with concrete lintels; an original opening to 1<sup>st</sup> floor with brownstone lintel and cill, but a timber casement here rather than a sash window.

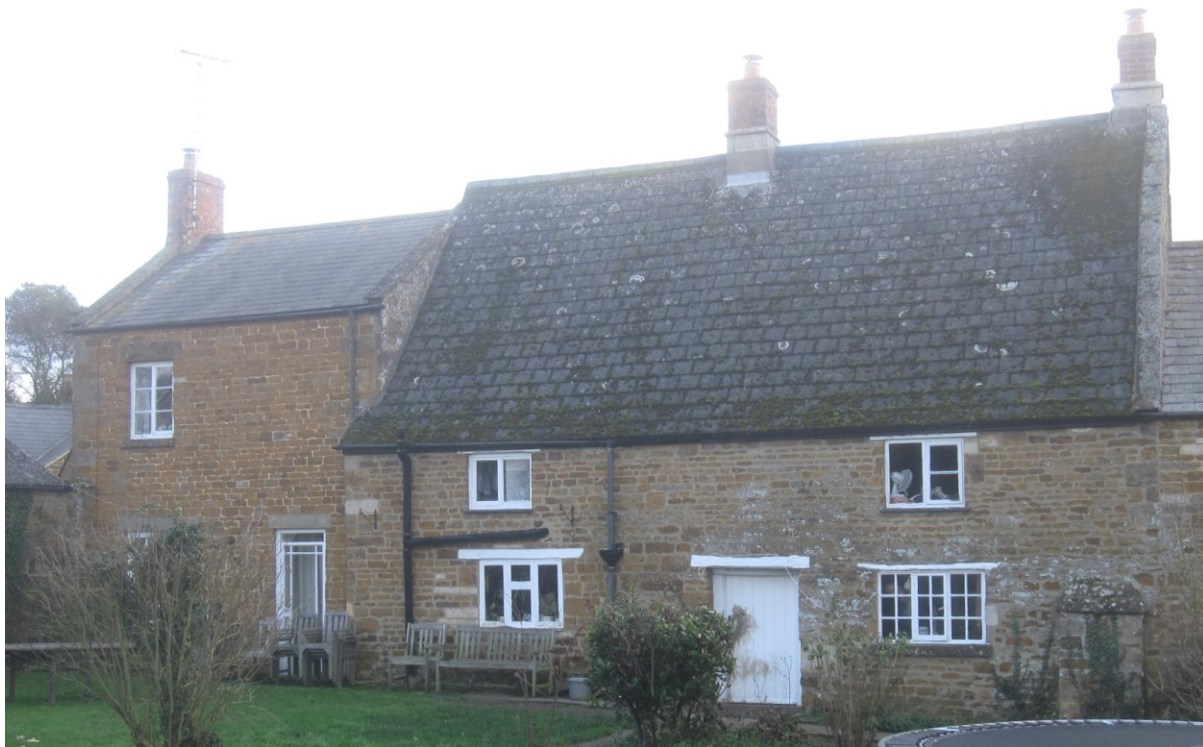
The rear west side

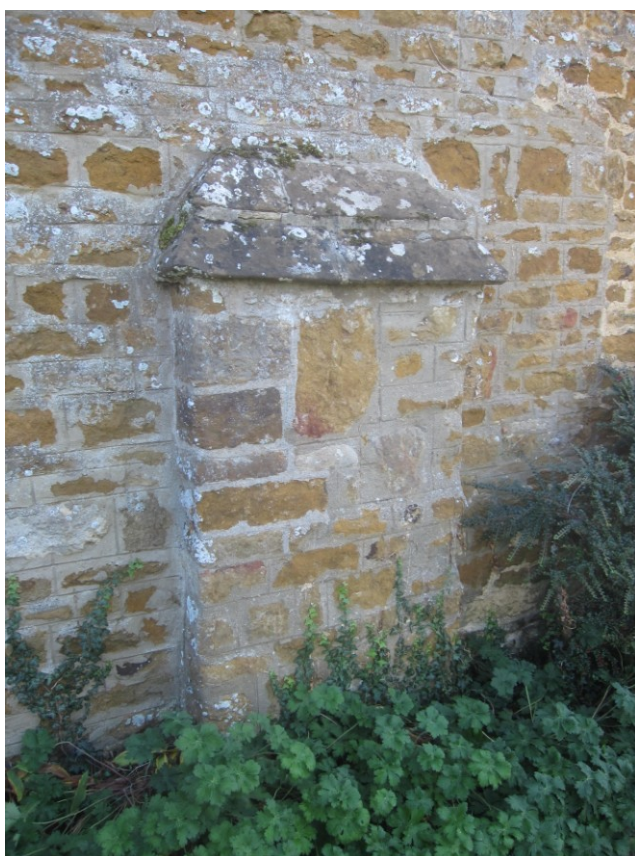
The projection which houses a former bake oven to the rear west

The S room has a large inglenook fireplace; chamfered beam with no stop to E but an ornate stop to W - a shallow raised section of truncated pyramid shape, half-round bar; and fairly long run-out stop. Stone ashlar jamb to E. To the W side wall, there is an oak plate at inglenook beam height, and some brick patching below – probably the blocked opening of a bake oven (housed partly in the external projecting 'buttress')

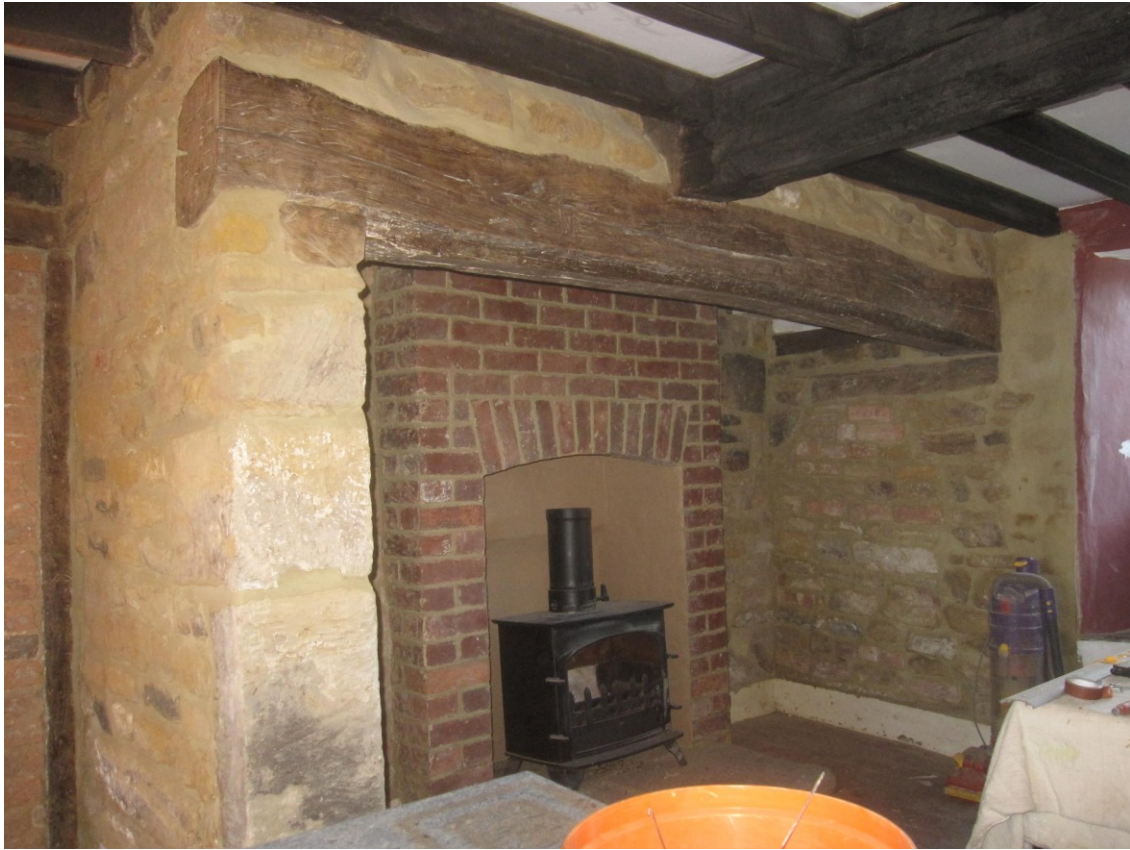
The inglenook fireplace in the south room (original kitchen)

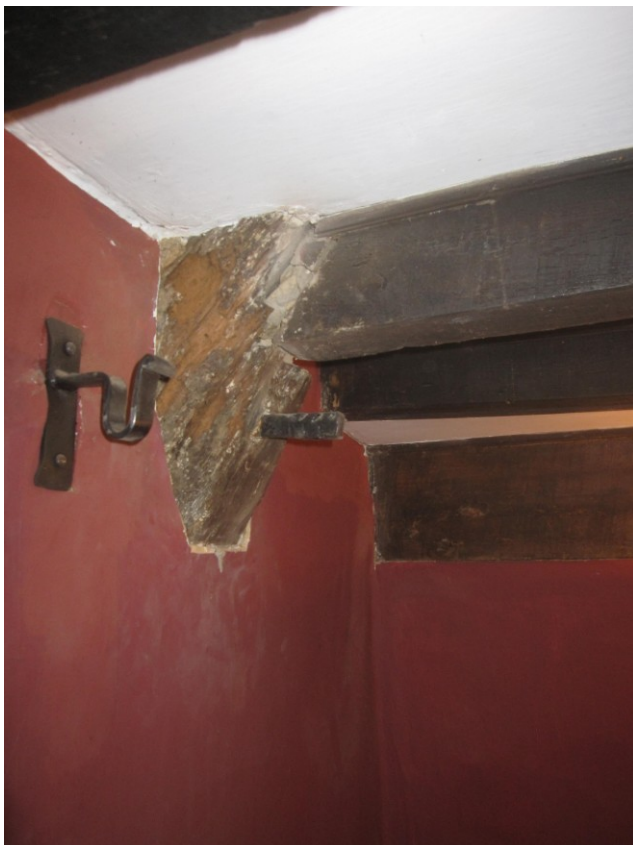
The cut-off cruck blade in the south room

here). Two spine beams (rather than the usual single one), some ogee stops. Original floor joists survive, rectangular with very small chamfers. Near the NW corner, a small section of timber, set at an angle, protrudes from the rear wall just below ceiling level. This must be a surviving piece of a cruck blade, which ran down in the thickness of the wall towards ground level, but has been cut off at first floor level. The angle of the cruck blade is not as steep as normally found. The rear wall here is 770mm thick, noticeably more than the front wall, which is 630mm thick. No evidence is visible of the opposing cruck blade in the front east wall, which may have been entirely rebuilt. Also uncovered during recent work is a blocked doorway to the E of the inglenook: two rectangular oak studs are tenoned and pegged to a lintel/plate, which continued further to the E. The bricks used to block the opening are of narrow type, ie C18/early C19, not the normal post-1850 bricks.

The earliest part of the building is the surviving section of cruck blade. This probably dates from a house of ‘open hall’ form, dating from the C15 or earlier C16. Cruck-built structures of this type were the standard local form for ordinary village houses, before being replaced in the C17. The cruck truss would have formed an arch, reaching from the ground up to the apex of the roof, with no first floor. The original walls may have been of mud, but were later replaced in stone.

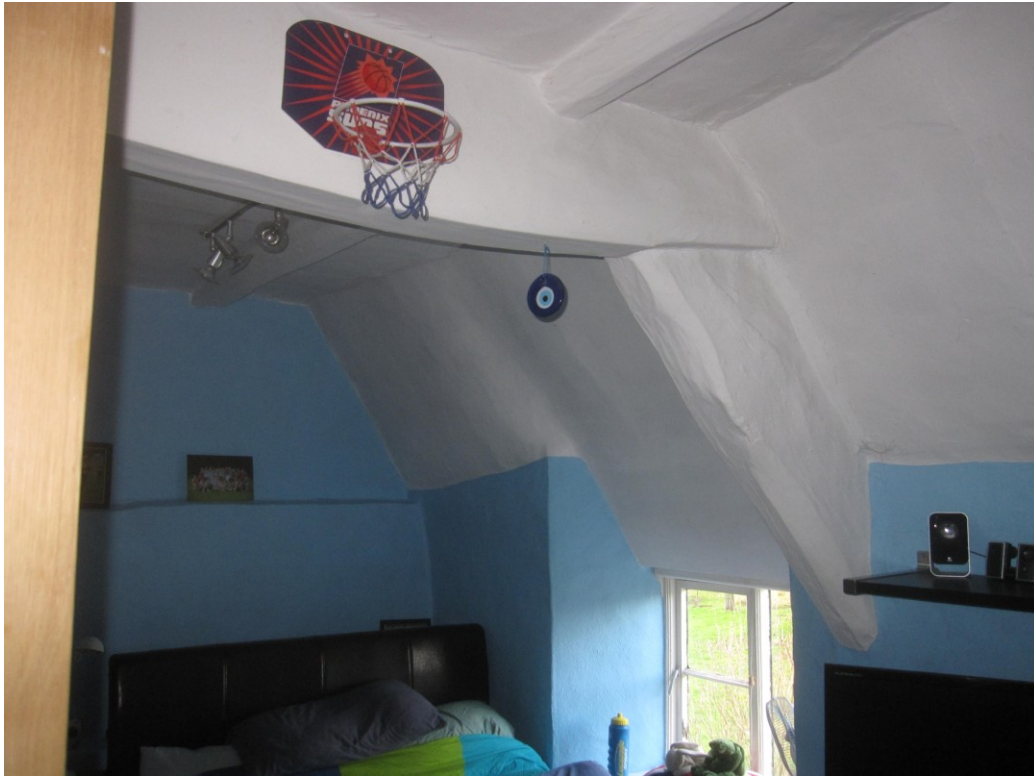
Bedroom with truss T1

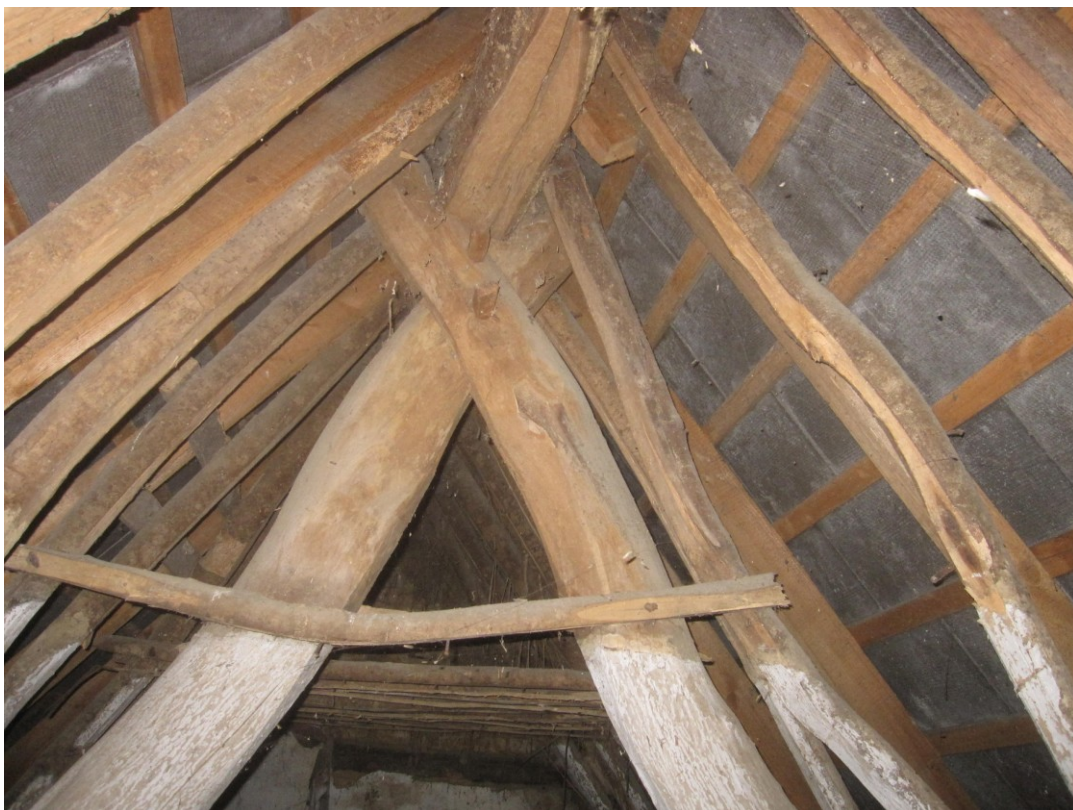
The upper part of truss T1 (north face)

The location of the original stair is now unclear – both the current staircases are modern. There are two roof trusses of A-frame type, with intermediate support to purlins from the stone cross-wall which has the central chimneystack. Both trusses of similar type: rather crudely-shaped principal rafters, lapped scissors apex with big squarish pegs, carrying a roughly-shaped ridge. Lapped and pegged collar. Originally, there were two purlins to each side, carried on the backs of the principal rafters. Some of the purlins are of squared oak, re-used; others of rougher, rounded oak. Straight-splayed scarf joints visible to purlins. Rafters are of ash pole type, surviving in fairly complete condition.

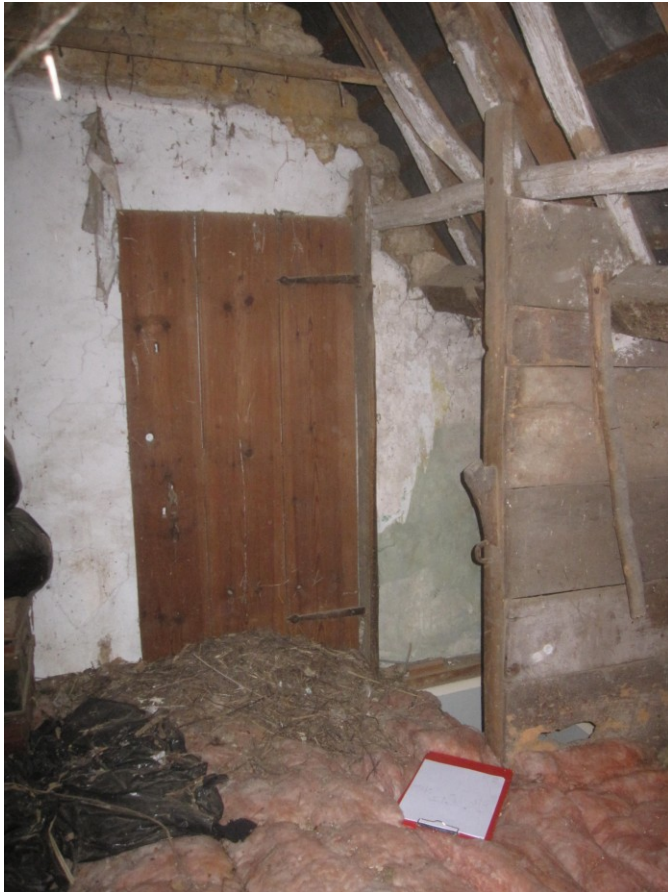
The attic over the south room,  
with small lobby for former stair

The attic over the S room formed a useable space, with floor joists, plaster on reeds to the underside of the (formerly thatched) roof and a high-set horizontal ceiling of ash poles. The whole space was white-washed. Access was via ladder/steep stair to the NE corner, rising into a small lobby, with a pine door, on pintle hinges. There was a small window to the S gable (blocked by the later S end). The central area of the roof

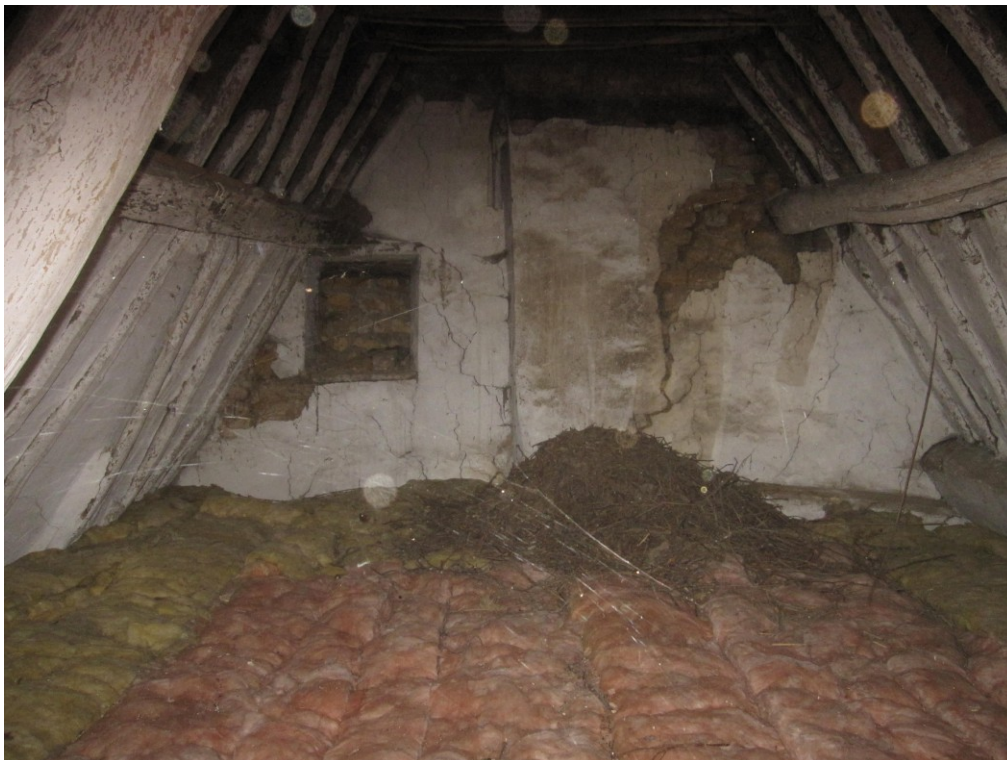
The attic over the south room, looking south towards gable with blocked window

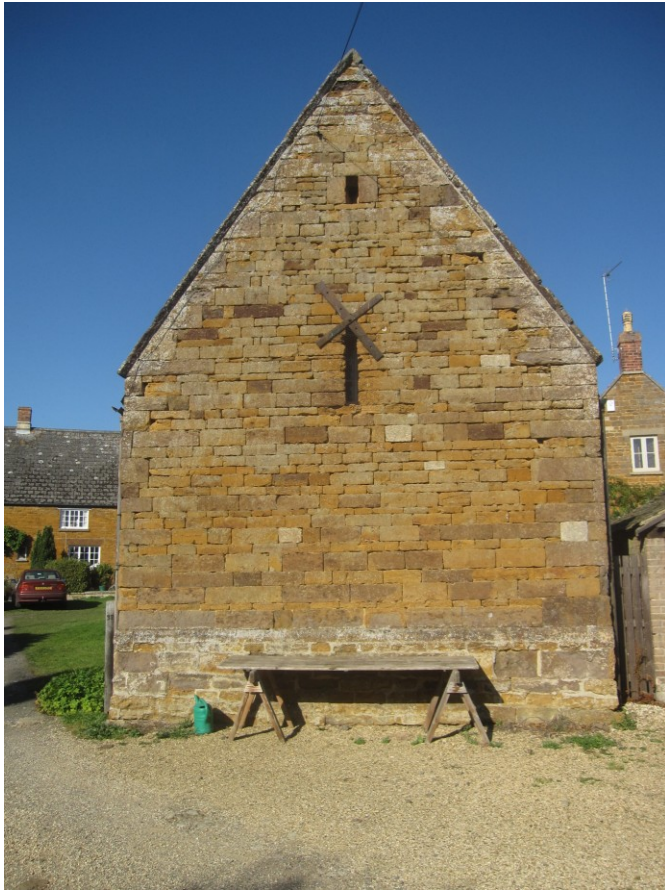
The south gable of the outbuildings range

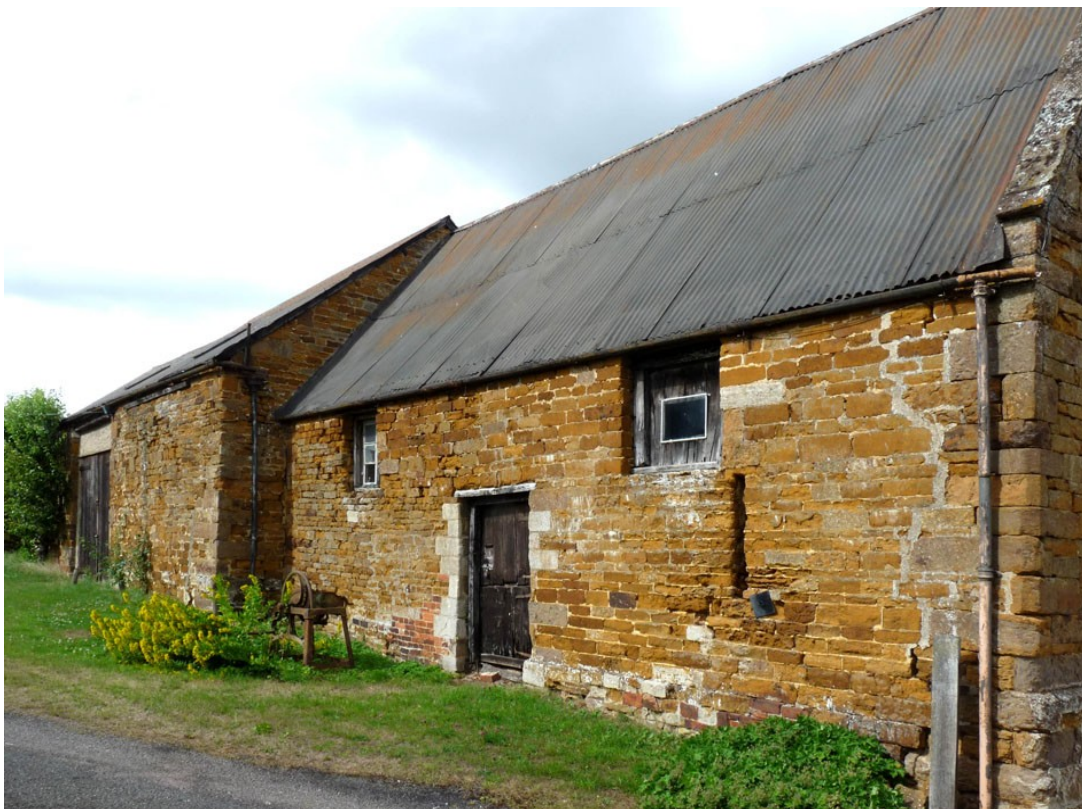
View of outbuildings range from south-west

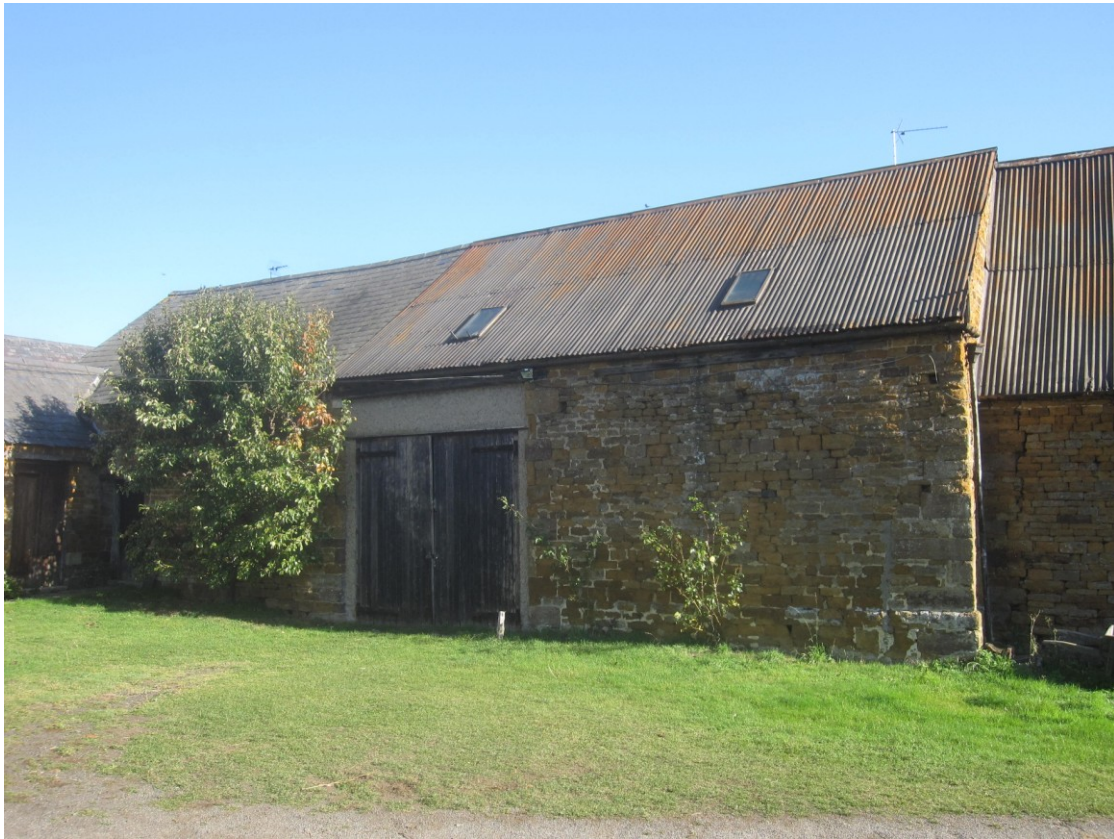
The west front of the barn

A fine range of ironstone farm buildings survives, probably of C18 date. The main barn is of three bays, with a wide, full-height doorway in the front W wall, offset towards the N. There is a smaller doorway in the opposing rear wall, which would have provided the draught for a central threshing floor – before the building of the house immediately to the E, No 39. An old door frame and door survive here, of rough planks and crudely trimmed ledges. There are no other openings or ventilation slits in the walls. Old brick floor. The roof has two roughly-shaped tie-beams, with modern timbers and corrugated iron above, with Welsh slates to the N end.

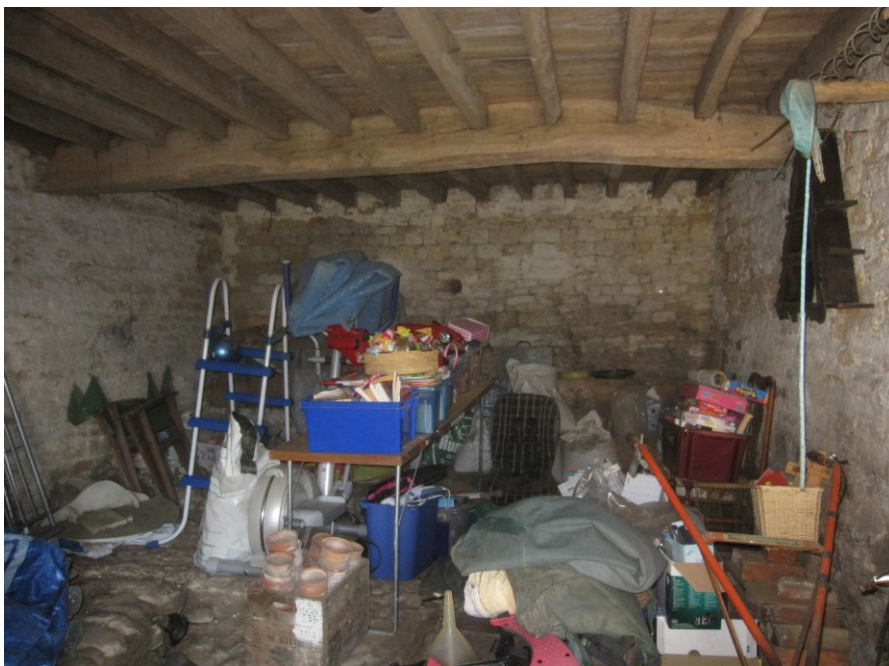
Interior of the north outbuilding

Attached at the N end of the main barn, and integral with its original construction, is a further stone-built section. Wide front doorway with old oak door frame. Inside the front door is a small storage niche. Small vent slit to NW, and a rather larger window in the upper N gable. Good cobble floor. Along the length of the E wall is a timber cattle-feeding trough, supported on crude timber posts. This section has a first floor, a good quality oak structure with two transverse beams and tenoned, rectangular joists, all unchamfered. A steep ladder stair from the main barn gives access to the first floor, rising over the stone cross-wall, which goes only up to first floor level. The high quality first floor suggests use as a granary, though the stairs access is internal, rather than the normal external stair. At the NW corner is a later extension, a small single-storey store, with plain doorway and a vent slit to the upper W gable.
