**Lyddington Manor History Society
Historic Building Survey**

**Jasmine Cottage, 105 Main St
Lyddington, Rutland**

HISTORIC BUILDING SURVEY REPORT

JASMINE COTTAGE, 105 MAIN ST, LYDDINGTON

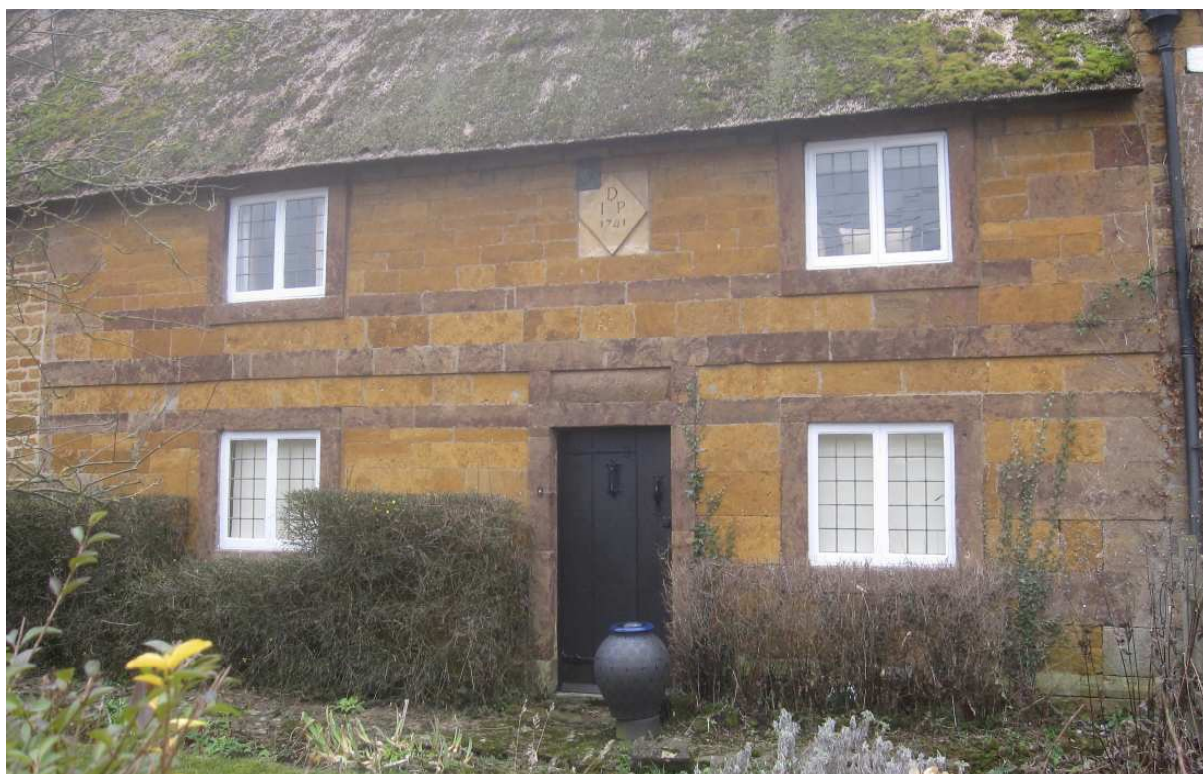
The east front of the main block

The front of the main block has high-class stonemasonry, of neatly cut ironstone ashlar, with four band courses of brownstone ashlar. Good quoins demarcate the main block, with straight joints against the adjoining house to the N, and to the extension to the S. The door is centrally set, with windows either side to ground and first floor. All four windows and the doorway are set in plain, slightly projecting surrounds of brownstone. Above the door is a recessed panel with a pulvinated (curved) frieze, a sophisticated detail. Set centrally over the door is a date-stone of limestone, with a diamond-set projection which carries the initials D T P and the date 1741. The arrangement of the initials, with 'D' at the top, indicates that this represents the family surname, with the husband's first name starting with 'T' and his wife's with 'P'. To the top left of the date-stone is a metal fire insurance plaque. The door (now blocked inside) has plain oak boards. The windows have timber casements

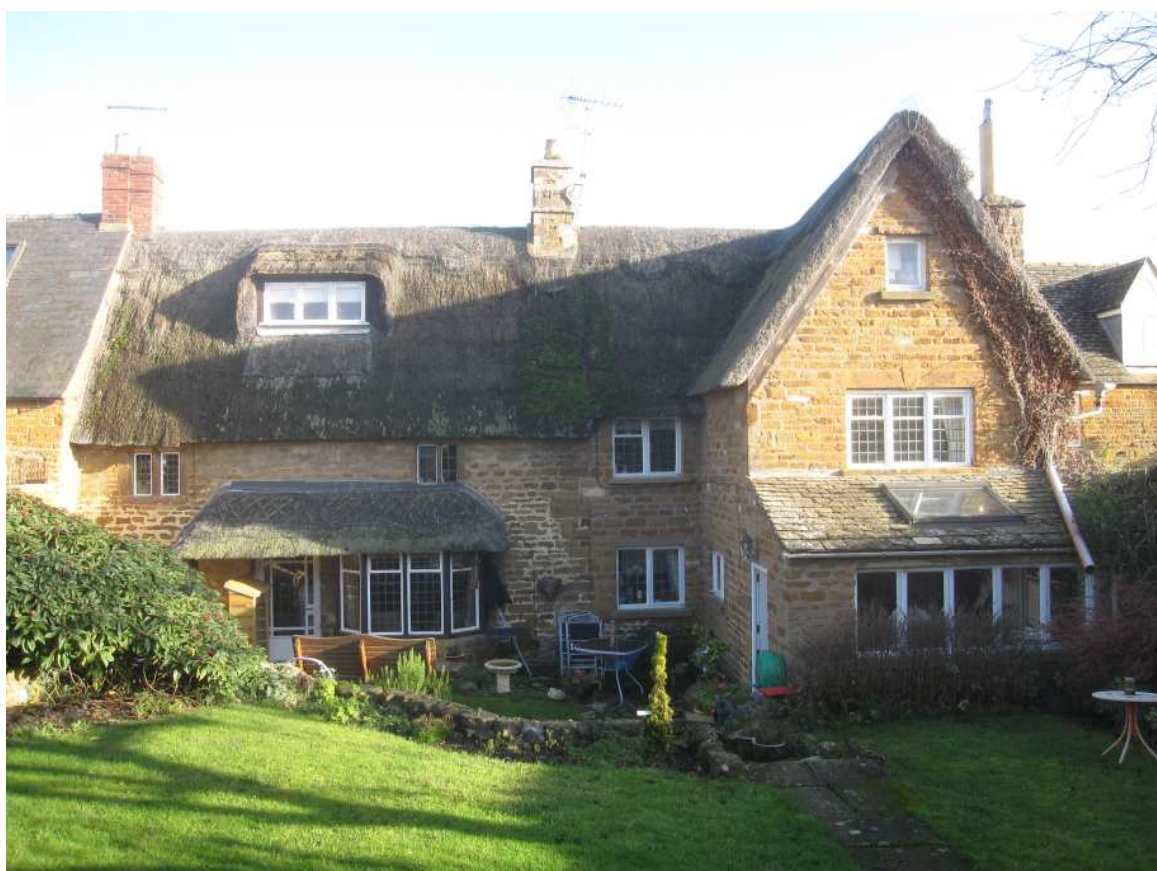
The rear west side

The rear W side of the main block has coursed rubble, with good quoins to the S where it abuts the extension. To the N, the adjoining house steps outwards to the W at the abutment, and there is only one stone of quoin type to No 105. To the N, the ground floor has a small rectangular window, with an ironstone surround, like a C17 single window. Above, on the first floor, is a 2-light stone-mullioned window with ovolo-moulded jambs, a broad, flat-chamfered mullion, and chamfered head and cill. The ground floor doorway opening has plain ironstone quoins and an oak lintel – not modern work, but of indeterminate age. A modern bay window projects under a thatched roof. Above this is a 2-light stone mullioned window, here all chamfered, with a thinner mullion, though the head indicates that this may once have been wider.

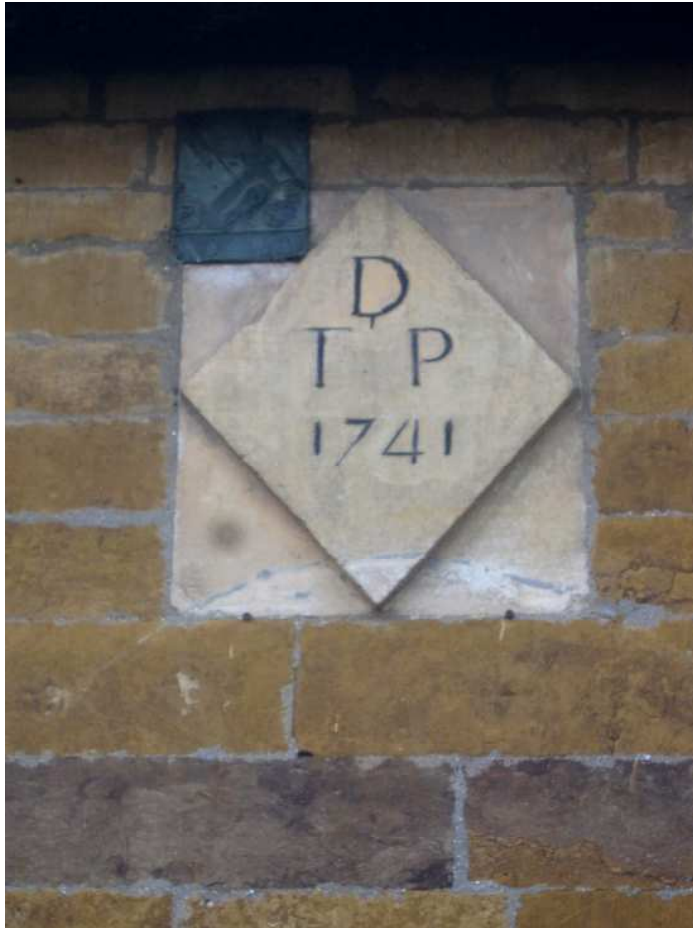
The 1741 date-stone

The front wall of the main block was evidently rebuilt in 1741. This build included the elegant front doorway, and seems also to have included four 2-light stone mullioned windows, which probably had a chamfered central mullion. However, it seems likely that this was a re-working of an earlier house, dating from the 17th century. The ovolo-moulded window in the rear wall, the ingle window and the main first floor structure all probably date from the 17th century. The presence of the ingle window suggests there was originally a large ingle fireplace in this location. The current ingle fireplace seems more C18 than C17 in character. The location of the stair in this C17 house is unclear, and the building may also have extended further to the S.

The sophisticated design of the stone front to this house is interesting, especially in that it combined advanced features (such as the pulvinated frieze over the door) with older-fashioned elements like stone-mullioned windows. It is also a very high-class frontage for a modest-sized house. The fact that the date-stone includes the family's initials indicates that the owner/tenant had a certain pride in his newly rebuilt home.

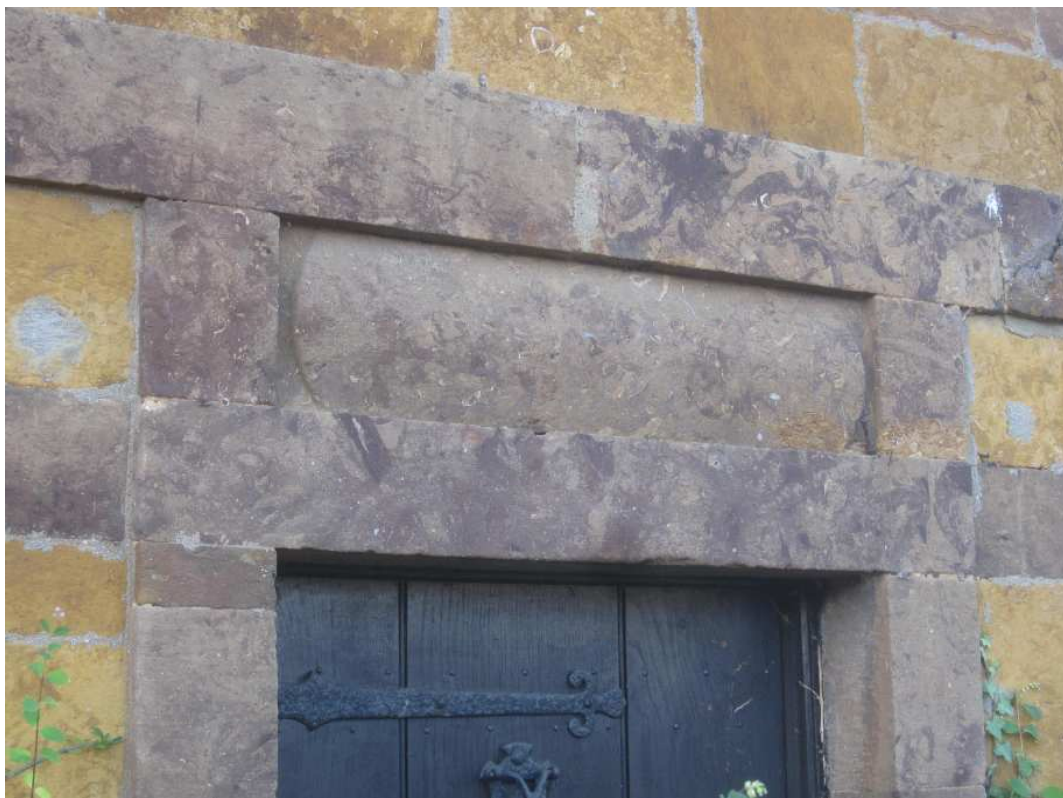
The front doorway, with
pulvinated frieze

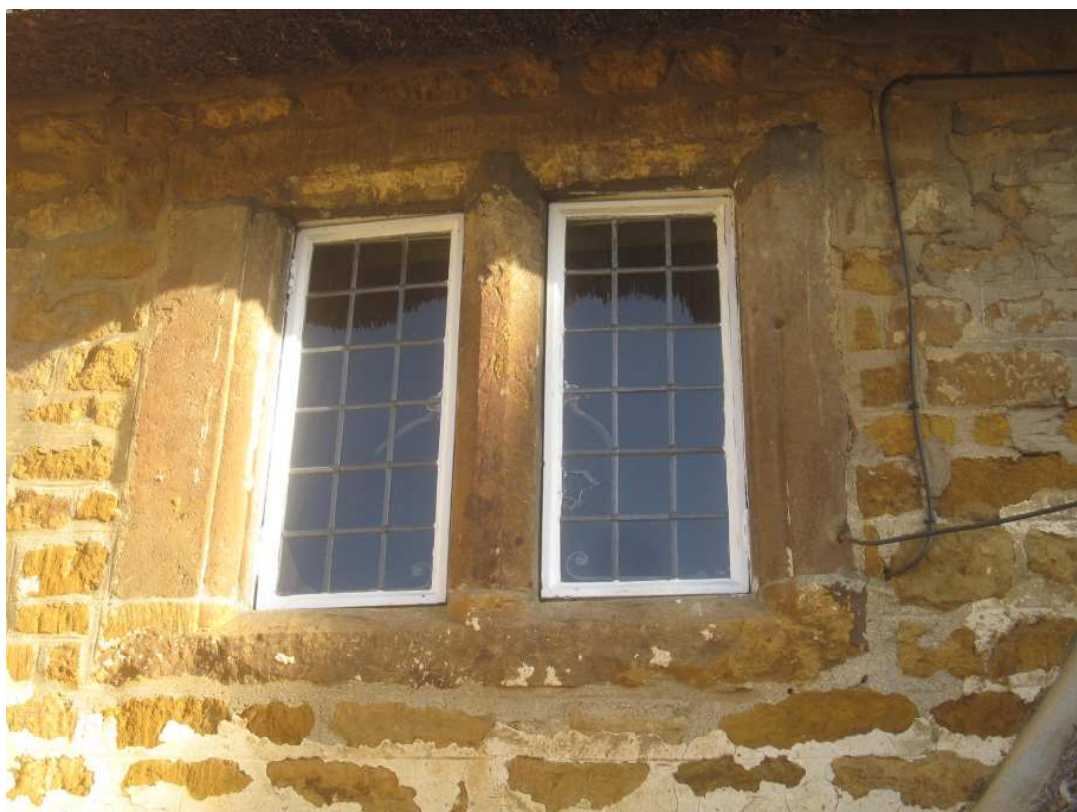
Rear first floor window, with ovolo-moulded jambs and chamfered mullion

Few old features are visible on the first floor, and roof timbers to the converted attic have been covered up. The two stone windows to the front wall have the cut-off remains of a central stone mullion to the stone window head, and stone jambs, all of indeterminate profile. In the rear wall, the S stone window has plain chamfers and a lintel of re-used oak. The N window has ovolo-moulded jambs and chamfers to the mullion, head and cill. The head, which has a mason's mitre joint, incorporating both the ovolo and plain chamfer mouldings, which indicates the whole window is of a single date.

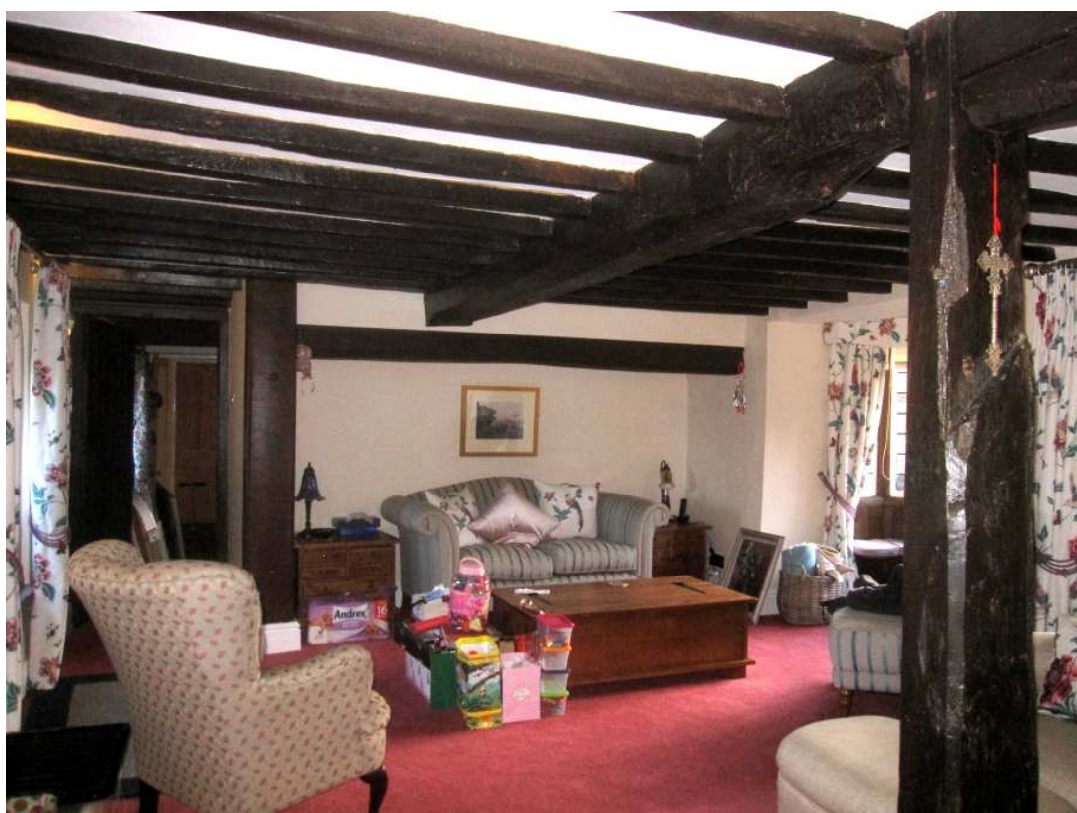
The Interior of the main block, with inglenook fireplace

The ground floor of the main block now forms a single space, though there would originally have been a partition, where an inserted (re-used) timber post supports a scarf joint in the ceiling beams. The larger room to the S has a wide inglenook fireplace, with a plain, chamfered oak beam. The ceiling spine beam has chamfers and good ogee stops to the S end, though none to the N. The floor joists appear contemporary with the beam, generally around 70mm wide, with small chamfers and run-out stops. The N end formed a smaller room, with a narrower spine beam,
