**Lyddington Manor History Society
Historic Building Survey**

**Poplars Farm,
2 Stoke Road,
Lyddington, Rutland**

HISTORIC BUILDING SURVEY REPORT

POPLARS FARM 2 STOKE ROAD, LYDDINGTON

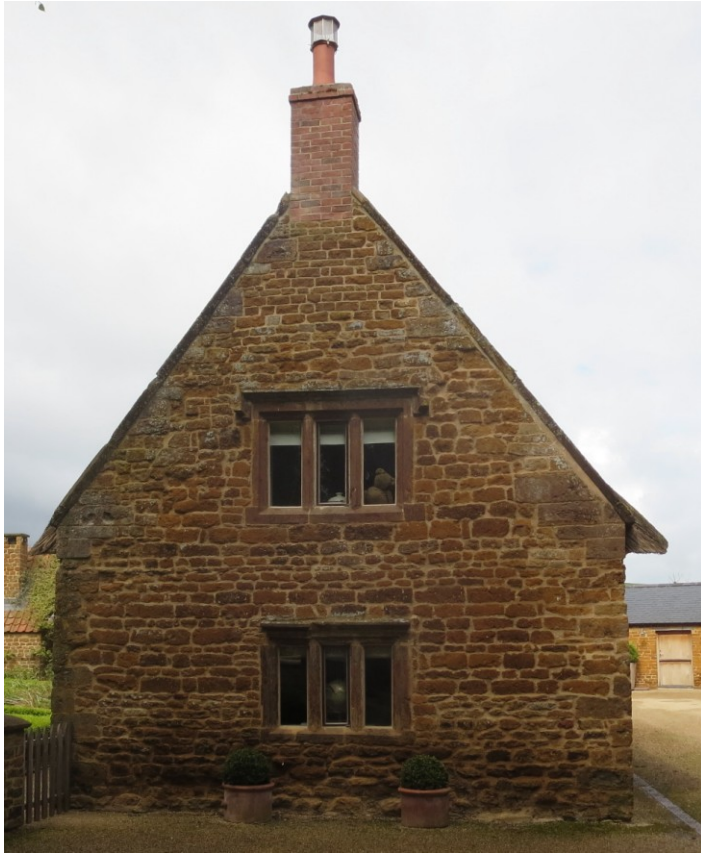
The E front gable has well-coursed ironstone, with ironstone quoins, gable parapet and plain kneelers. Ovolo-moulded ironstone windows to ground and 1st floor. The ground floor window has a cyma cornice, but the 1st floor has a cavetto cornice with dropped ends. The mullions to both windows are chamfered inside, not ovolo-moulded. Rebuilt single-flue brick stack to apex, cutting the gable coping.

The east gable

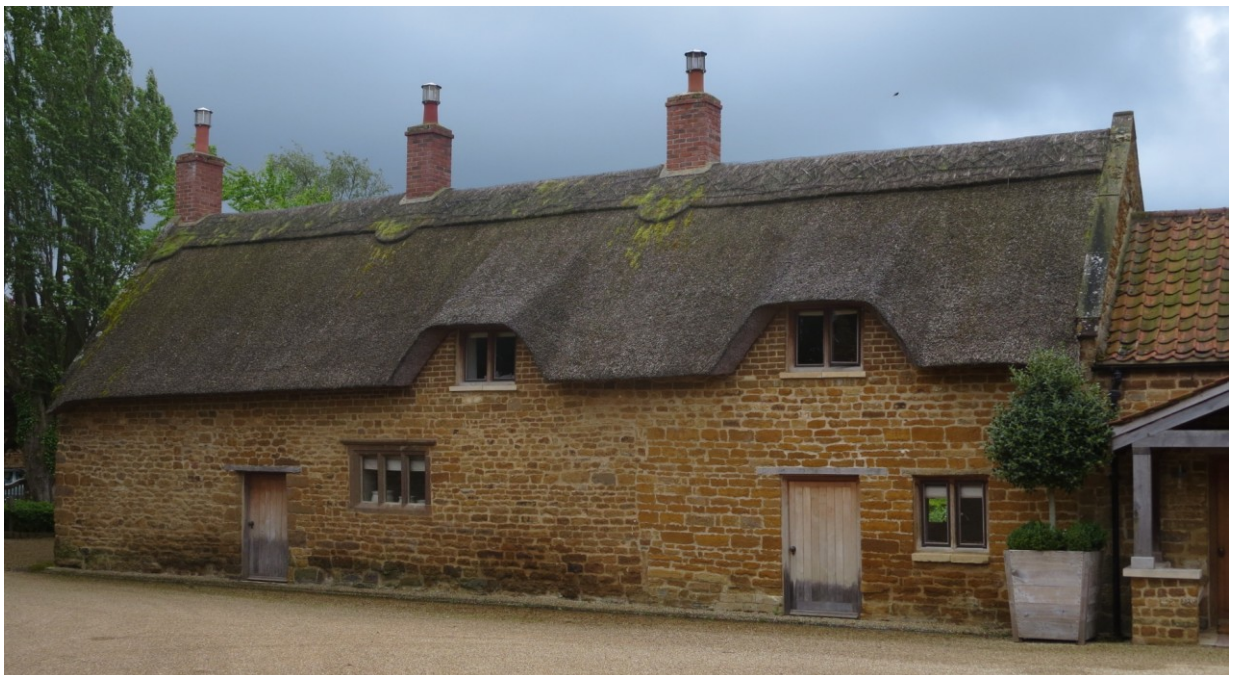
The N side E bay, up to a blind doorway, has some unusually irregular ironstone, not laid to courses. This section of wall may be an older survival, as it is also 100mm thicker than the adjoining wall. The blind doorway has good quoins and an old timber lintel. Next is a 3-light ironstone ovolo-moulded mullion window, with cyma-moulded cornice. The W bay of the N wall has largely been refaced in larger-coursed ironstone, to counter some of the outward bulging stonework to the central section.

Here there is another doorway with ironstone quoins and old timber lintel, with a modern timber window to its W. The upper courses of the first floor have been rebuilt, as have two dormer window surrounds.

The north side

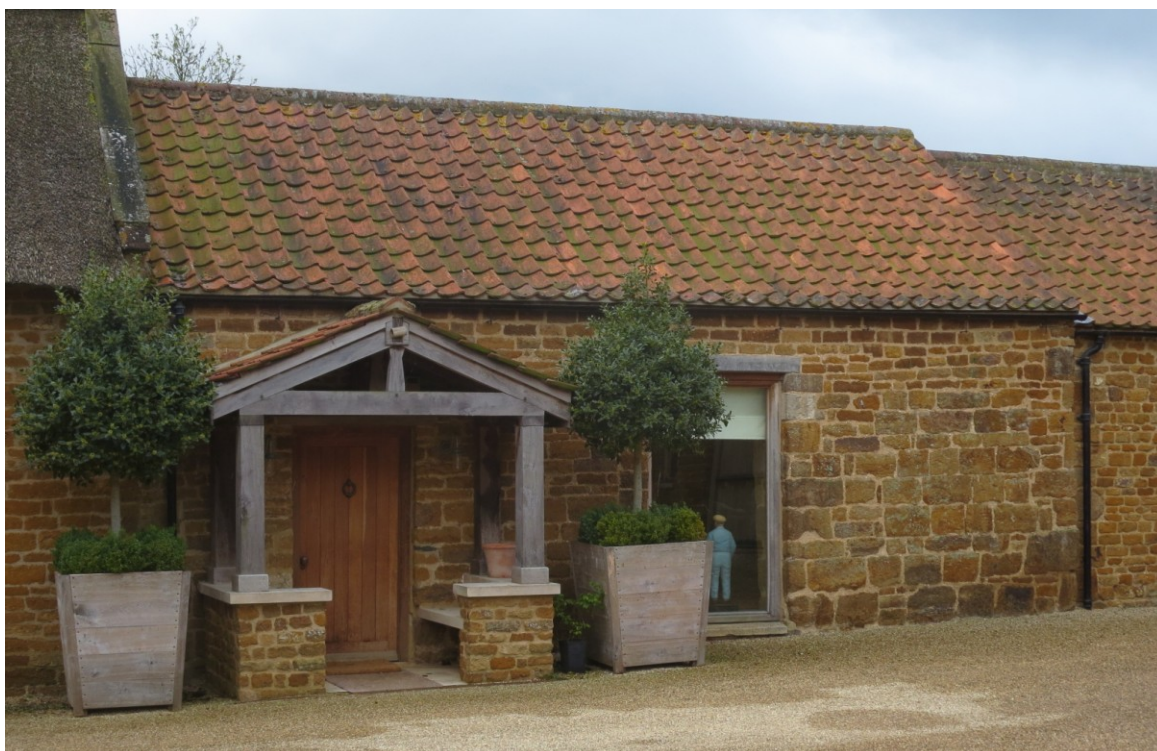
A single-storey outbuilding, of coursed ironstone with pantiled roof abuts the W gable of the house (now converted to domestic use). Probably C18. The masonry has some quite large coursing, especially to the N wall. Wide doorway to N, though this seems to be a re-working of an earlier, lower opening, with former jamb and cut-off lintel to the E. To the E is the current doorway, a later insertion. Small square window to rear wall of chamfered stone. Inside, a small cupboard recess is set just to the W of the main N doorway – suggesting this may originally have been a stable. Modern roof structure.

North side of former attached outbuilding

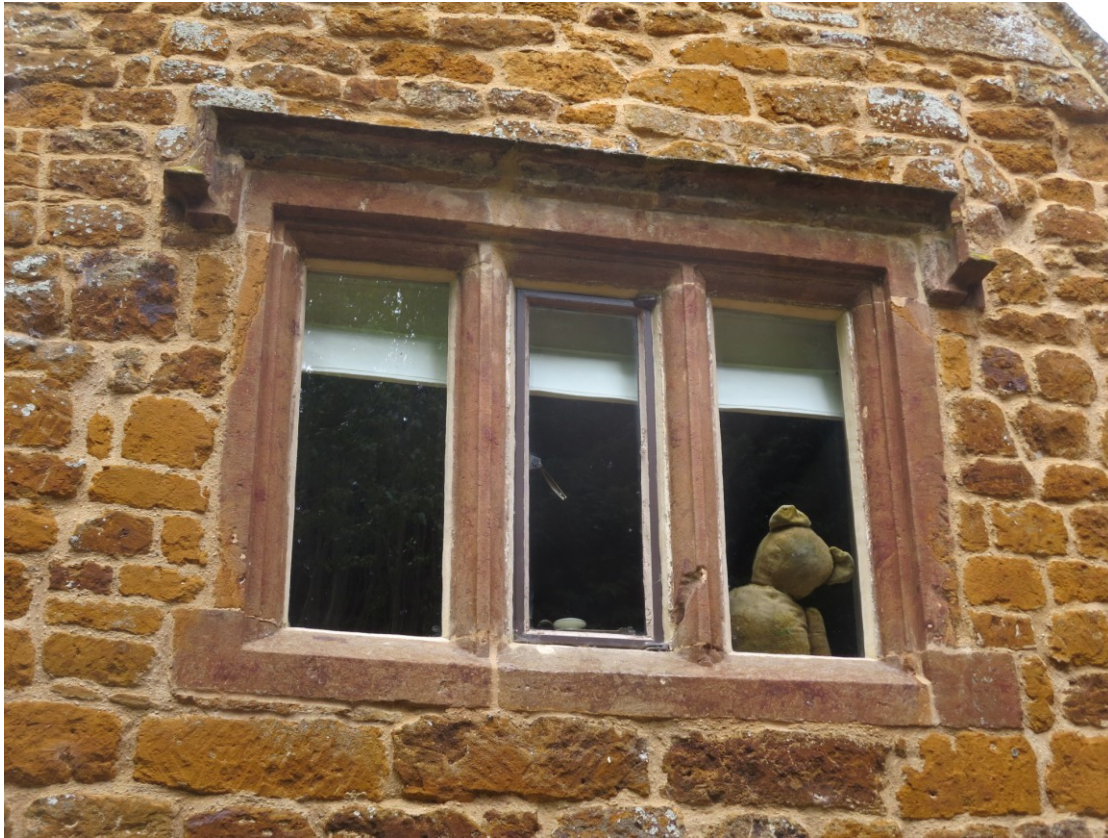
Mullioned window with hood mould to first floor of east gable

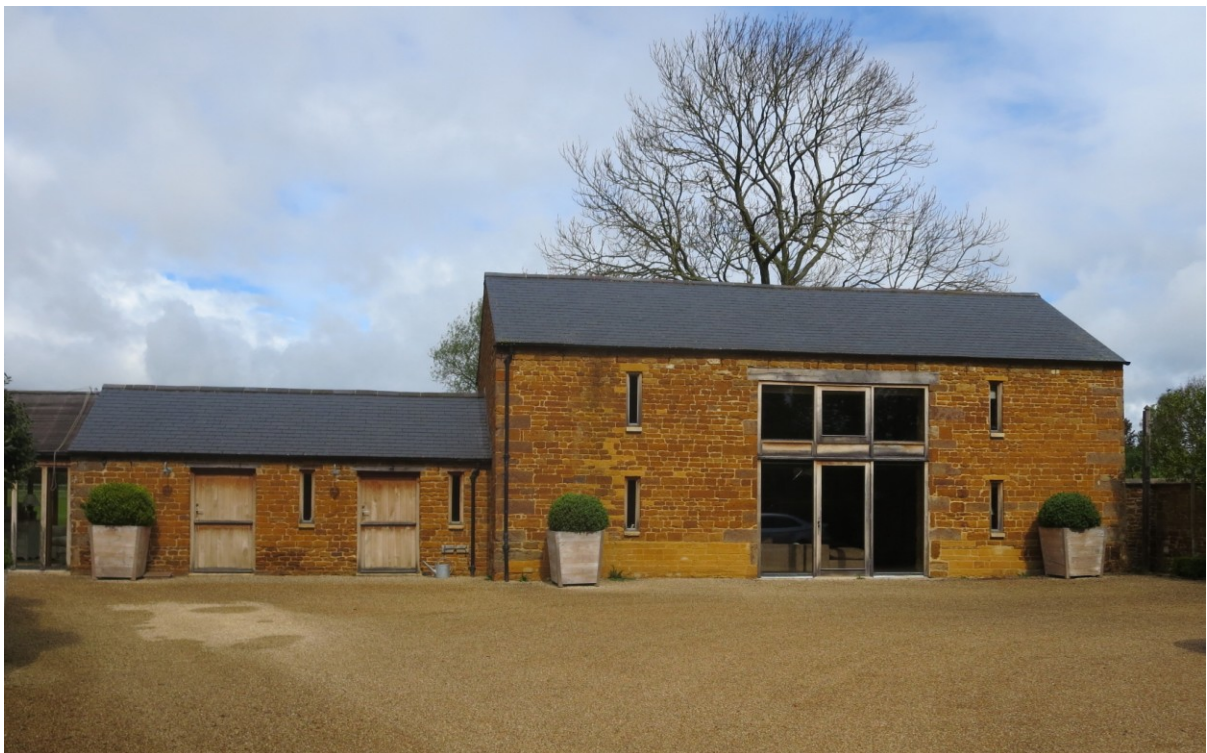
NW of the house is a large ironstone barn, 11.6m x 5.2m internally, now converted to domestic use with an inserted 1st floor. Probably C18. Large doorway opening to E front, offset to the N. Good masonry with a chamfered plinth to all sides where visible and various ventilation slits, both lower and upper. . The rear pedestrian doorway is apparently a recent insertion, so it seems there was no opposed set of threshing doors – an unusual feature. Modern roof structure and slate roof, with no kneelers or indication of the original height/pitch of the gable ends.

Abutting the main barn on the S is a single-storey outbuilding with stone walls, slate roof and modern openings. Two softwood kingpost roof trusses inside, the post/tie with a bolt/captive nut detail, of later C19 date. Modern extensions now link the house to the barn. Along the N side of the farm yard the stone wall shows evidence of further lost outbuildings.

The east side of the barn and outbuilding

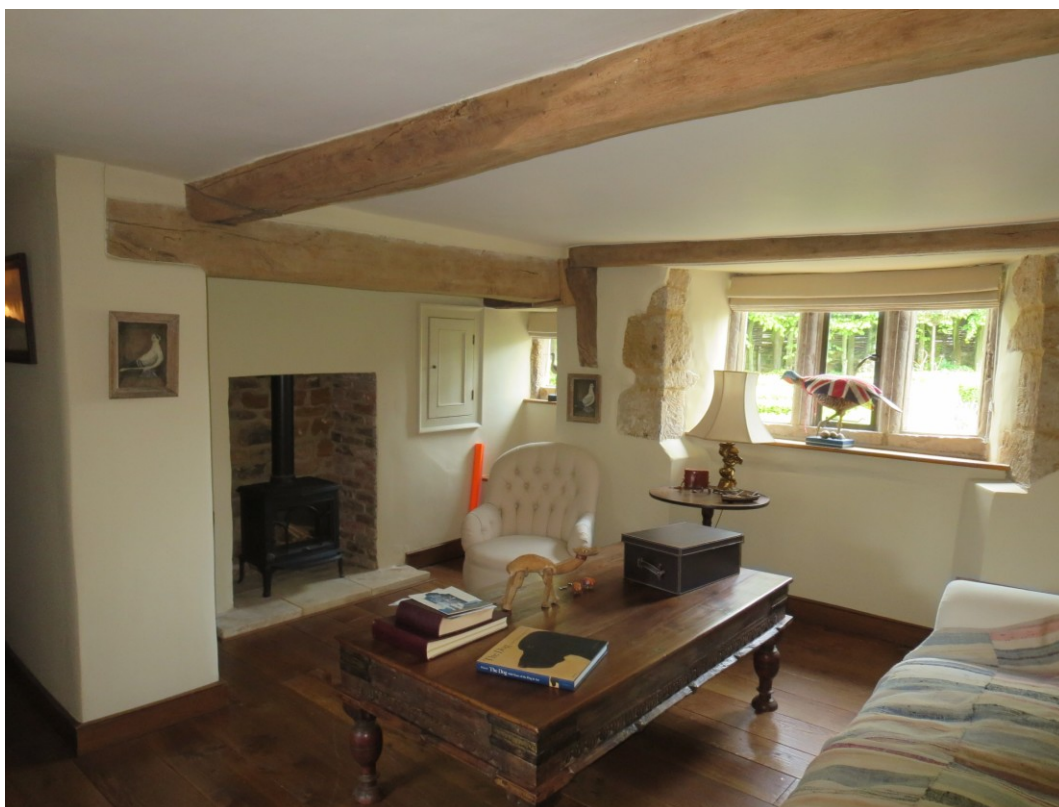
The central room has a spine beam, with a scarf joint over the modern ingle beam; no stops to the W, run-out stops to the scarfed-on end to the E, with bolted iron strap. The inglenook fireplace is newly built, including its cheek wall and ingle beam. However, the ingle window and scarf joint indicate that there was originally an inglenook fireplace here, probably replaced by a smaller fireplace in the C19th. The N and S walls have side wall oak beams to carry joists, though that to the S has recently been replaced. The S wall beam is supported at its E end, next to the ingle beam, by a jowled oak post, set into the wall. The jowl is carefully shaped and has neat chamfers, so it seems likely it was always a jowled post support, and is not a cut-down cruck blade. The N wall beam is chamfered and one projecting timber corbel beam can be seen.

The central room, looking south-east

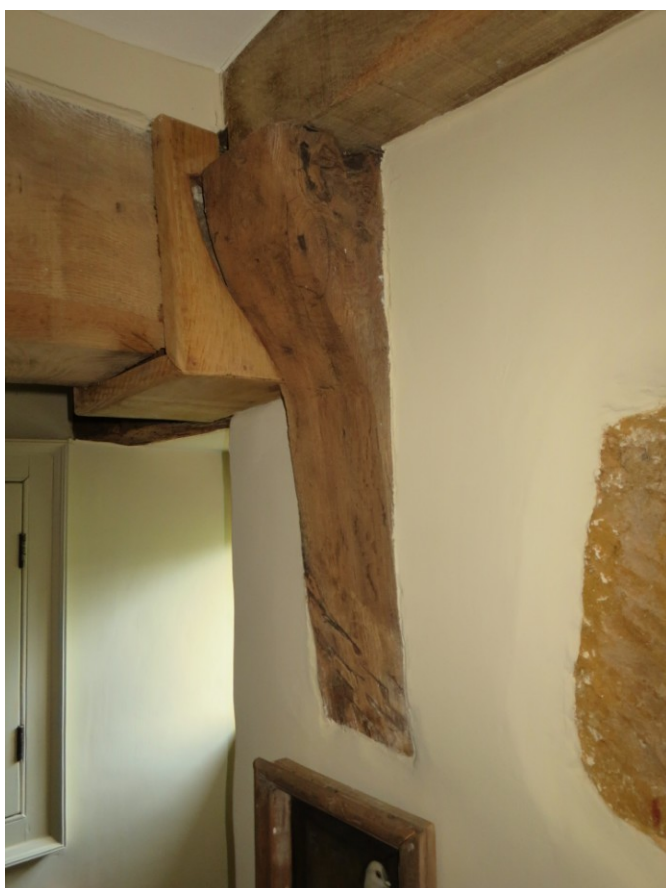
Jowled oak post supporting
wall beam to central room

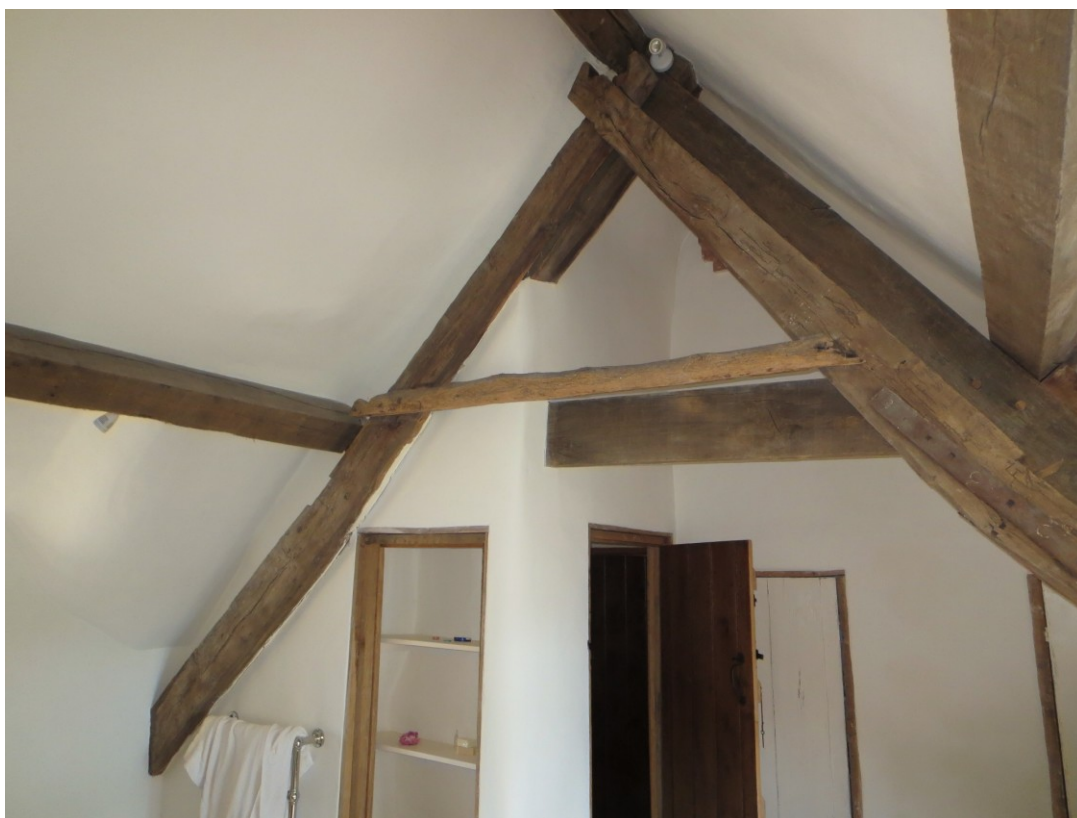
The central room has an early truss (T1) set just W of the tall gabled dormer window. It is of A-frame type, though the lapped collar has been cut out. Trenches for single, pegged side purlins, scissors apex with squared seating for ridge (lost), with two big skew pegs. The S principal has been reinforced with iron strapping (re-used cart tyre metal). A later high-set collar is nailed across the principal rafters. In the 600mm thick crosswall E of the truss (which incorporates the chimney flue) there are two cupboard recesses with old timber frames (which must post-date any inglenook fireplace).

Truss T1, west face
