**Lyddington Manor History Society  
Historic Building Survey**

**Prebendal Farm, 11 Church Lane  
Lyddington, Rutland**

# **HISTORIC BUILDING SURVEY REPORT**

## **PREBENDAL FARM, 11 CHURCH LANE, LYDDINGTON**

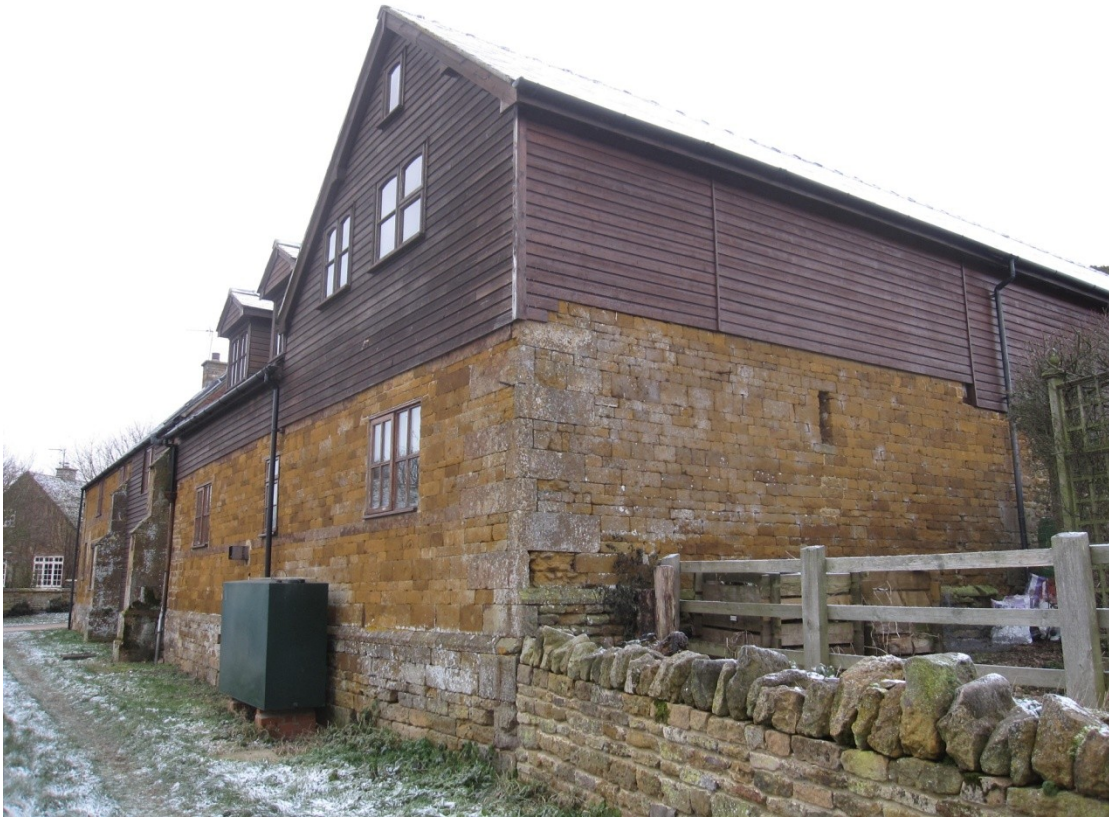
The N gable has similar walling as elsewhere, but cut down at higher level. At the centre of the wall is the one surviving ventilation slit, now blocked. It has plain square jambs and a plain ironstone lintel and cill.

View from the north-east

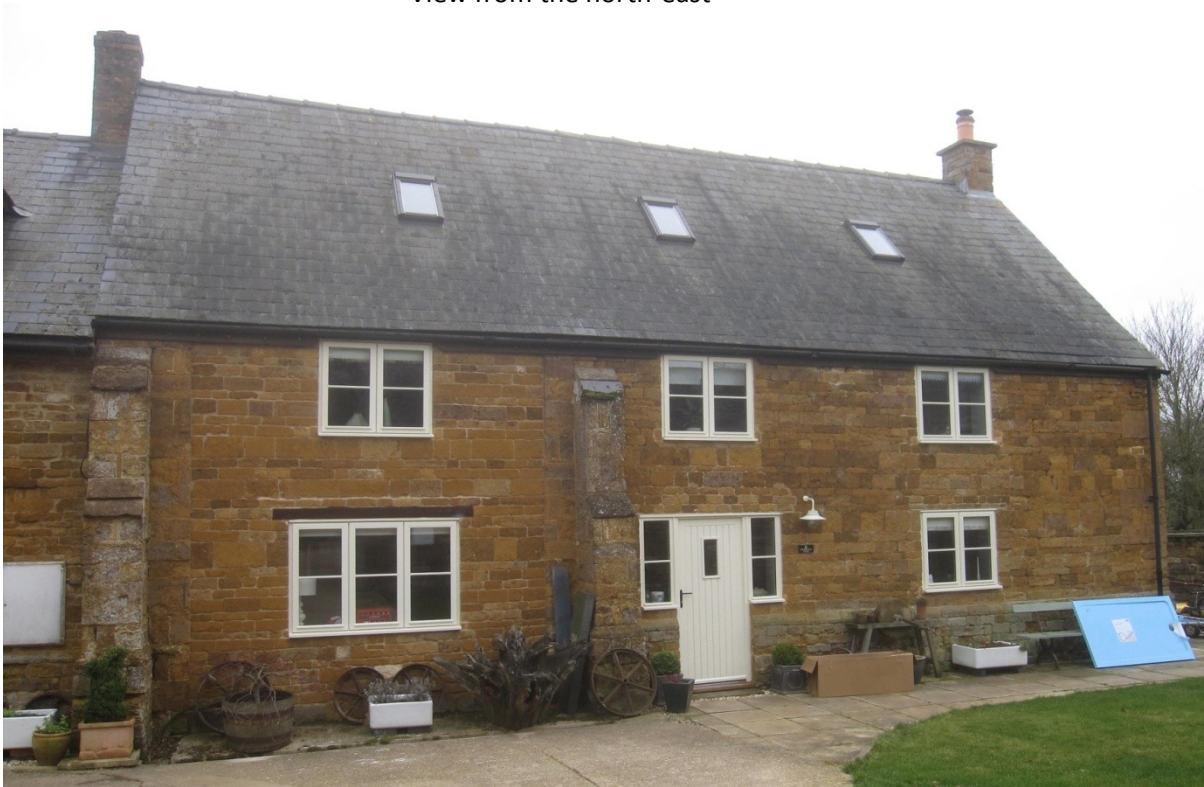
The barn as built is of 6 bays, though the N section has been reduced in height. The W front has the former full-height barn door opening, now blocked, with buttresses to either side. The door bay was offset, with three bays to the left and two bays to the right. The buttresses rise to just below eaves height, with weatherings at the top and half-height of brownstone. A chamfered plinth runs around the whole building, including the buttresses. Below the plinth, the buttresses have an additional square plinth to the outer face only (not the sides). To the N of the main barn doorway is a wide doorway with a cambered arch over, of ironstone voussoirs. A 1980s photos

The west front – remaining two-storey section

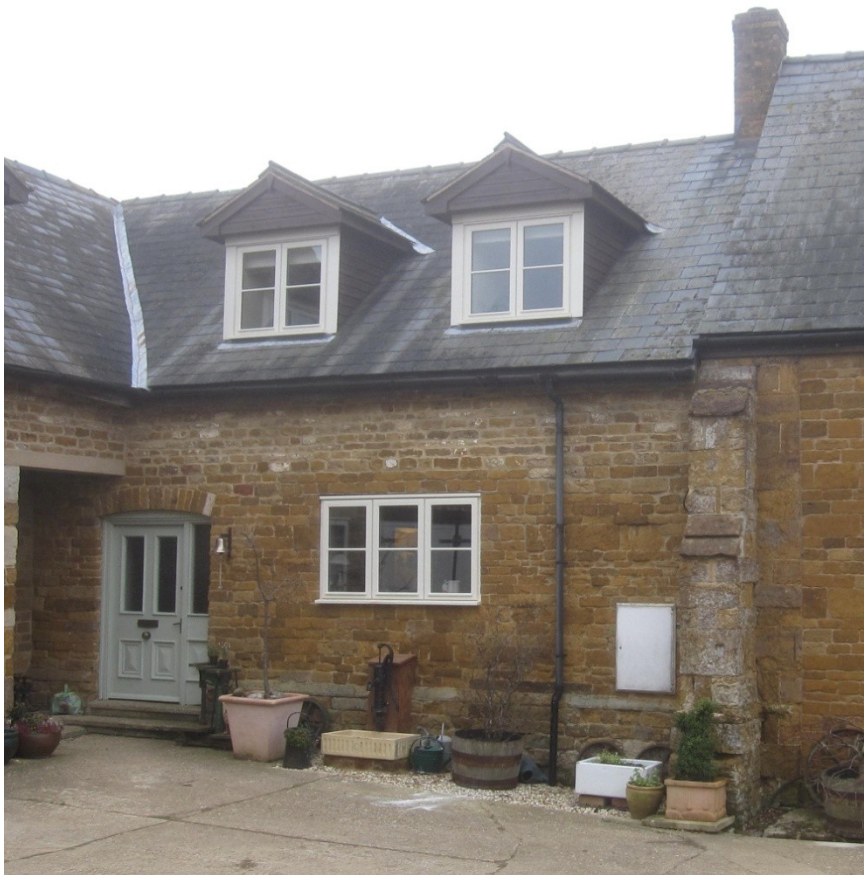
shows an old stable door here. This opening appears to be an original feature, not a later insertion. Modern window openings have now masked the earlier openings, including original ventilation slits, but evidence from survey elevations and a few photos of c.1985 (before conversion works) allows the pre-1985 appearance to be reconstructed. To the S of the main barn doors there was a tall vent slit, and a loading hatch, set just below eaves level.

The west front – south end

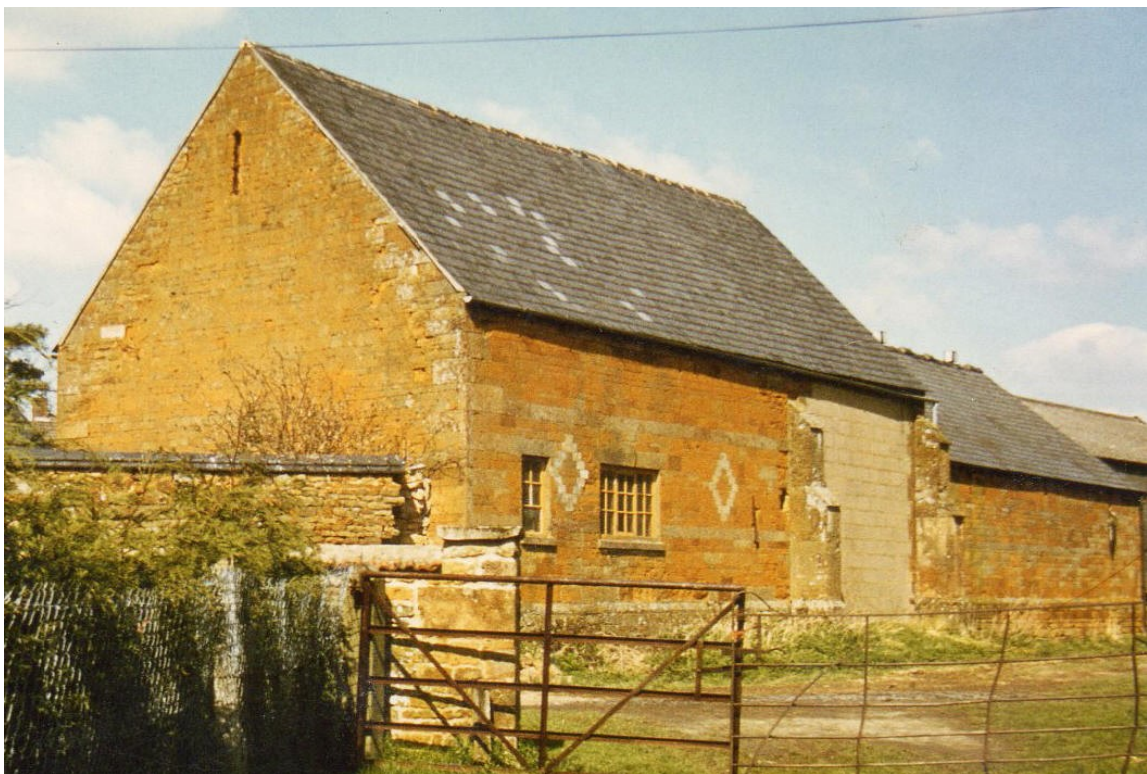
The E side has the same type of walling as the W, with buttresses either side of the former barn door opening. This side has two bands of brownstone ashlar across the whole length of the wall. To the S of the barn doorway, the wall has two carefully made lozenges of limestone ashlar, the pattern set flush with the surrounding ironstone – an unusual feature. There is no sign of this feature to the N of the doorway. Near the S end is a plain opening, now blocked with boarding, with a plain ironstone lintel and concrete cill – probably an insert of C19 date. There was a similar, wider window opening beside it in 1985, later replaced in almost the same position by a modern window. The 1985 survey indicates three vent slits to the section of wall N of the main doorway.

View from the south-east before conversion

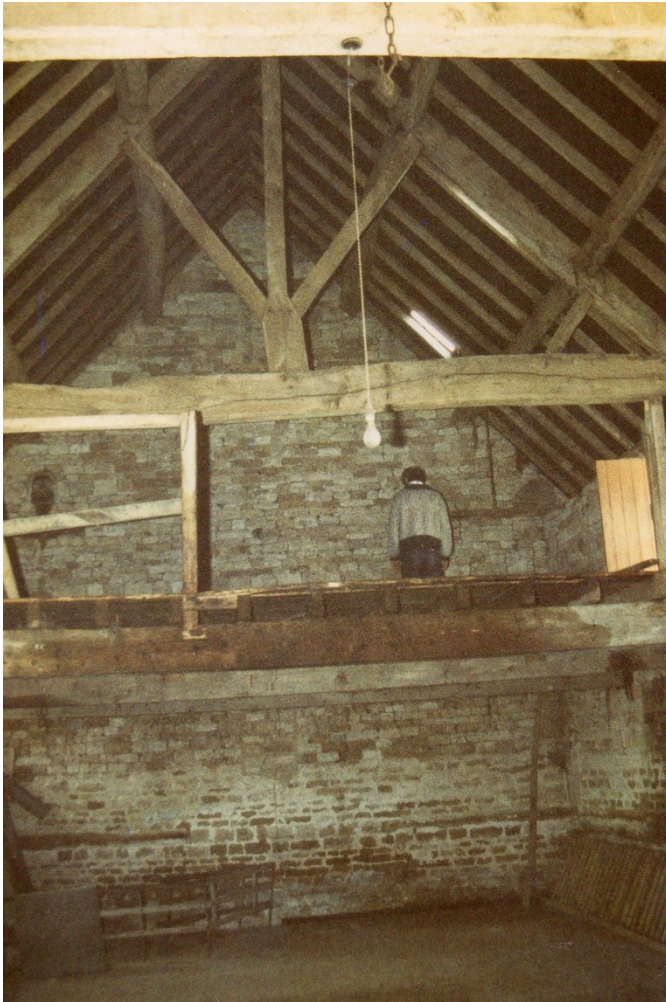
1980s photo, looking south

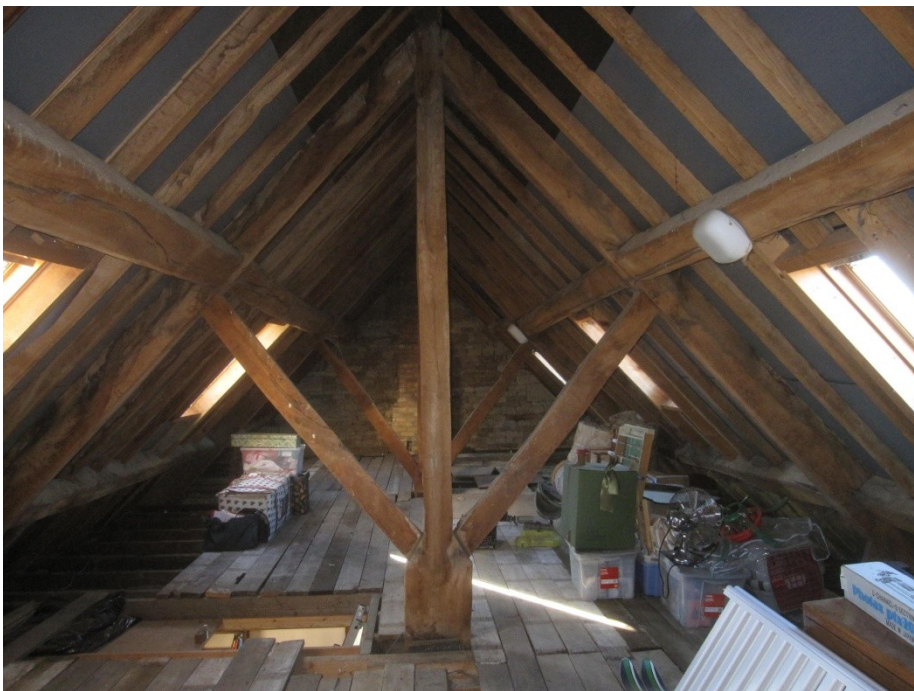
The southern three bays of the original oak king-post roof structure survive in very complete condition. The three northern bays were lost when the building was reduced in height. The tie-beam is straight, with small chamfers and ogee stops to the underside. A stout king-post is tenoned and pegged to the tie-beam, with a jowled base and head. Raking struts rise to the principal rafters, and there are further short raking struts near the eaves. There are two sets of tenoned purlins, and no ridge beam. There is a very full set of scribed carpenter's marks. The sequence shows that there were two trusses to the missing N section of the roof, T1 and T2. Trusses T3

The king post roof structure, looking south

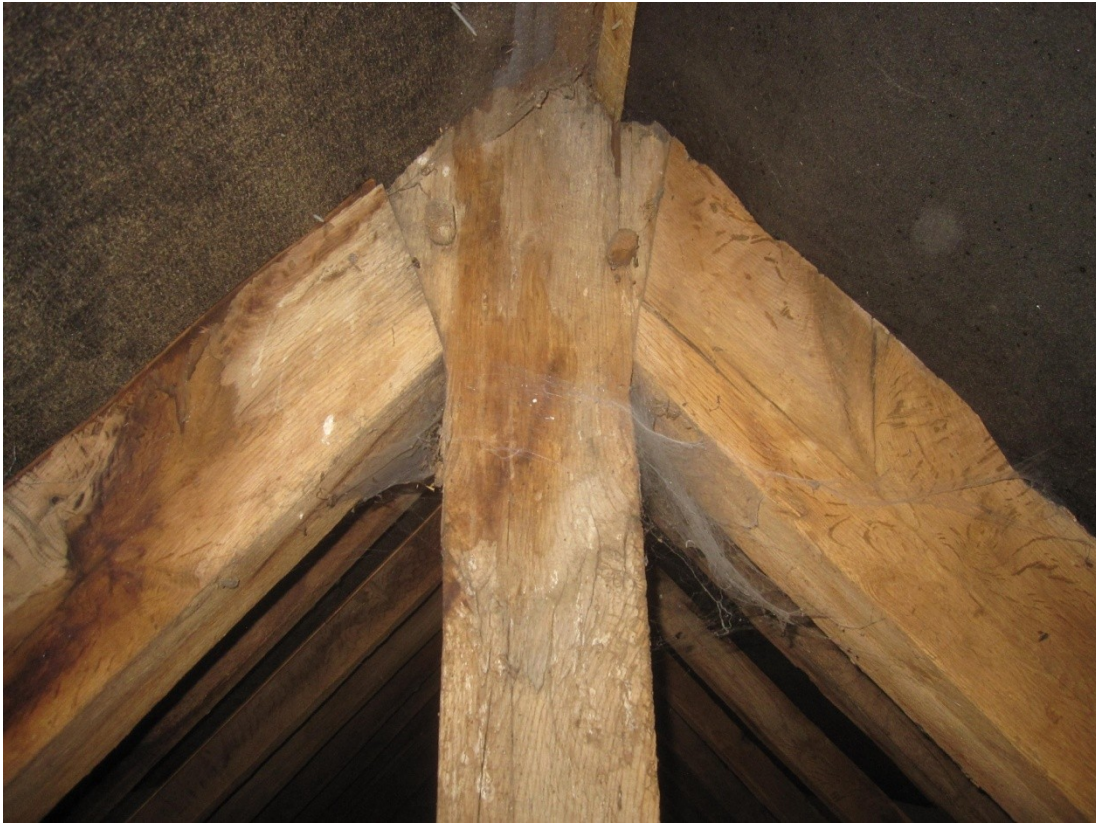
Rafters are tenoned to the lower purlin and lapped across the back of the upper purlin. The rafters have a bridled joint at the apex, without a peg. Each rafter couple has a peghole just below the apex on the W side (one peg still in situ to N end), which must have been for fixing a plank-shaped timber on the W slope, at ridge level – perhaps a prototype ridge board. There are 8 rafter couples in each bay.

Apex of king post truss

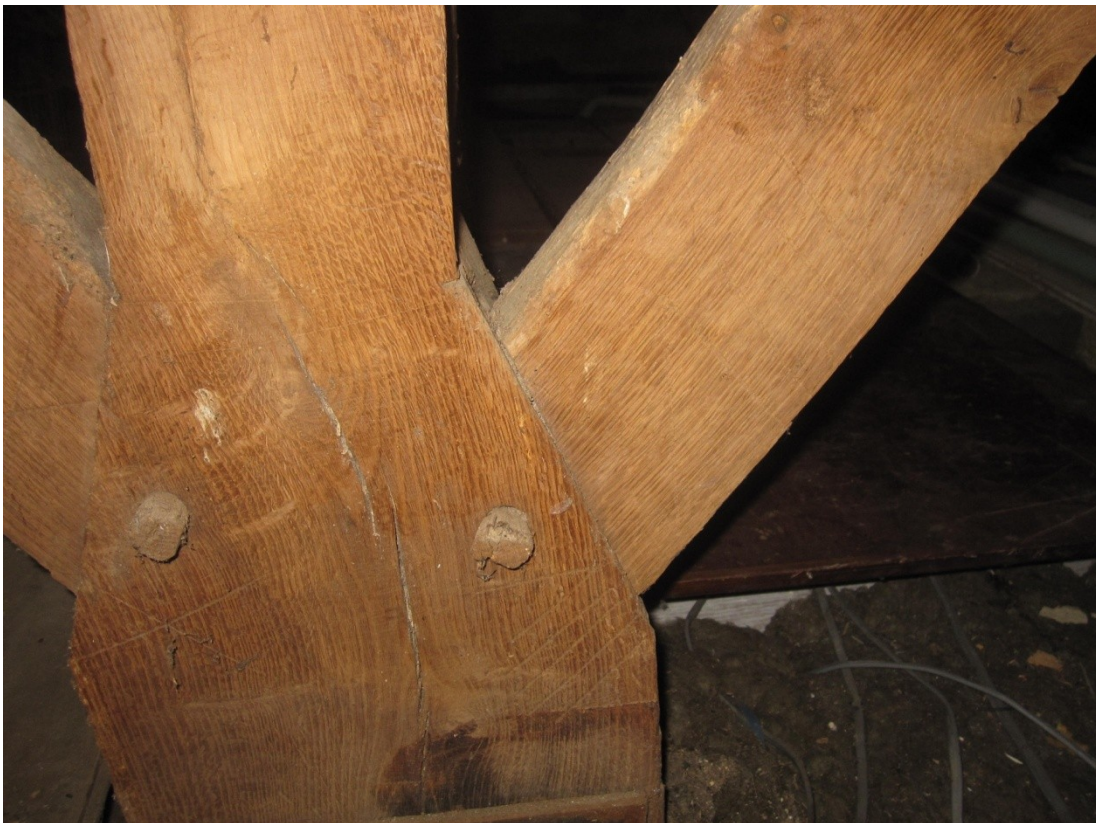
Foot of king post
