Lyddington Manor History Society Historic Building Survey

The Knoll, 103 Main Street, Lyddington, Rutland

HISTORIC BUILDING SURVEY REPORT

THE KNOLL 103 MAIN ST, LYDDINGTON

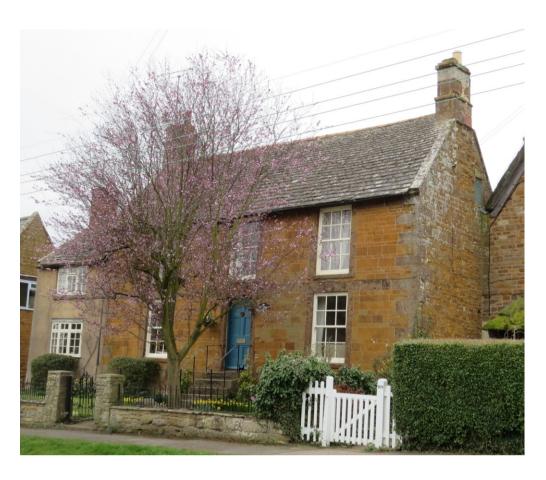
The east front

The main E front is a high quality, symmetrical design with fine masonry. Quite tall, with two full storeys set over a cellar. Finely jointed ironstone ashlar, with dressings of brownstone. Band courses of brownstone at first-floor level and eaves, and a 40mm

square-set plinth. Central front door, approached up stone steps with an iron railing. The doorway has a beaded brownstone surround, projecting slightly from the wall face; flat, beaded lintel with projecting triple keyblocks, the central one fluted. 6-panel C20 door. Tall sash windows set to either side of the door, also with beaded surrounds and projecting triple keyblocks. Three tall sash windows to first floor, with timber lintels at eaves level. To the N of the door, not aligned under the sash window, is a cellar window of stone-mullion type, with a plain, square-cut central mullion and surround.

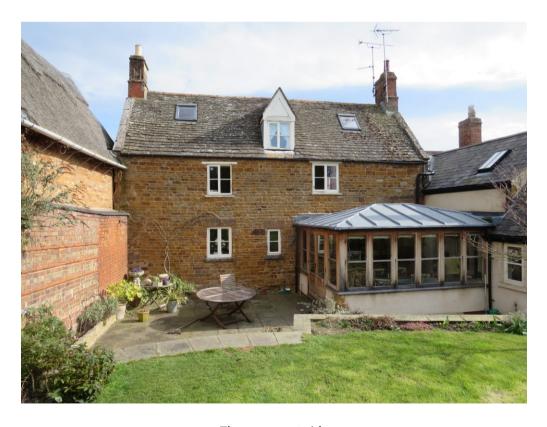
The rear west side

The rear W wall of the main block is partly covered by a modern conservatory, though most stonework is still visible. Coursed ironstone rubble, with larger courses near the top. The SW quoins are visible both at first floor level and ground level, where they now form the jamb of a doorway. N of this doorway is a window, with jambs that look slightly re-worked, though the flat ironstone lintel appears original. Next to the N is the original back doorway, with good quoins and a square-cut flat ironstone lintel. Beyond the conservatory is a small window with a deep flat ironstone lintel, then a wider window, set at a slightly higher level. This window is a 2-light timber casement, with a C19 stout pegged frame. Two straight joints at low level in this area indicate an area of re-facing, to correct outward bowing of the wall. But there is no evidence for the former projection shown here on the 1804 and 1848 maps, nor of an opening through the wall to suit the timber lintel visible inside. The first floor has two 2-light timber casement windows with timber lintels, set at slightly different heights. The central dormer for the attic now appears of modern construction.

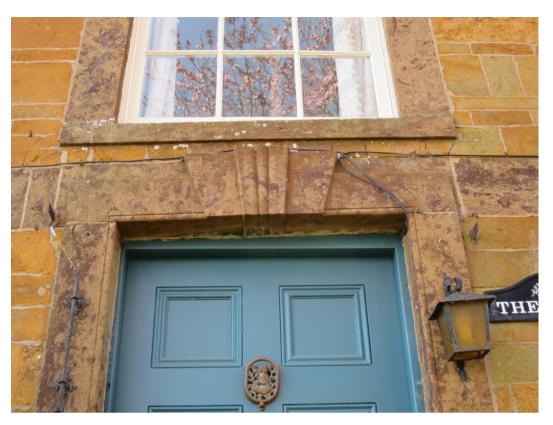
The head of the front doorway

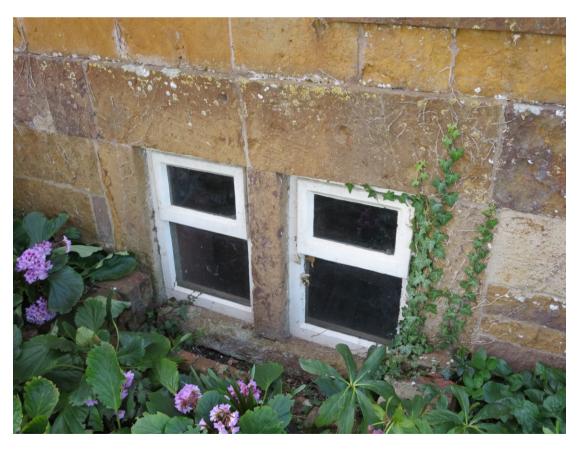
Stone-mullioned cellar window to east front

Integral with the design of the plan is the cellar and its stairs. Few local houses incorporate a cellar, but the rising ground into which the house is built no doubt encouraged its provision here. The cellar window still uses a stone mullion, though of plain, square profile, not the older ovolo-moulded form. Stone windows are still used at this date in lower-status areas, and had an obvious advantage in damp cellars over timber windows. Unusually, the cellar here was for more than just storage. It had a sizeable original fireplace, presumably for various service uses. It is odd that the cellar was placed under the parlour, rather than the kitchen, but its stair does connect directly to the kitchen (and was also convenient for the back door).

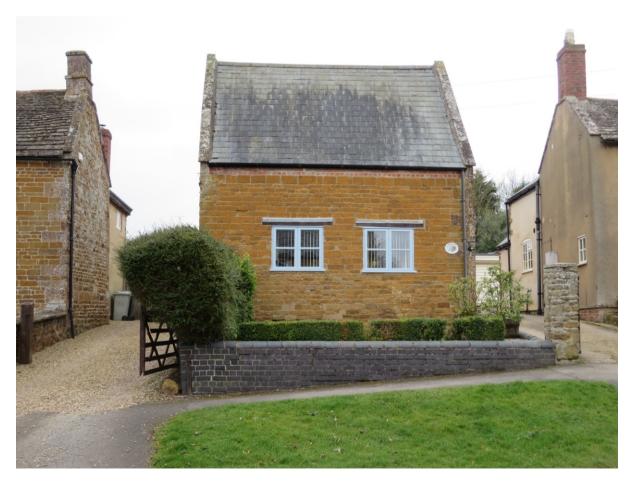
The former outbuilding (101A) to The Knoll, perhaps a dovecote

To the SE of the house is a small stone building, now a separate house – No 101A. However, as shown on early maps (see below), this was previously an outbuilding on the plot of The Knoll. The building is a small rectangular structure, of a tall single storey. It has well-built coursed ironstone walls with good ironstone quoins. The gables have plain kneelers and gable parapets, with a rolled apex. The roof is of Welsh slate to the E front and concrete tile to the rear, but the building up of the eaves in lateC19/early C20 brick shows that it was probably thatched at an earlier date. The building had no original openings to the E front or the S gable, though modern windows have been inserted for the conversion to domestic use. The N gable has a modern window at upper level which might have been an earlier opening, a loading hatch. The rear is largely covered by a modern extension, though the N part has a wide former doorway, blocked with modern brickwork. The tall, well-built rectangular form of the building is very similar to the standard type of dovecote, of 17-18th century date. It seems likely that it was built as a dovecote, though it may well have been converted to other uses by the 19th century. Further investigation of this building is needed to confirm this.

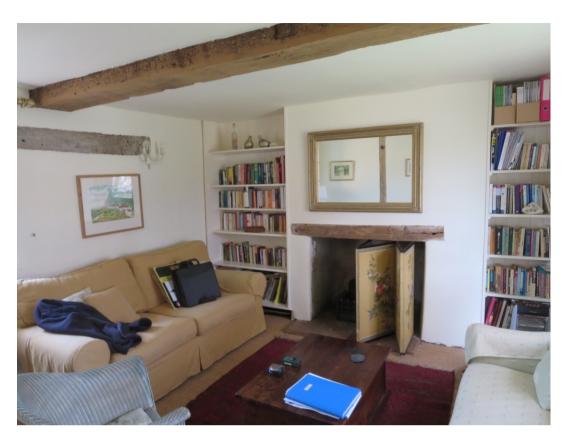
The north room

rather Art Deco in feel and probably earlier C20. The N room has a transverse oak beam with only partial chamfering. There is a large chimneybreast, now with a plain, plastered fireplace opening with rough oak lintel. In the rear W wall there is a large oak beam at door-head height – probably a former doorway into the rear projection which is shown here on the 1804 map. The window to the S of this has a thin lintel of pine, the N end of which is cut into the older oak beam. So it appears that the window post-dates the doorway. The partition dividing the N room from the stair hall is of 60/65mm deep brick (visible to the SW), but also has a single exposed vertical oak stud and a beam running across the top.

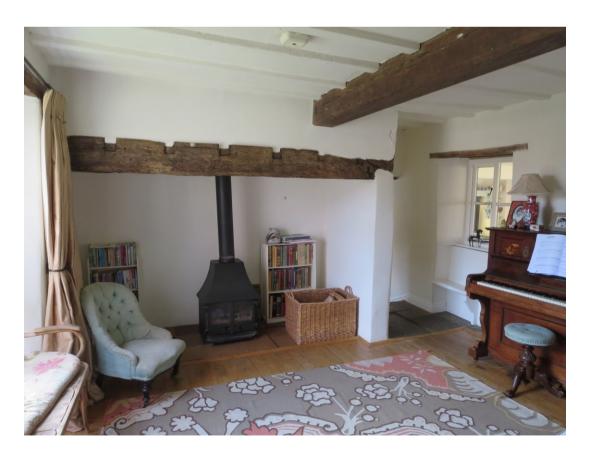
The south room, with inglenook fireplace

The S room has a large inglenook fireplace, its beam a re-used ceiling beam with empty mortices for floor joists. The hearth has been relaid, using old pierced tiles from a maltings floor. The spine beam is of pine, not oak, with chamfers but no stops, and tenoned floor joists. To the SW the window has a window seat, and there is good quality stone paving which forms steps down to the extension.

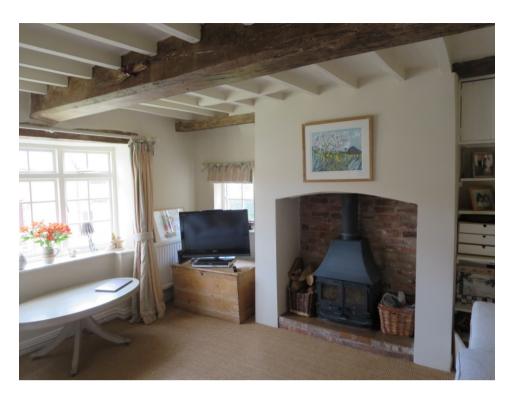
The extension at the south end

The extension has a brick chimneybreast with plain-plastered fireplace. The fireplace opening has a shallow arch, probably of brick. Transverse oak beam, chamfered with run-out stops, and tenoned floor joists. Rear door of plank and ledge type with wide boards. The rear extension is now of modern construction.

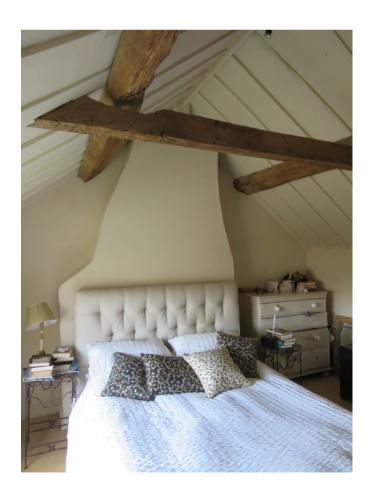
Roof structure in the southern extension

The N bedroom has a small C19 cast iron fireplace set in the chimneybreast. There is now a bathroom in the S bedroom of the main block, so the former fireplace here is blocked off. The bedroom in the S extension has a large, tapering chimneybreast, but no fireplace. The roof has heavy purlins, previously supported at mid-span by a collar, which clasped the purlins to the principal rafters. The purlins and collar are of roughly shaped oak. Painted rafters, somewhat irregular, with ridge-board. The tops of cut-off vertical central struts remain to the N, S and centre of the room.

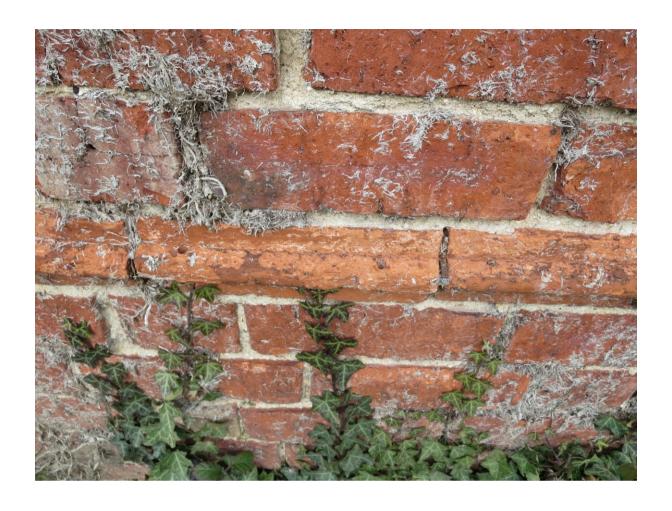
Shaped bricks with holes for planting wires to garden wall

Along the N side of the rear garden is a brick wall, with an unusual feature: it incorporates two/three rows of specially made moulded bricks, with a semicircular projecting nib perforated with two small diameter holes. The holes allowed tie wires to be inserted, to enable plants to be trained against this south-facing wall. No doubt the wall was intended for trained fruit trees, to accompany the orchard indicated here on the 1886 map and mentioned in the 1848 schedule. The lower, W section of the wall has its original bricks of 1850-90 date, but the taller E section has been rebuilt in C20 commons, re-using the rows of moulded bricks. Such special bricks are sometimes found in Victorian kitchen gardens, but usually associated with high-status houses, not ordinary village farmhouses. A brick of this type, Foxley's patent brick, was patented in c.1864 (see *Charleston Kedding: A History of Kitchen Gardening*, Susan Campbell, 1996).
