**Lyddington Manor History Society**  
**Historic Building Survey**

**The Manor House, 22 Main St**  
**Lyddington, Rutland**

## HISTORIC BUILDING SURVEY REPORT

### THE MANOR HOUSE, 22 HIGH ST, LYDDINGTON

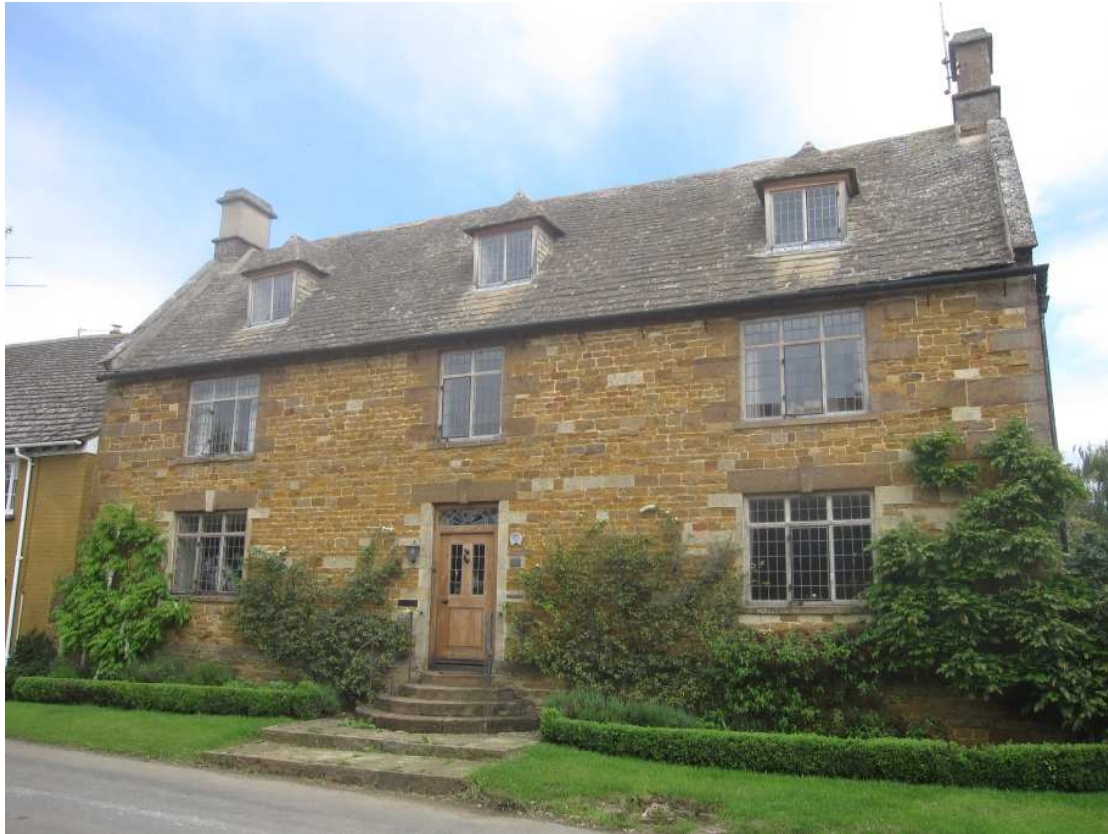
View of the west front

Two tall storeys, with attics. The W front has a careful symmetrical composition, with central doorway, flanked by 3-light windows to either side on the ground and first floors, with a 2-light window over the door. Three hipped dormers are set over the first floor windows. A chamfered ironstone plinth runs across the whole front, with square, straight-cut ends to either side of the doorway. Window and doorway openings have flat brownstone lintels with a neat central keystone, of limestone to the N ground floor window, but brownstone elsewhere. The doorway and ground floor windows have jambs of bonded limestone, but 1<sup>st</sup> floor window jambs are of bonded brownstone. A semicircular flight of four ironstone steps leads up to the front doorway, set at a raised level above the street.

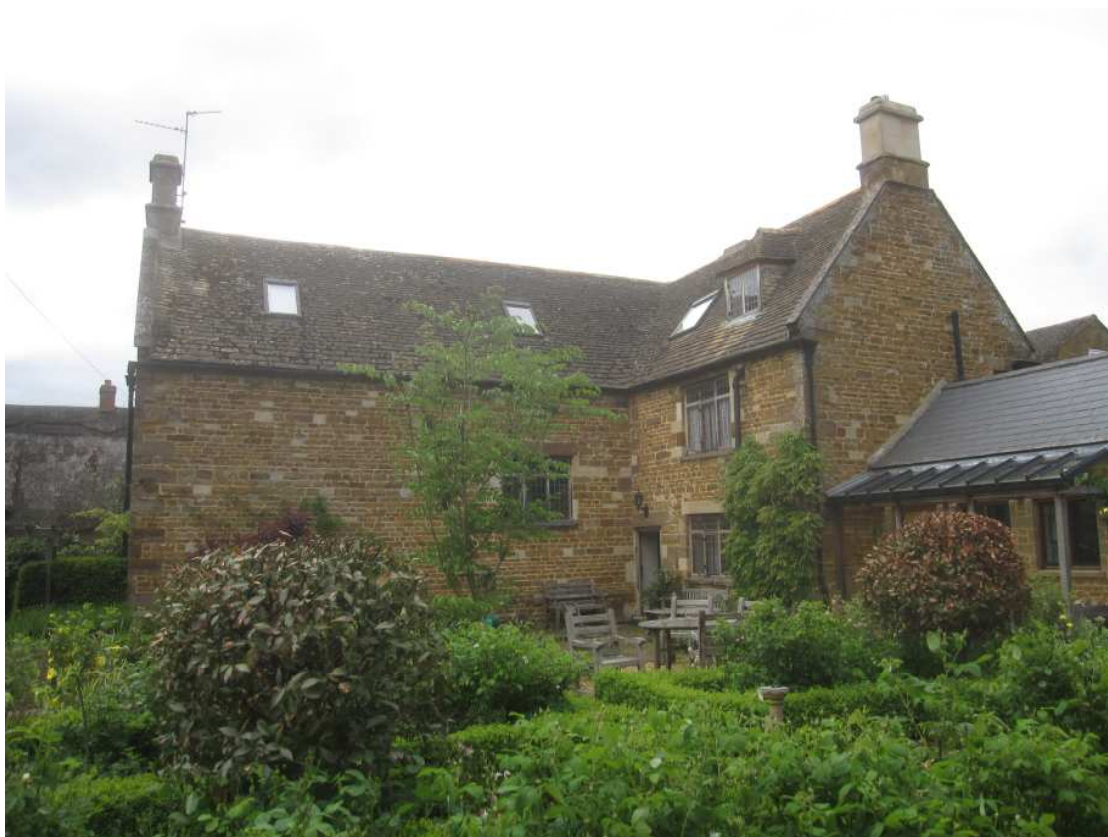
View from the east

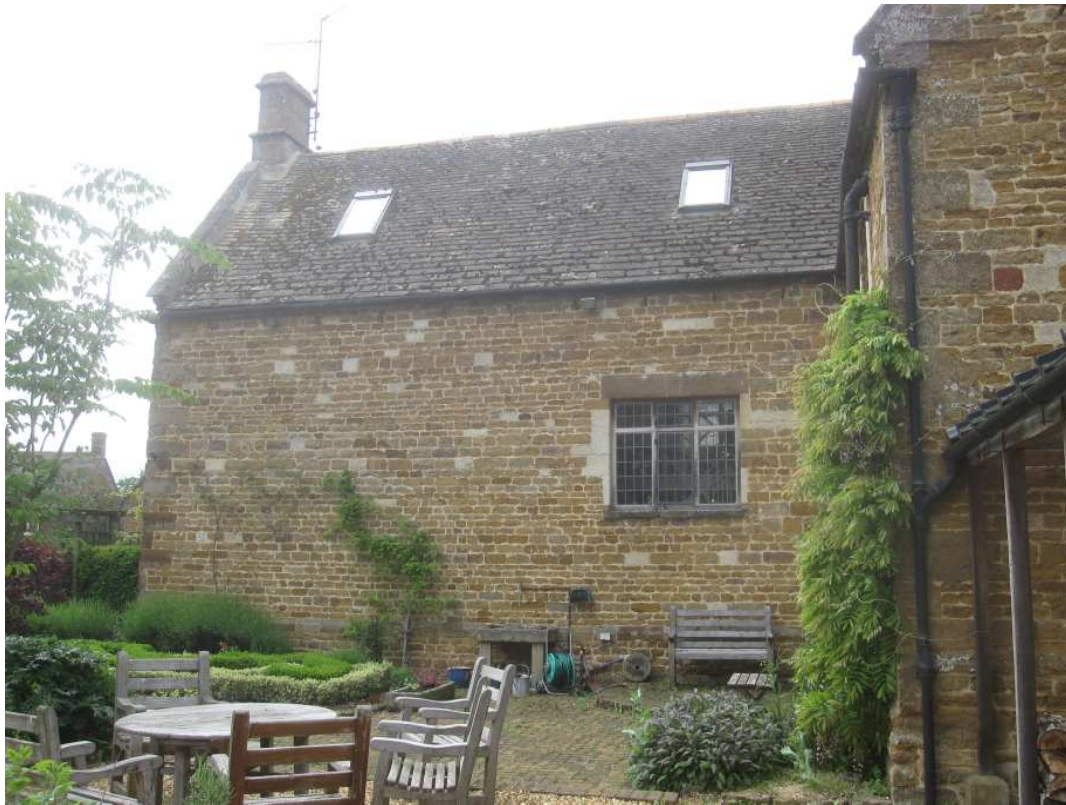
The rear east wall of the front block

The front block rear elevation to E has a chamfered plinth which stops a little short of the rear doorway, with whose frame it would otherwise collide. Small cellar window set low down with square-edged ironstone jambs and lintel, and restored square central mullion. The upper wall is blank, except for a large 3-light oak window (restored), set at mid-floor height for the stairs. It has jambs of limestone with some ironstone and a flat brownstone head with keystone, as elsewhere.

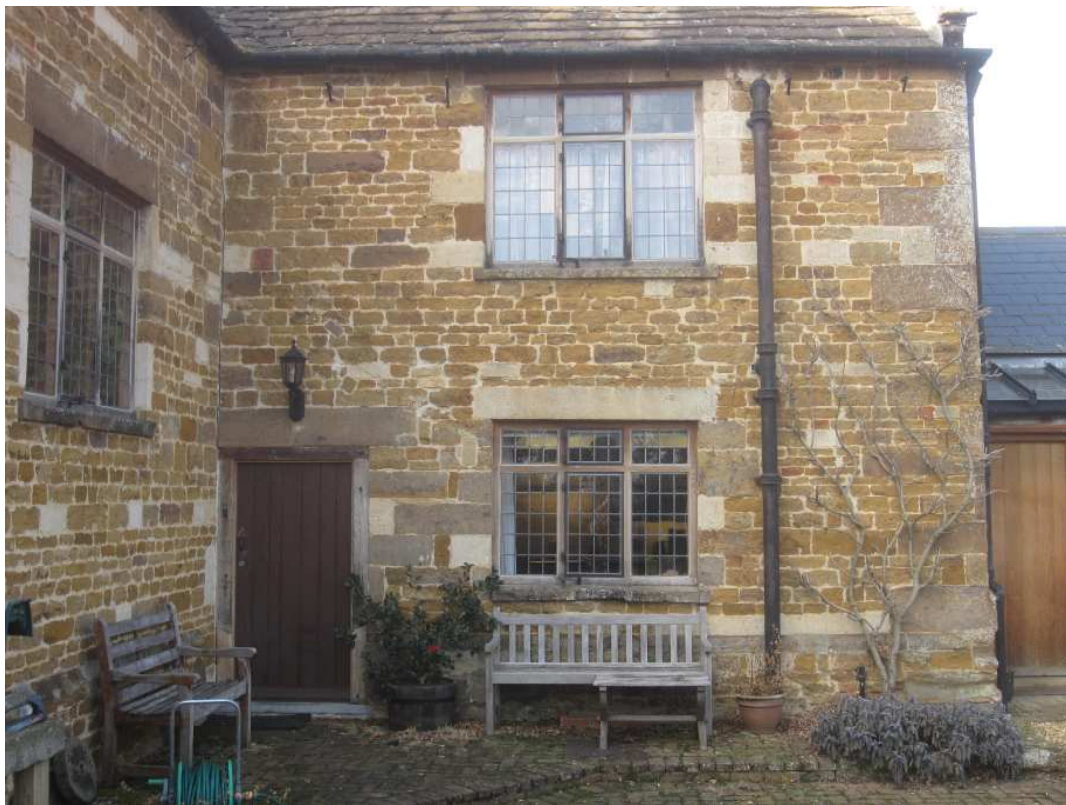
The south side of the rear wing

The rear wing S elevation has a chamfered plinth. The back doorway is set in the corner, with an old stout oak frame with bead moulding and flat brownstone lintel, in

two pieces with no keystone. The line of a former lean-to porch roof can be seen over the door. Large ground floor window with similar window to 1<sup>st</sup> floor and 2-light hipped dormer above. The openings have jambs of ironstone/limestone. The ground floor window lintel is of a single piece of limestone, probably replaced. The 1<sup>st</sup> floor window has a brownstone lintel with wide keystone. Restored oak window frames.

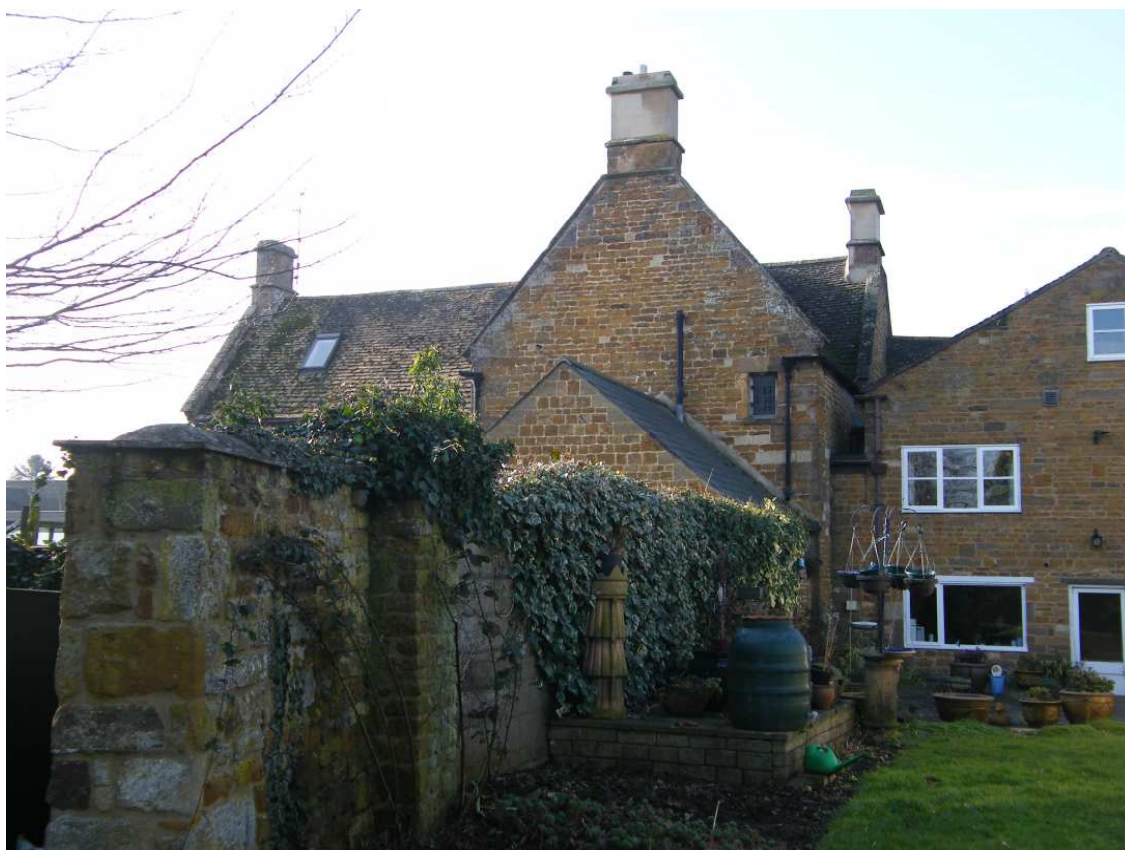
View from the east, with 24 Main St adjoining

The E gable has the plinth set once again at rather higher level, due to rising ground (though the external ground level has been reduced, with the top of the stone footings visible). The gable is blank except for a small 1<sup>st</sup> floor window, which has a good keystone to its flat lintel, despite its short span. The ground floor is now masked by the recent extension, with a doorway in the place of a former small window. Gable parapet with moulded corbels as elsewhere and the same type of 2-flue chimneystack, though the upper part has been recently rebuilt. The N side of the rear wing is partly masked by an extension to the rear of No 24 Main St, the visible parts to the NE being blank.

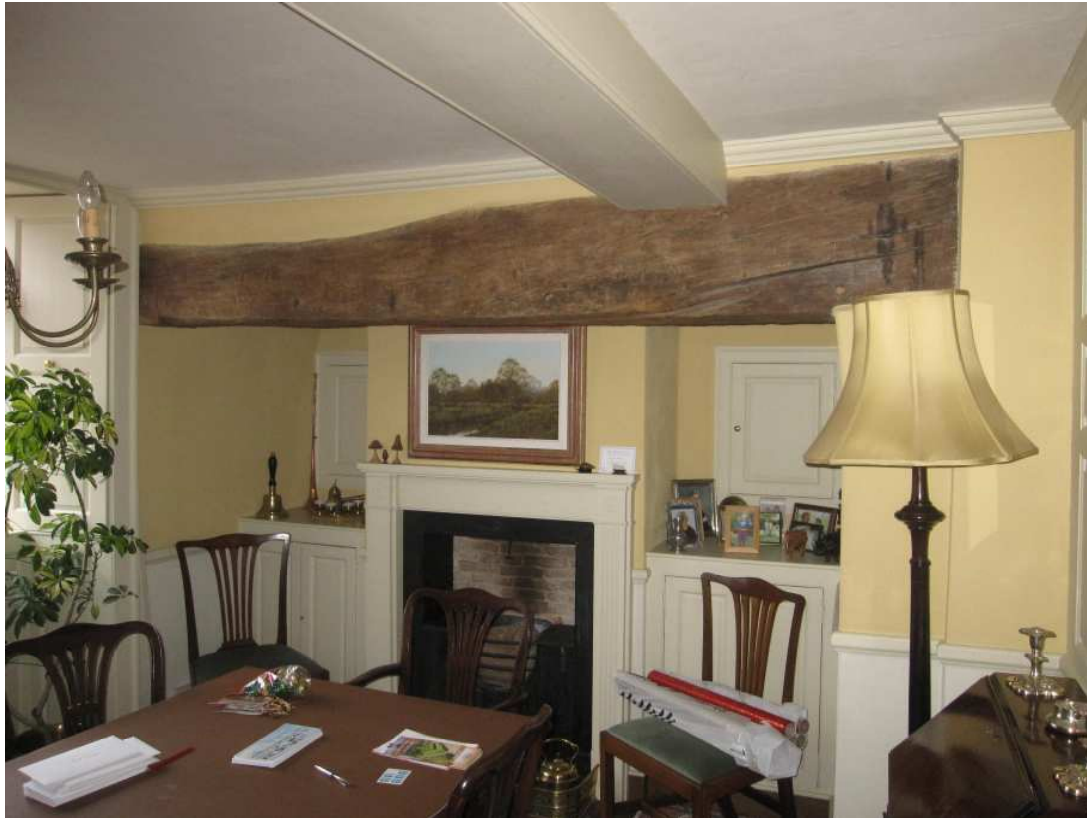
Inglennook fireplace in the north room (hall), with burn marks to right end of beam

The N room (originally the hall, now dining room) has a large inglenook fireplace with a massive, unchamfered beam. Multiple, very deep burn marks to the R end a single deep mark near the centre. During building works, an oak plate and re-worked masonry were revealed to the E bearing of the ingle beam, indicating that the beam has been re-set at a rather higher level – probably for better headroom when a range was fitted. Restored spice cupboard doors. Cased spine beam, understood to be of elm. Original (re-fitted) panelled partition, with central doorway and two panels of pierced Chinese Chippendale fretwork and original pressed brass knobs. The fretwork sections were probably open originally, to light the internal corridor, but leaded light glazing was subsequently fitted to the back face. The three glazed panels to the top of the door here were probably inserted at the same time.

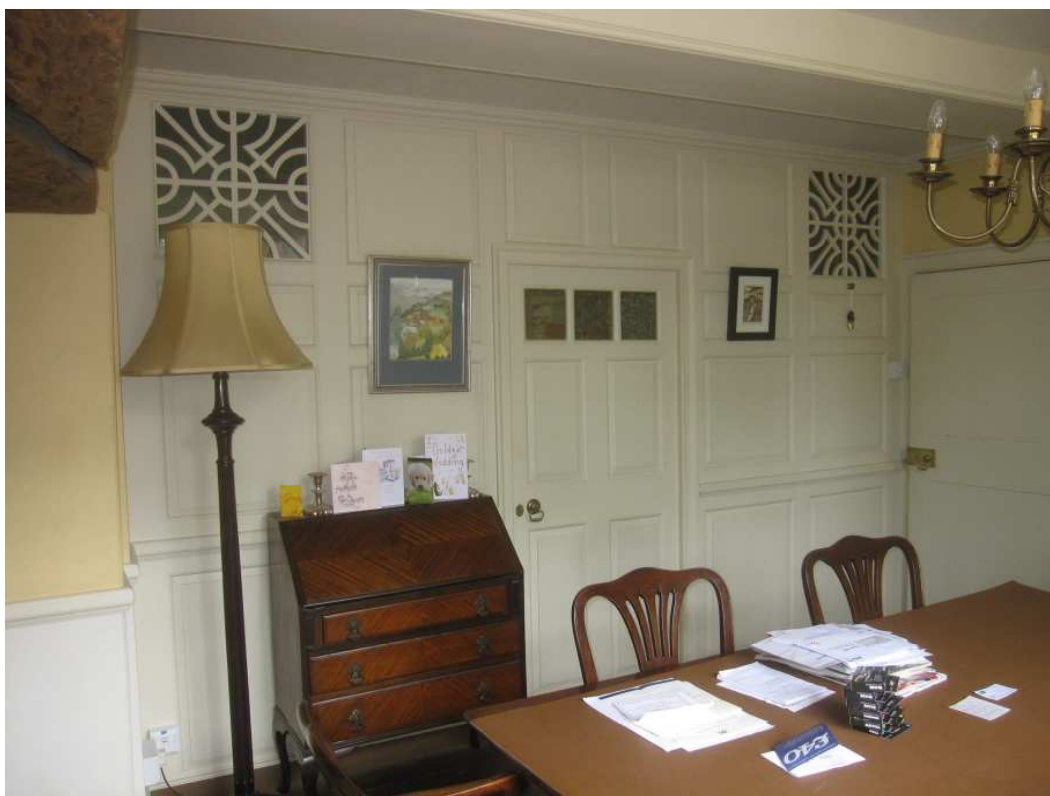
The panelled partition in the hall, with fretwork openings

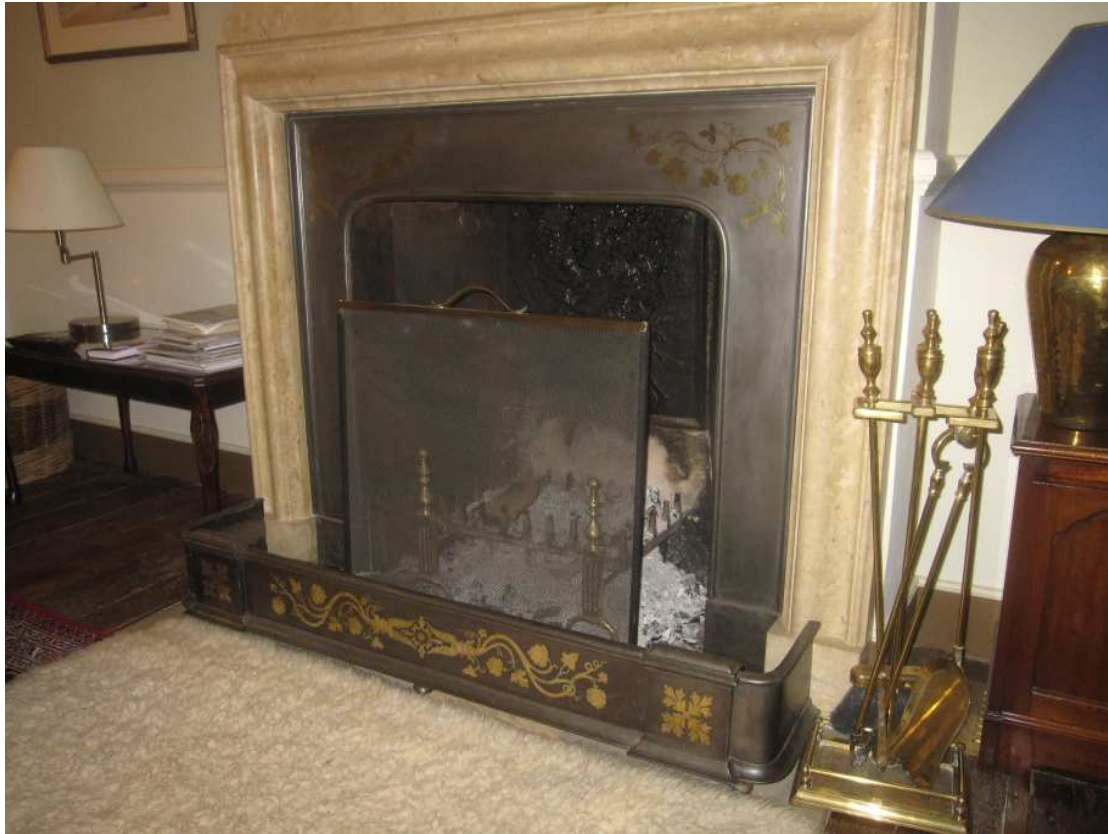
Original iron fireplace in the parlour, with modern stone surround

The S room (originally the parlour) has a fireplace with a very fine cast iron plate surround, decorated with inlaid brass, with matching fender. This was removed from the house around the 1960s, but recently retrieved and re-fitted. The stone fireplace surround is modern. Encased oak spine beam. Pine floorboards (over the cellar), c.160mm wide. The oak window frame has a graffiti date: JS 1799.

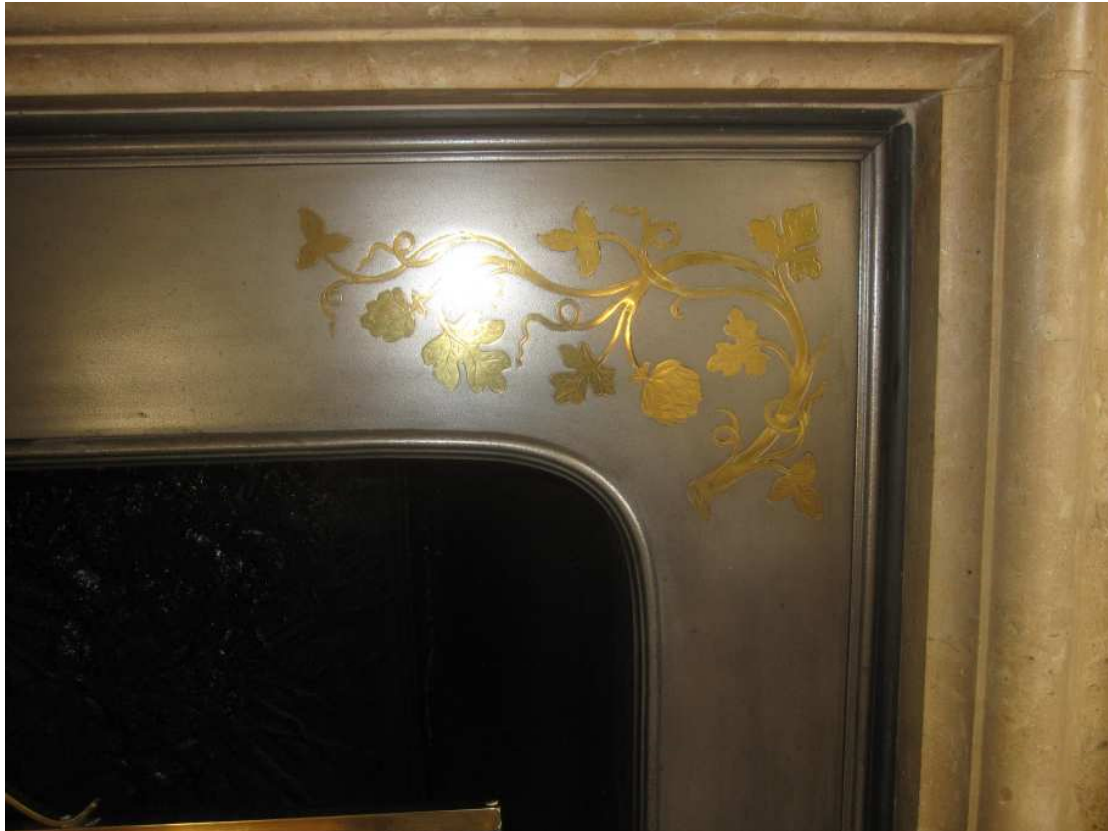
Detail of brass inlay to fire surround

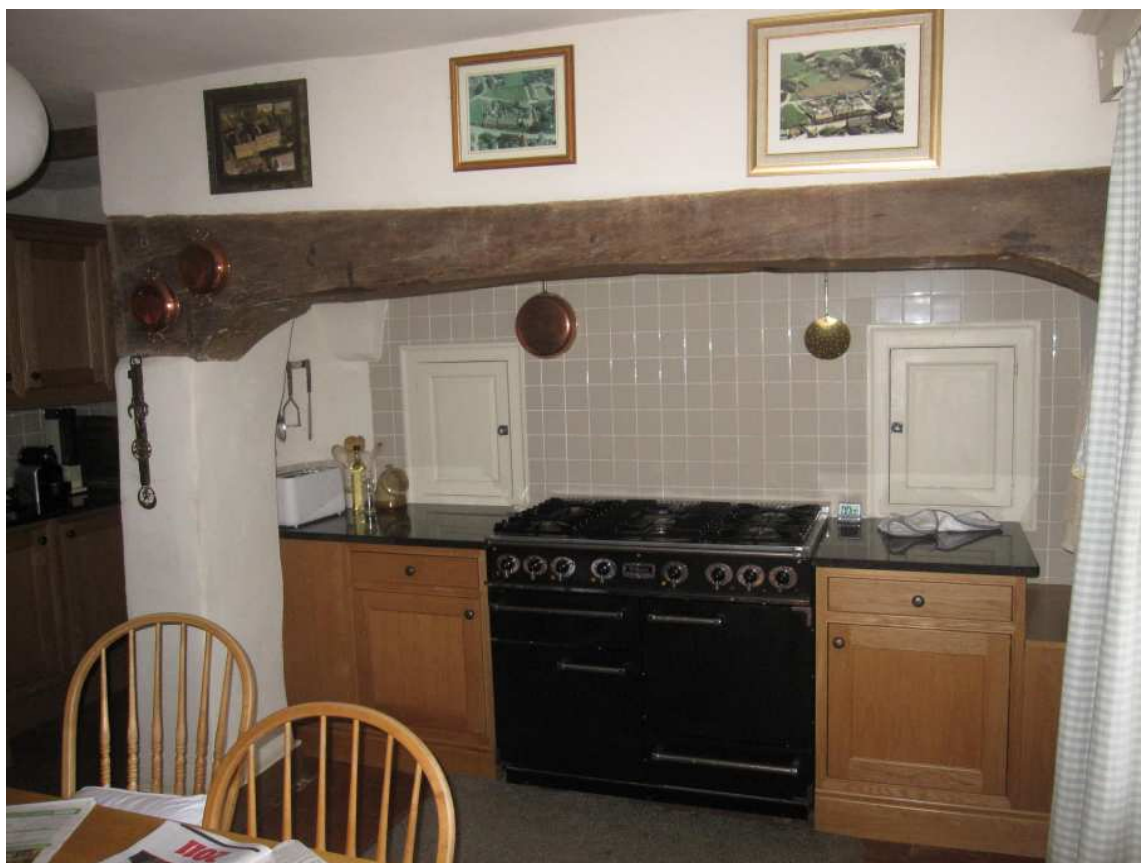
Inglenook fireplace to kitchen in rear wing

The wall between the front block and the kitchen is of 9 inch brick not masonry, indicating both blocks are of a single build. The kitchen in the rear wing has another large inglenook fireplace. Massive beam cut into an arched shape, unchamfered. Multiple burn marks at L end. The L cheek wall curves outwards and is of thin section, presumably of brick; it has an internal flue above (not visible), so was probably for a copper. At R side is a cast iron hob with stone jambs and lintel and a grate, and another internal flue. Spice cupboard doors restored, with original hinges

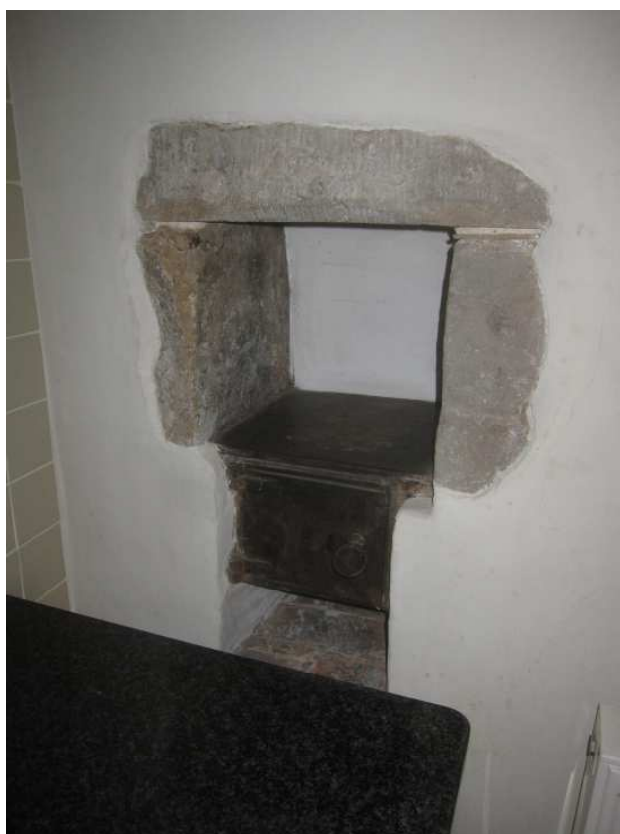
Cast iron hob grate to right side of kitchen fireplace

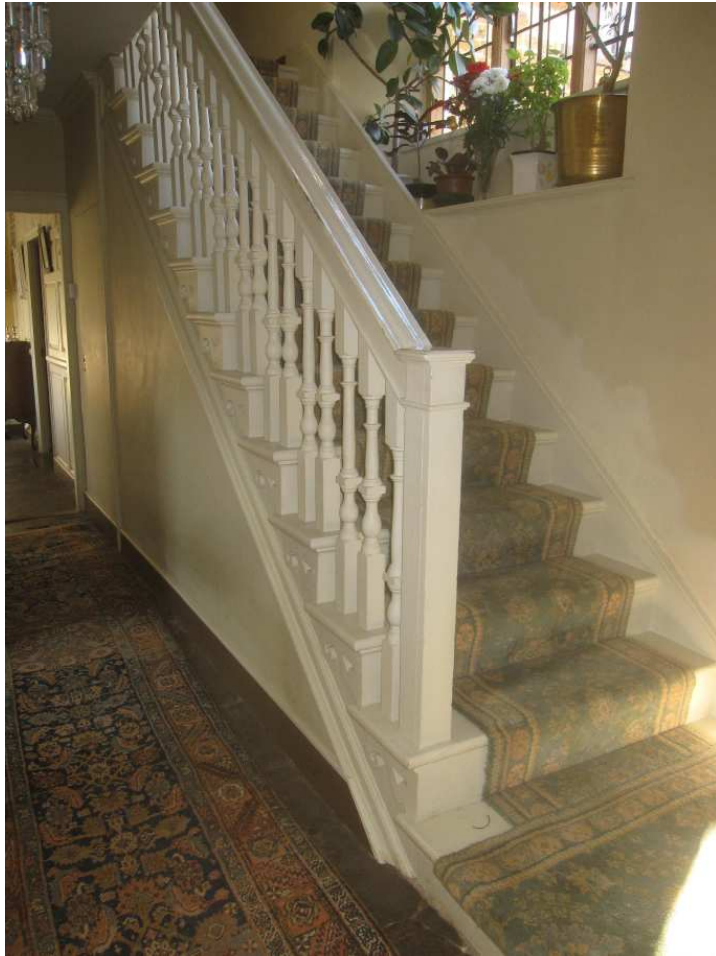
Stair balustrade to ground floor

The stair is of open-string type, with a straight run of balustrade between flat-capped square newels at the bottom and top. The string has ogee/scrolled decorative brackets. The handrail is of moulded square-type section, morticed and pegged to the newels. The turned balusters have a short vase shape below a moulding with an unturned square section, with a tapered column to the upper part. The undercarriage to the stair (as seen during repairs) had crude oak bearers, nailed up to the first floor joists. On the first floor a balustrade of Chinese Chippendale fretwork pattern has been fixed against the newel, the two balustrades meeting awkwardly, as well as being of different styles. However, there is no evidence of alterations or re-use in the balustrades or staircase layout, so it seems the combination of styles represents the original design. Various other examples of Chinese Chippendale pattern stair balustrades have been found around the country dating from the 1750s, so this style was very much in vogue. All timber is understood to be of pine, except the undercarriage. During restoration of the stair window a hole was found in the S jamb, around first floor level which seemed to have been formed to house the projecting 'horn' of a former window frame of the 1750s type. But there is no evidence for such an alteration in the external masonry, and a window position here would clash with the stair location.

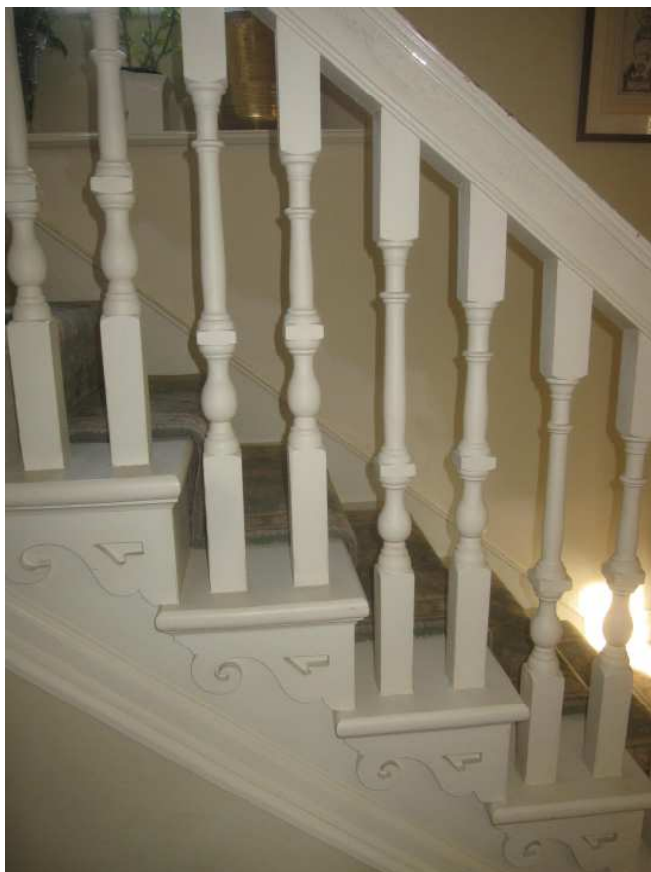
Detail of turned stair  
balustrade

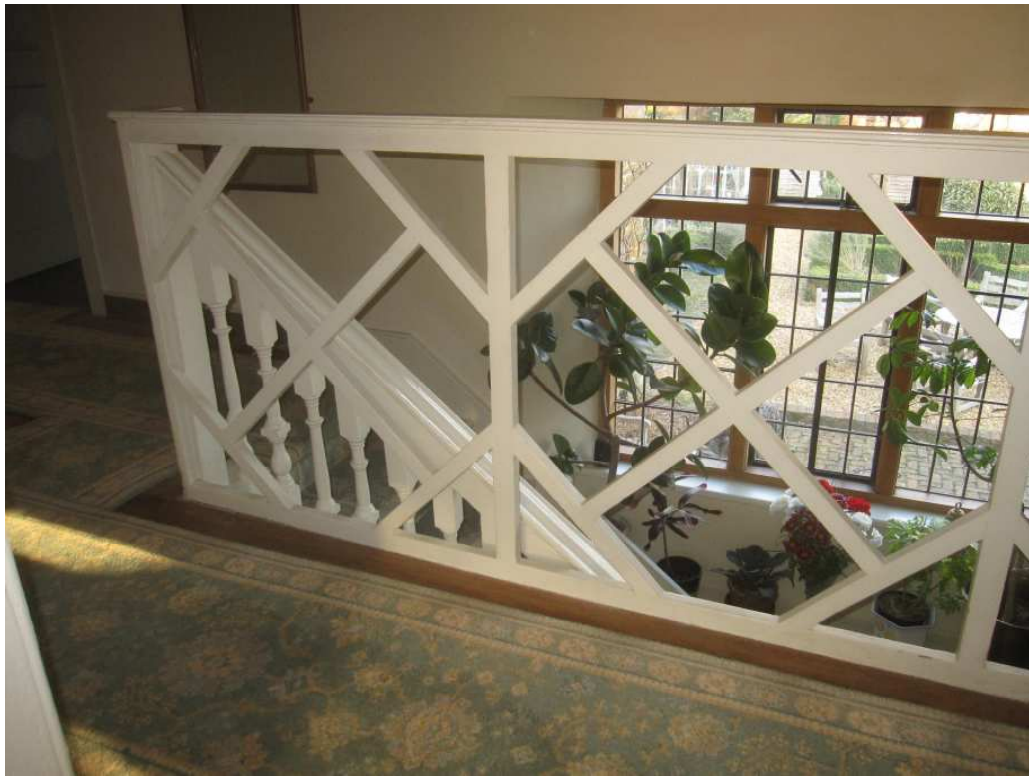
Stair balustrade to first floor

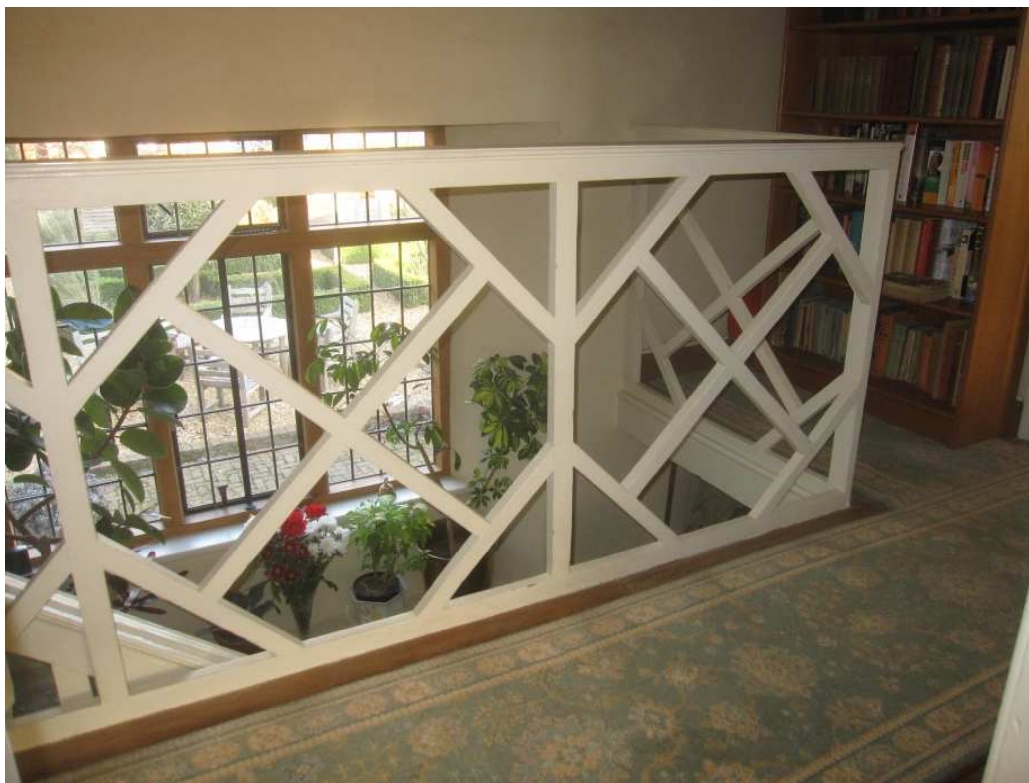
The Chinese Chippendale stair balustrade

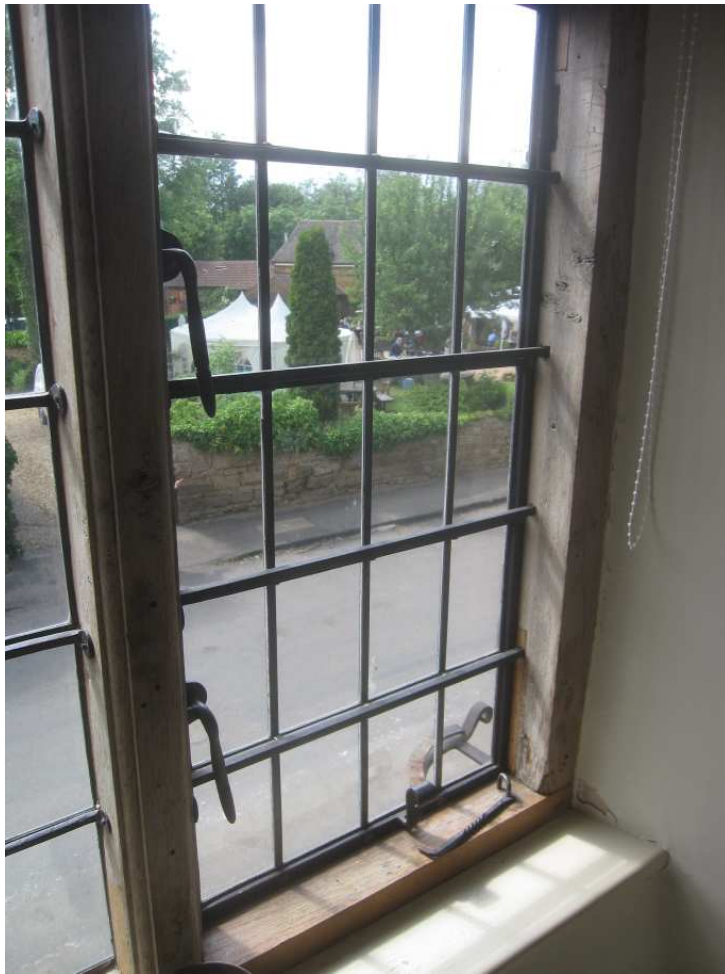
Detail of original oak window  
with ovolo moulding to mullion

The interior is rich in early fixtures and fittings, with many original 2-panel doors and (on the ground floor) window shutter assemblies, as well as the particular fittings noted below. The 2-panel doors are moulded, raised and fielded to the front and plain to the back, with H-L hinges. The oak windows to the front elevation retain substantial original fabric. The outer frame and transom are square-edged, but the mullions have a neat ovolo moulding.

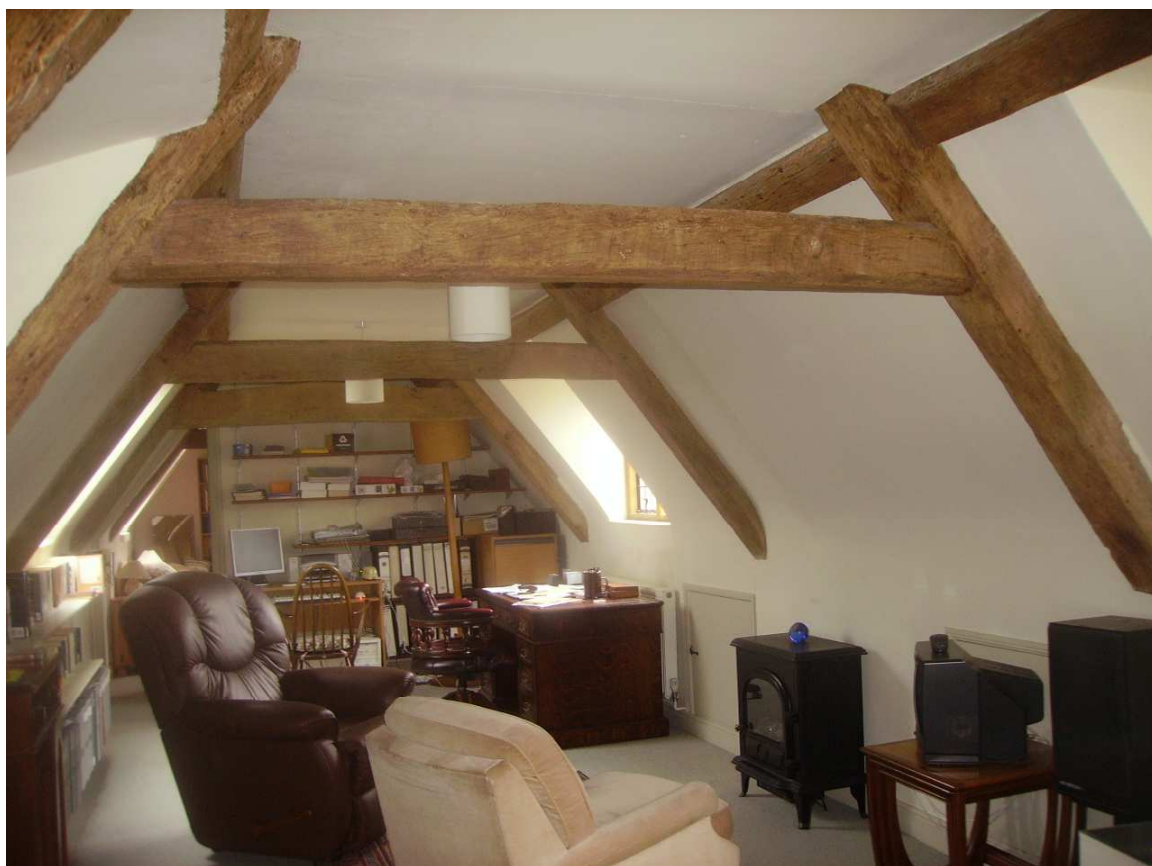
The roof trusses of the front block, looking south

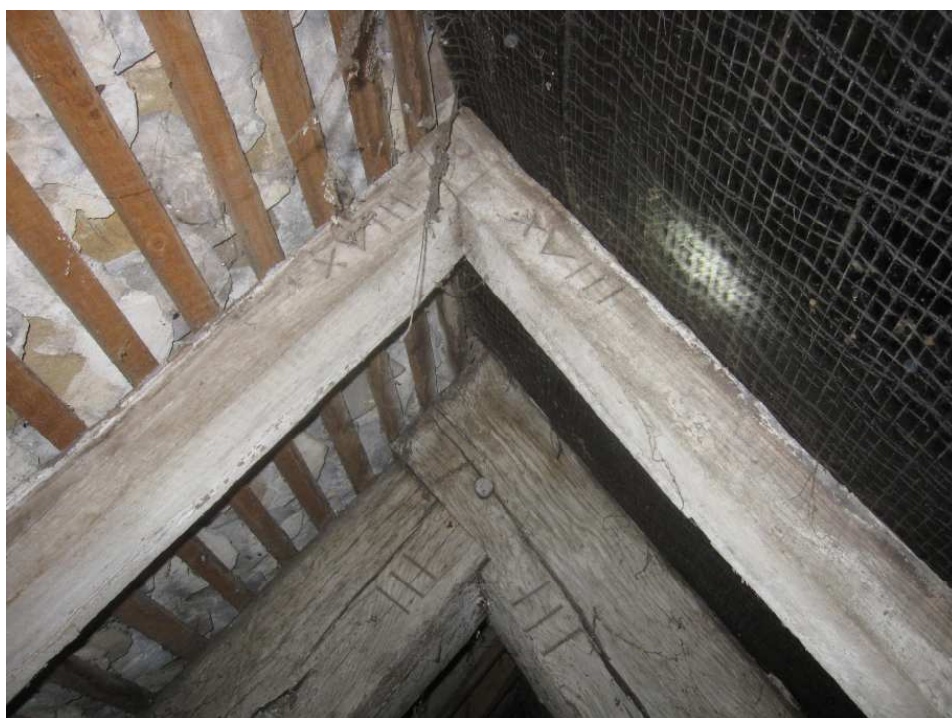
Carpenter's marks to the apex of truss T4 and adjoining rafter couple

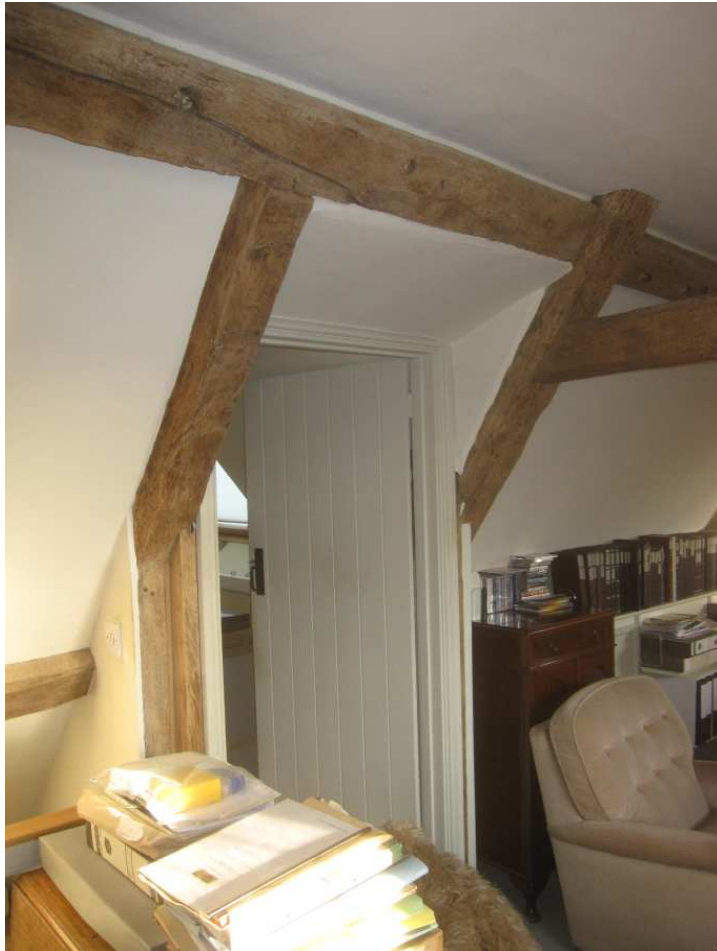
The roof structure at the junction of the front block and rear wing, with additional trimmer/rafter to allow for doorway

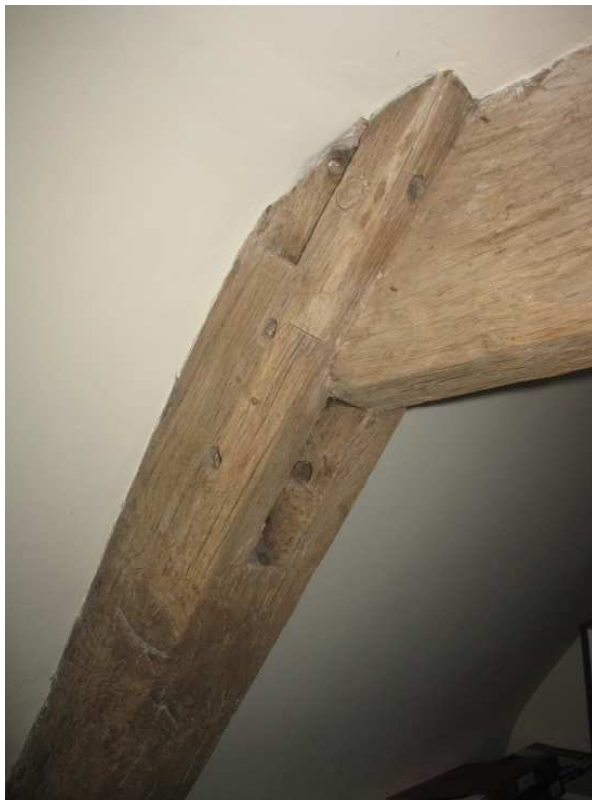
Detail of the collar/principal rafter junction to truss T5 in rear wing. The re-used timber has the empty mortices for a collar and purlin, both set lower than the existing roof.

It is evident that the principal rafters of trusses T1, T3, T4 and T5 are all re-used, with T2 the only truss using all new timber. The re-used principal rafters all have long, narrow double-pegged mortices for wind-braces set fairly low down on each side, with single-pegged mortices for tenoned purlins just above the level of the current collars. At Truss T5 a former tenoned collar with double pegs has been re-used and set c.150mm higher, with a single peg. The collar to truss T3 is, like that to T5, of a taller, thinner profile than other collars, so is also probably re-used. Older scribed (not chiselled) carpenter's marks can be seen to the E principals of T3 (unclear) and T4 (V with a tag). All four trusses clearly all came from the same building, presumably the previous house on the site which was taken down in c.1758. If so, this would indicate that the previous house was of considerable size. It is possible that the previous house made use of timbers from the Bishop's Palace, where extensive buildings were demolished in the late 16<sup>th</sup> century.
