Lyddington Manor History Society
Historic Building Survey

**Threeways, 1 Main St,
Caldecott, Rutland**

HISTORIC BUILDING SURVEY REPORT

THREEWAYS 1 MAIN STREET, CALDECOTT

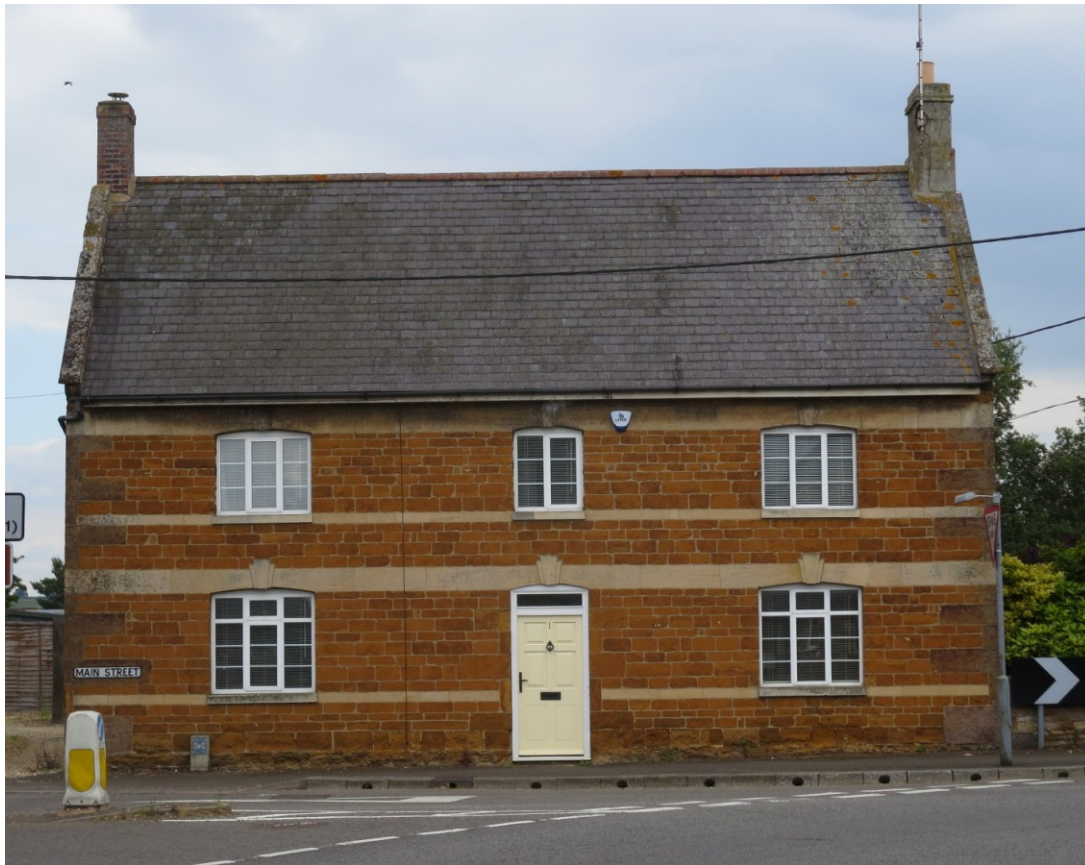
The W front is symmetrical, with windows either side of a central doorway. Finely cut coursed ironstone, with bands of Weldon-type limestone at window cill and lintel level to both storeys. The band course over the windows is deeper, with segmental arches over the openings and projecting triple keyblocks. The windows and door have been replaced in recent years, but a photo of c.1910 shows the earlier, probably original, detail. The windows were 3-light timber casements (2 lights over the door), with iron opening casements on pintle hinges and rectangular panes of glass. The door was 6-panelled, with a plain glass rectangular fanlight (as existing pattern). The photo shows the thatched roof, before its replacement in Welsh slate.

The west front

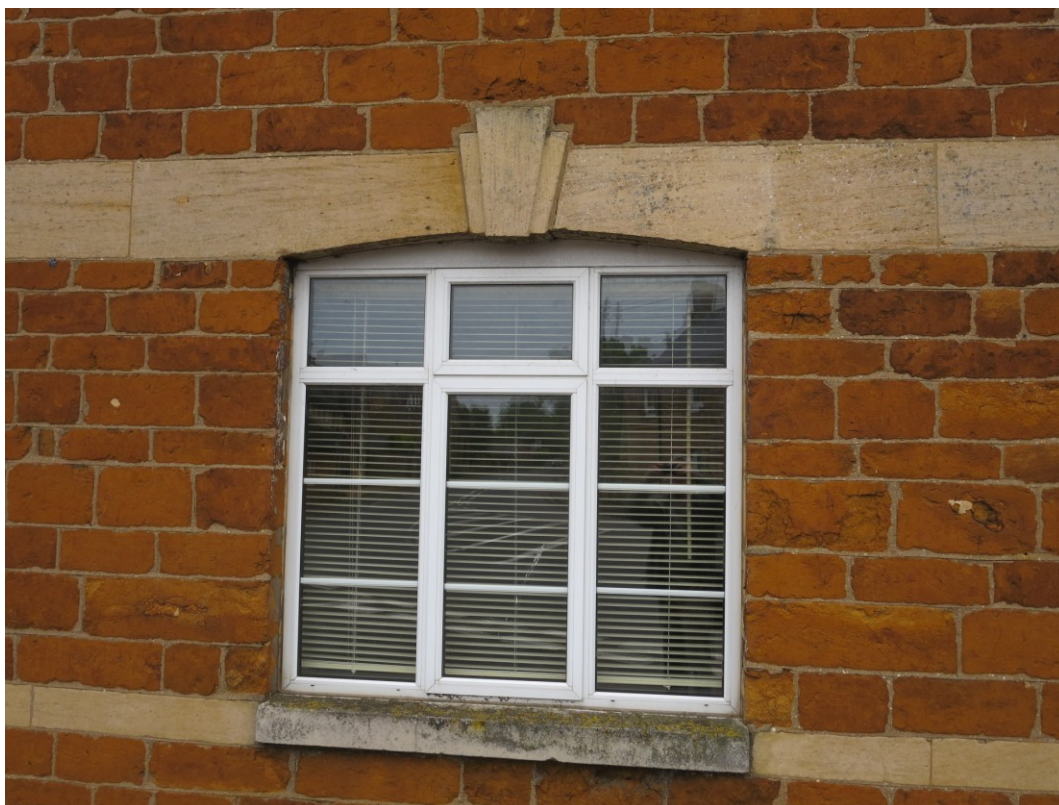
Window to ground floor front

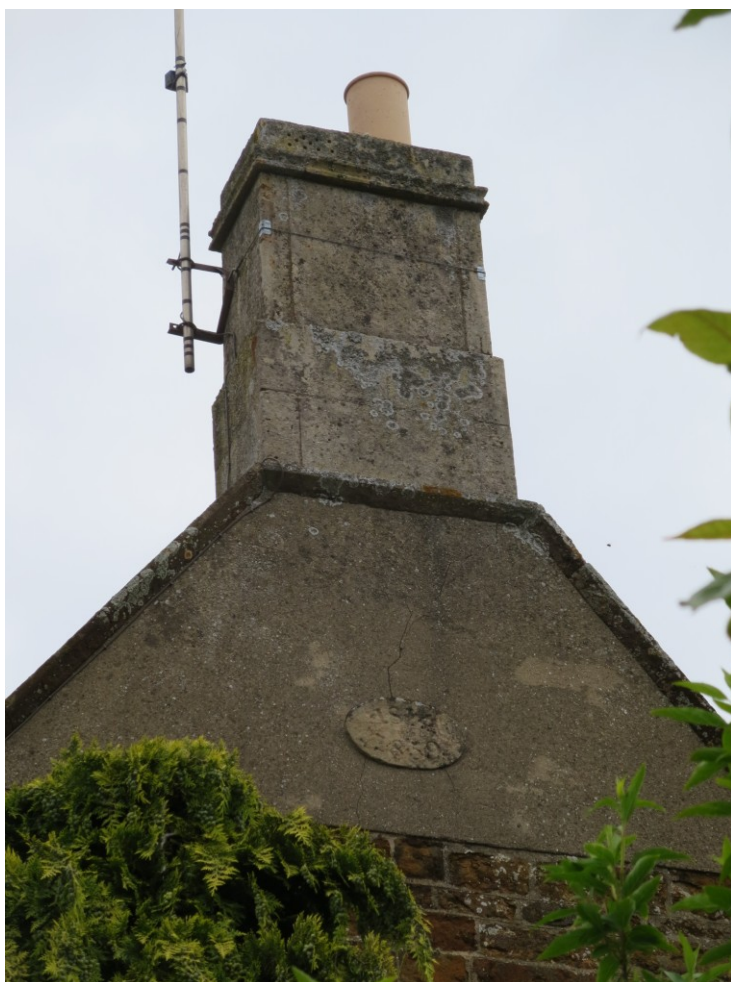
The S gable is blank, with coursed ironstone (less finely cut than the W front), good brownstone quoins and a gable parapet. Moulded corbels of ogee half-pendant type to both W and E. The top part of the gable is rendered, and has an oval date-stone, of limestone, bearing two dates: 1814 and 1859. The design and the lettering indicate that both the dates were cut at the same time, so the date-stone must be of 1859, but also records an earlier date of significance. It seems likely that 1814 is the date of the original building and that the gable end was re-worked in 1859. Above the date-stone is a 2-flue chimneystack of Weldon-type limestone ashlar, probably original. Square-cut plinth; square projecting cornice with unusual hollow moulding to vertical face; surmounted by a deep plain-cut blocking course.

The south gable

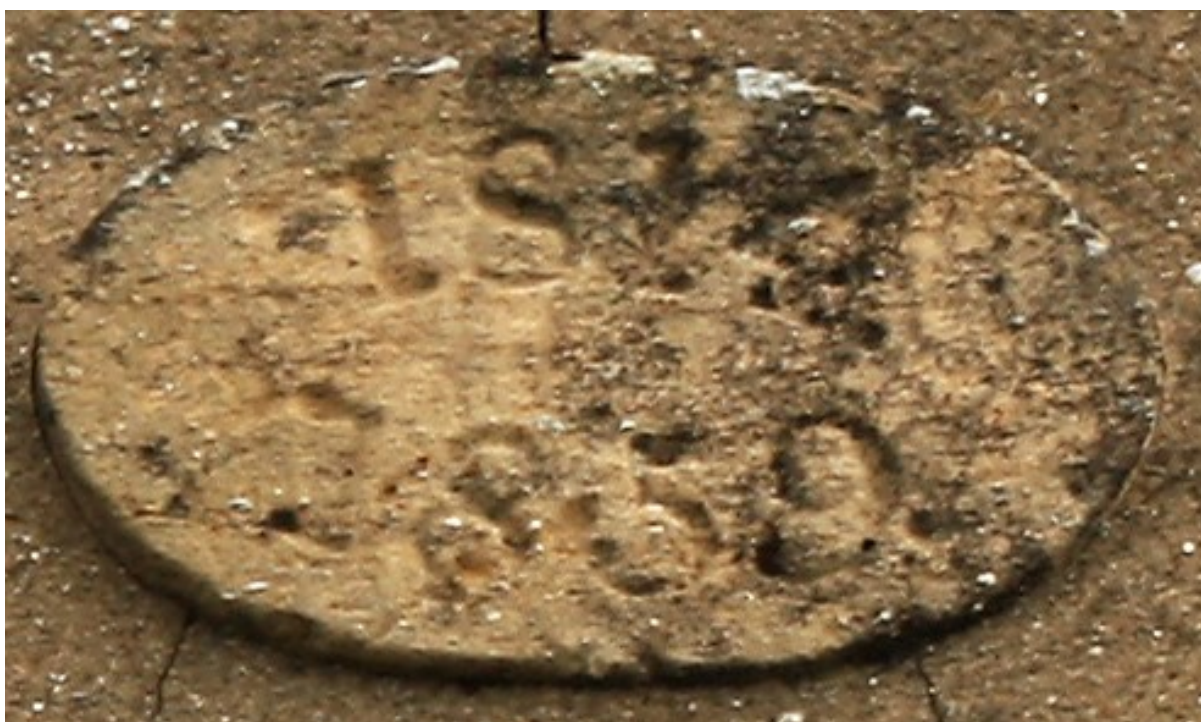
Date-stone to south gable: 1814 & 1859

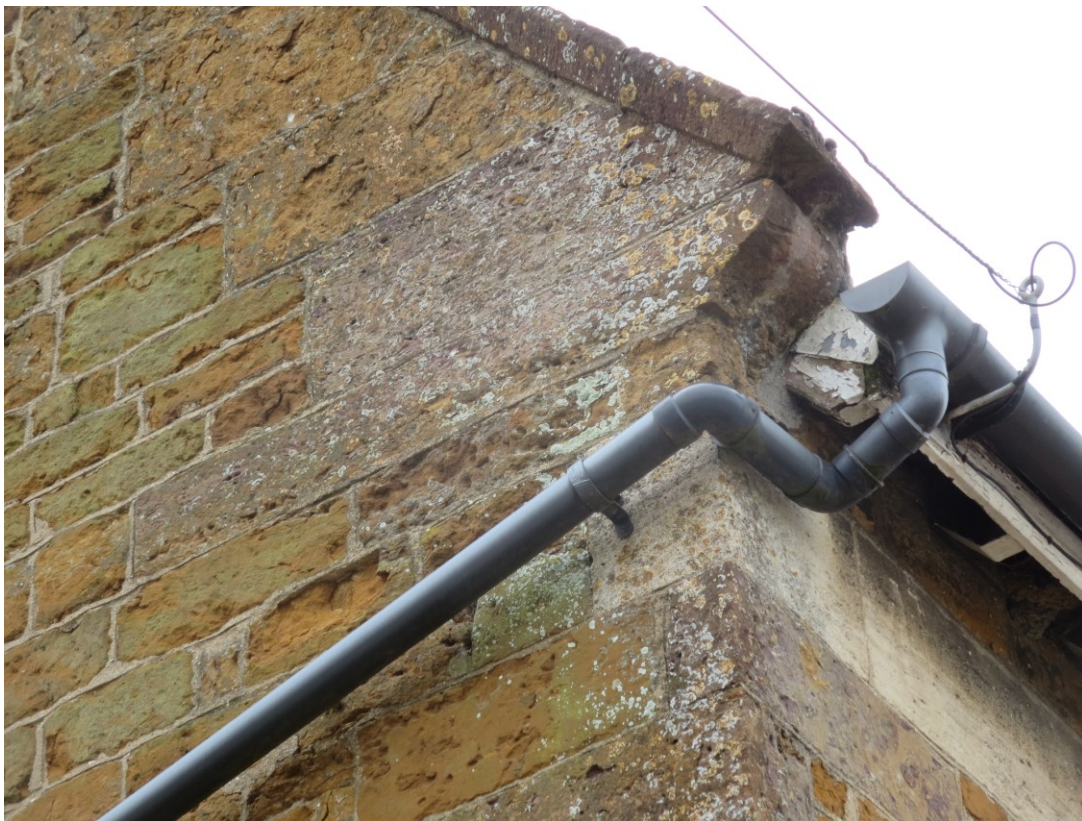
Plain ogee corbel with long tail to north gable

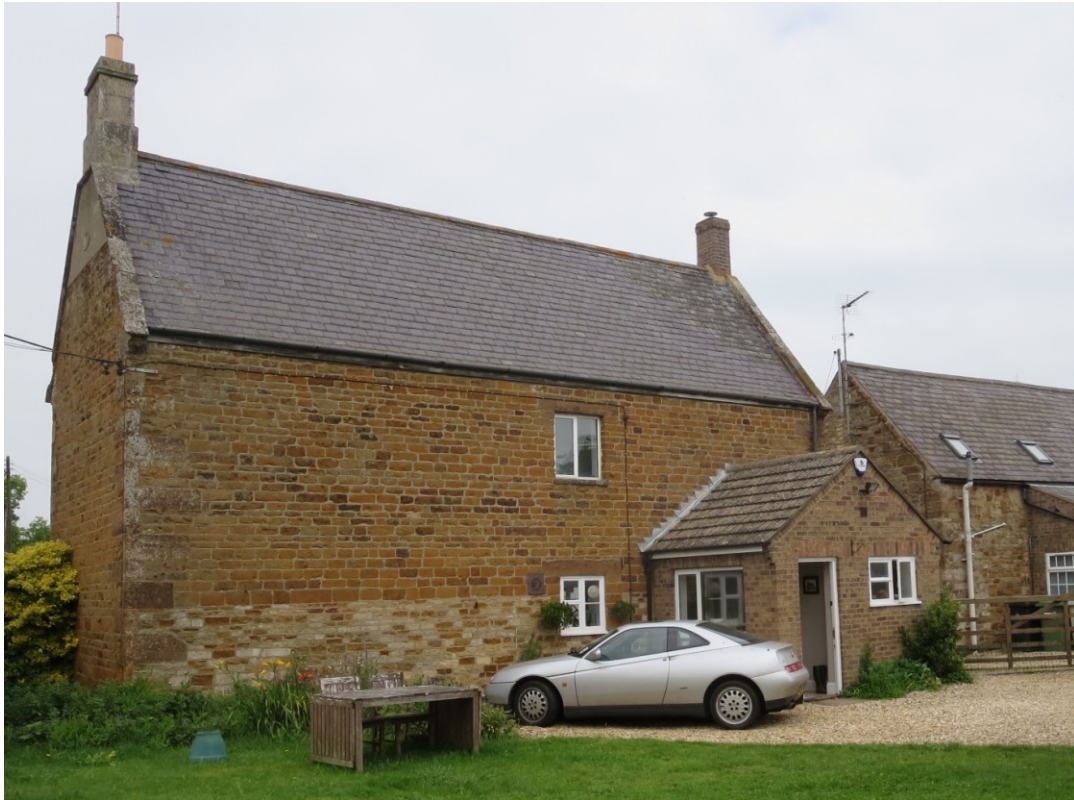
The rear E side has much blank walling – all the main windows are placed on the W front. A small single storey modern extension covers the N end. The lower part of the wall is of different stone than elsewhere, with much rubble limestone, more roughly coursed, and incorporating a few pieces of re-burned ironstone, re-used after being exposed to fire. The two windows, the 1st floor one placed directly over the ground floor one, have plain, deep lintels of brownstone, the 1st floor window also with a projecting brownstone cill. 2-light timber casement to the ground floor, modern replacement window to 1st floor. The back door, inside the modern extension, is of 6-panel flush-moulded type, the upper two panels now glazed; rimlock with reeded brass knob.

The rear east side

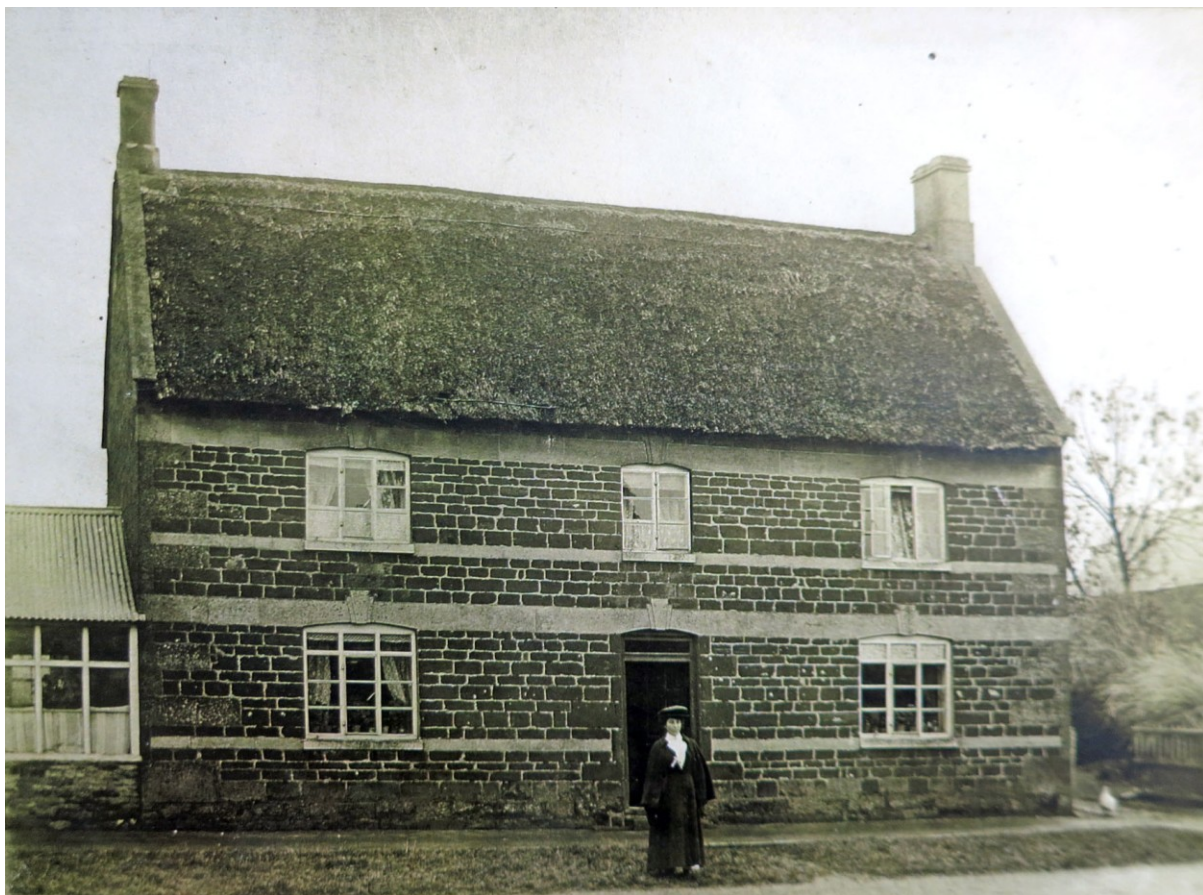
Photo of c.1910

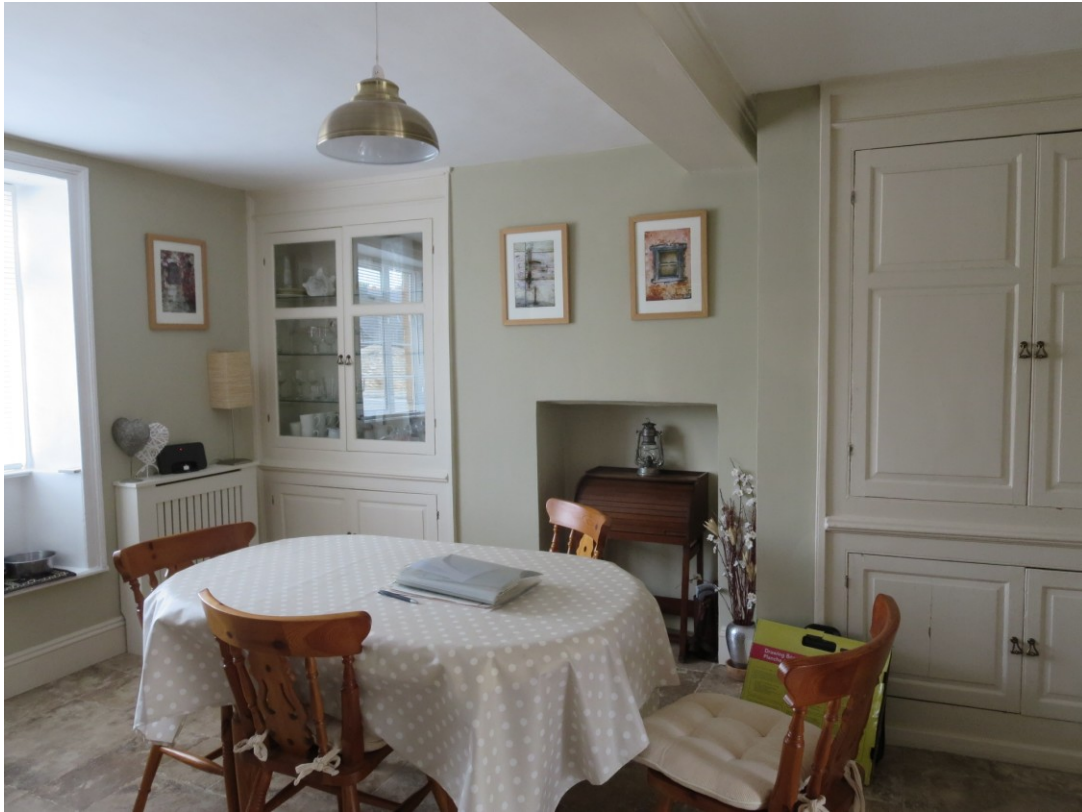
The N room has a projecting chimneybreast to the N gable, though the fireplace is now just a plain-plastered recess. Either side are fine built-in cupboards, the front of the right-hand one re-located forwards, to create a deeper cupboard. The upper doors of the left-hand cupboard are now glazed, but may originally have had raised and fielded panelling, like the rest. Front window with window seat and original moulded architrave surround. Spine beam with moulded casing. The present open-plan kitchen area would originally have been a small, separate rear service room. Here, the end of the spine beam inside the casing boards is visible, and can be seen to be a chamfered beam with an ogee stop, of C17-18 type. The beam bears onto the 9-inch brick partition wall but, rather oddly, passes beyond it into the service room. At first sight, this might appear to indicate an earlier phase, but the building form all points to a

The north room, with panelled cupboards

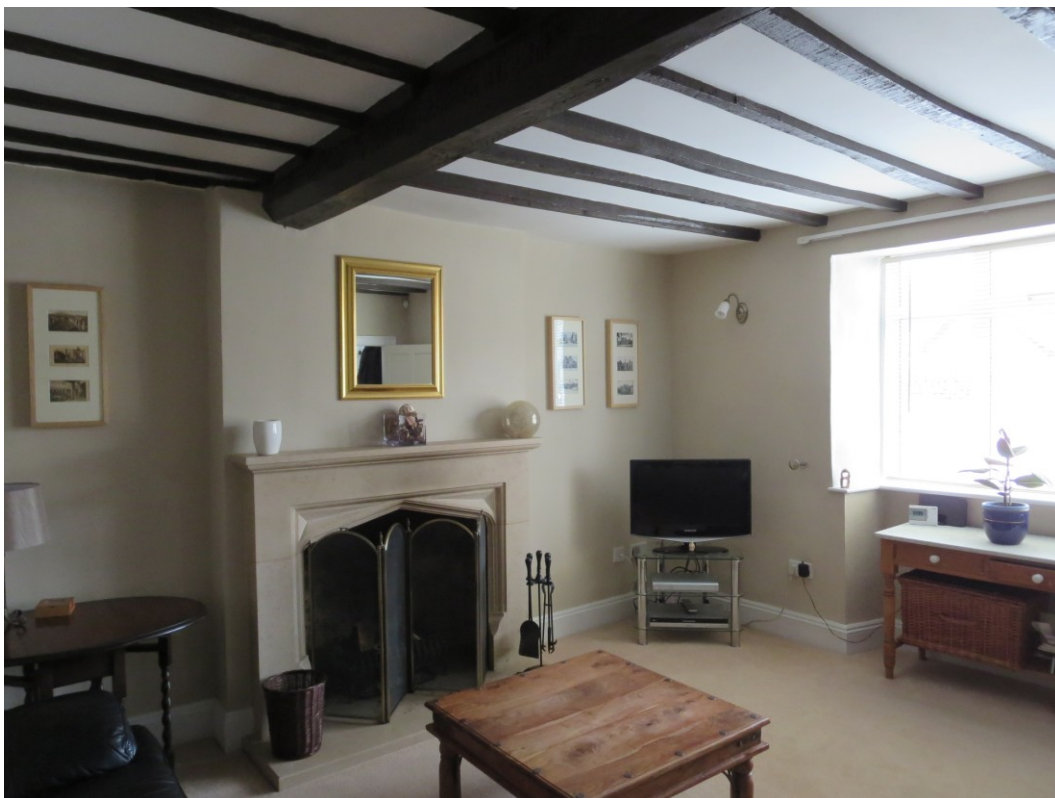
The S room has a shallow projecting chimneybreast, with a modern fireplace front. Original stonework is visible to the fireback, and brickwork (c.65x220mm) to the inner sides. Oak spine beam, chamfered, with no stops. On the W side, the floor joists are original, tenoned to the beam. To the E, the joists may be later, as they do not fit the mortices.

The south room

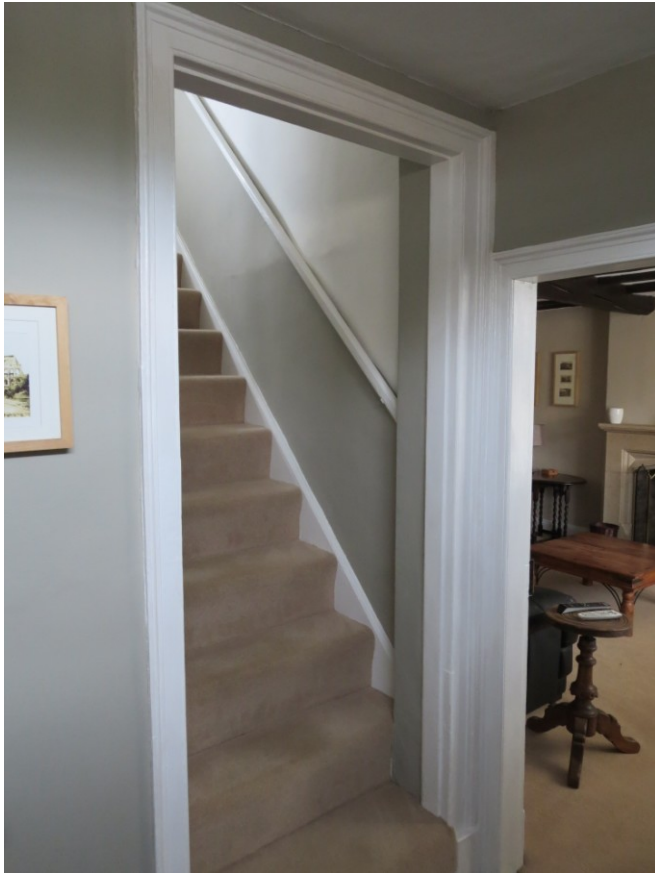
Inside the front door, the shallow hallway has the staircase rising steeply off it. 4-panelled doors with moulded architraves lead into the N and S rooms, with the same original architrave also around the stair opening. The hallway has a 9-inch (presumably brick) wall to the N side and a 4½ inch brick wall (rising right up to the roofline) to the S.

The entrance hall with stairs off

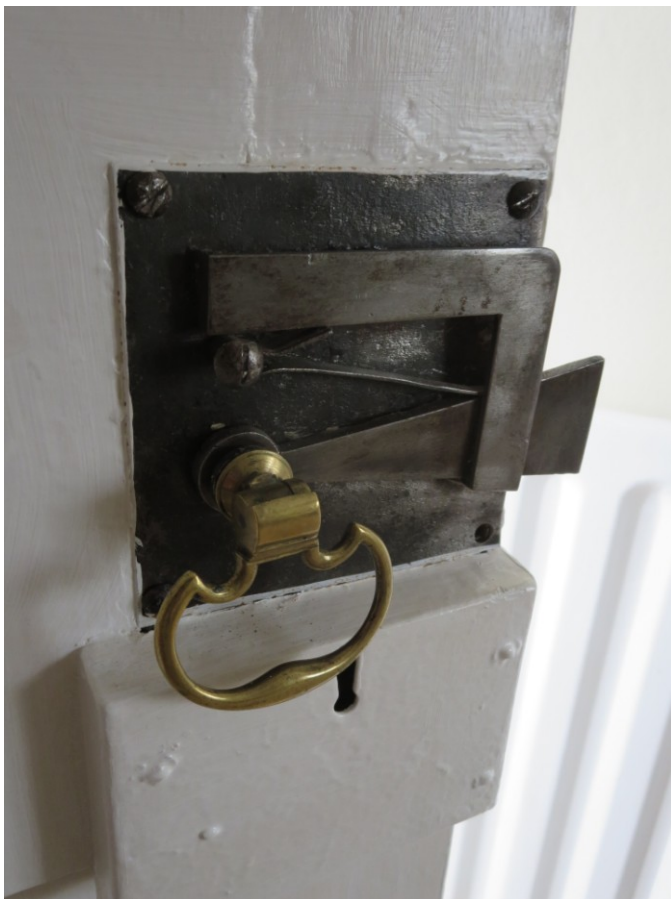
The central bedroom door still has its original latch, with exposed spring mechanism and brass drop-handles. The closet to the SW corner of the room (over the front hallway) also has a 2-panel door, with the same original latch and drop handle – here applied to the front of the door, and only one-sided. Pine floorboards are visible in this closet – presumably the original flooring, though not visible elsewhere. A brick pier to stiffen the 4½in cross-wall rises inside the closet – an intrusion considered acceptable in this unseen location.

Door latch to first floor closet

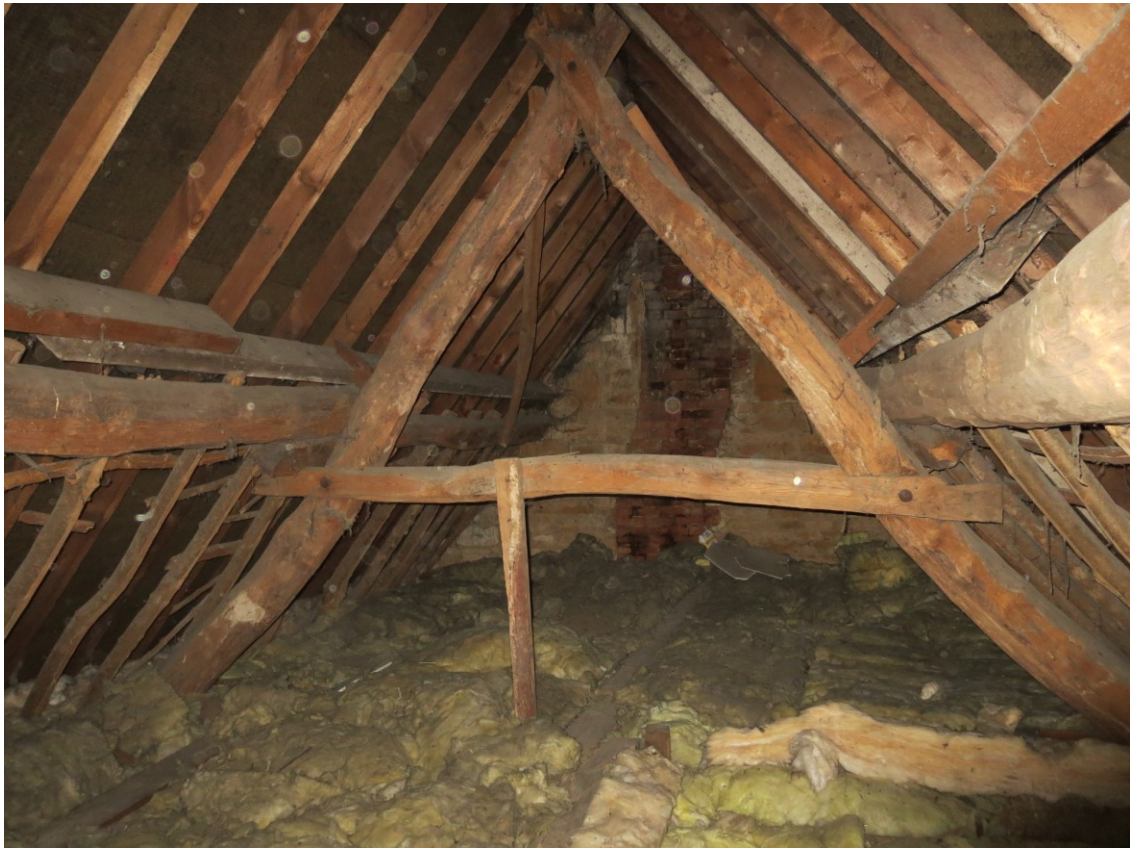
The original roof structure survives in fairly complete condition under the earlier C20 over-roofing in softwood and Welsh slate. Three bay roof with a single A-frame roof truss (T1) and a full-height 4½in brick cross-wall. Truss T1 has principal rafters and collar of roughly cut, S-shaped oak. Dovetail-lapped collar and scissor-lapped apex, the joints fixed with a single large-head forelock (cotterpin type) bolt, not timber pegs. Roughly shaped purlins are fixed to the back of the principal rafters with large nails, not pegs. The purlins and ridge, of oak, survive to all 3 bays. In the S bay, both purlins have c.75mm diameter holes drilled through them near the ends. These must be re-used lintels from a barn, the holes to receive harr-hung doors. The other main timbers appear primary to the roof structure, not re-used. The rafters (under the original thatch) were of rough ash pole type, most of which survive to the lower section, up to purlin level. There are the remains of some rough wind braces also of ash poles on the N side of T1, rising from the purlins to near the apex of the truss, and also one rising from the lower end of the truss up to the purlin. Some riven battens and twine to support the thatch also survive.

Truss T1, south face

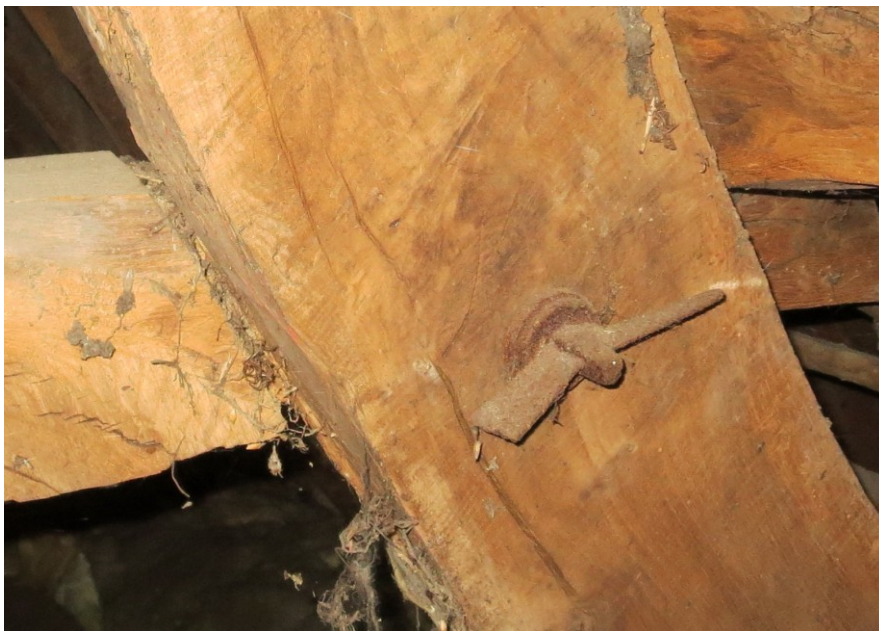
Forelock bolt to collar joint of truss T1
