**Lyddington Manor History Society**  
**Historic Building Survey**

**Wentworth Cottage**  
**8, Main Street**  
**Caldecott, Rutland**

## **HISTORIC BUILDING SURVEY REPORT**

### **WENTWORTH COTTAGE, 8 MAIN ST, CALDECOTT**

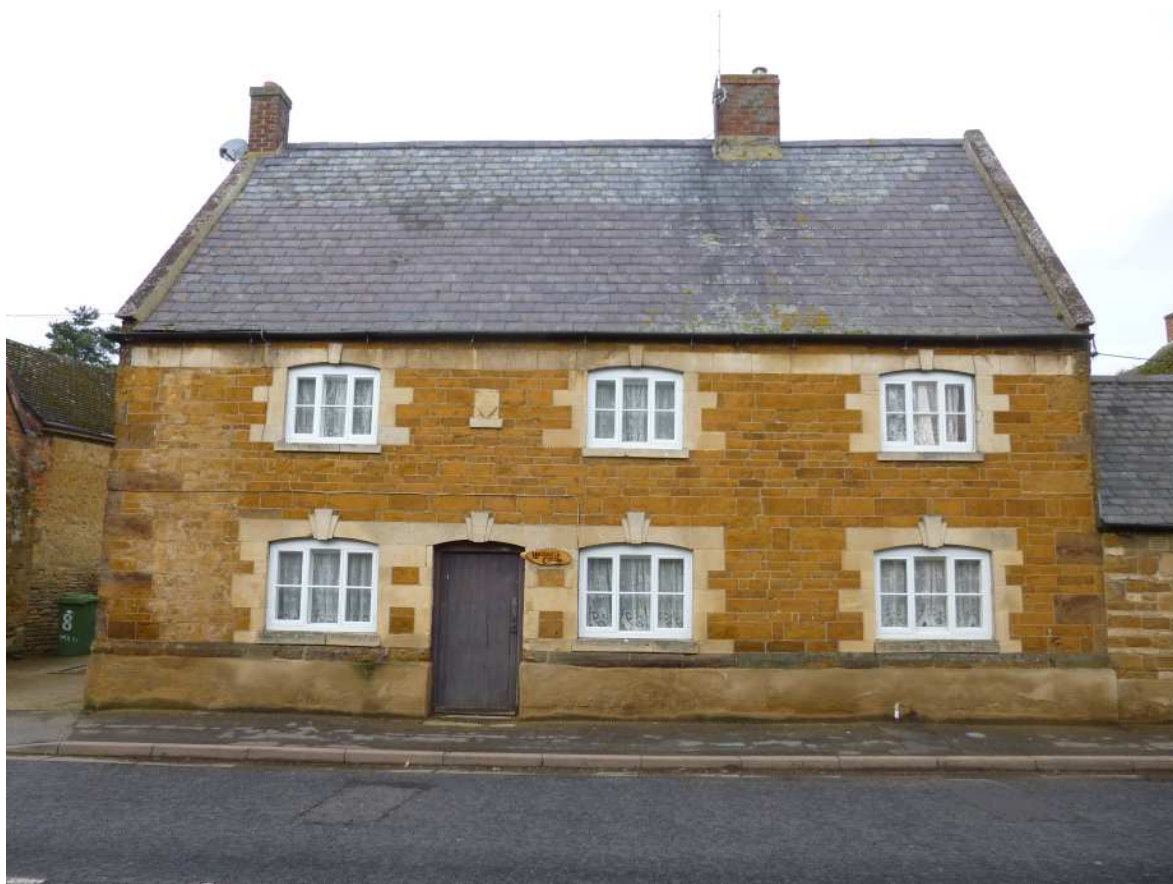
The S front has well-coursed ironstone with limestone dressings and quoins of brownstone/ironstone. Chamfered brownstone plinth, rendered below. Front door offset to the W, with 3 windows to ground floor and 3 windows to first floor directly above. All openings have bonded jambs, segmental arches and central key-blocks, of triple pattern to ground floor. On the ground floor a continuous limestone band links the lintels of the doorway and its flanking windows. Above the first floor windows there is a continuous limestone band course. Over the door is a limestone tablet, with diamond-set lozenge and projecting cill. It is of typical design and location for a date-stone, but the face is blank, with no inscription. Perhaps it had a painted date. 3-light timber casement windows, plain-boarded door. Two-flue brick stack to ridge, on stone base.

The south front

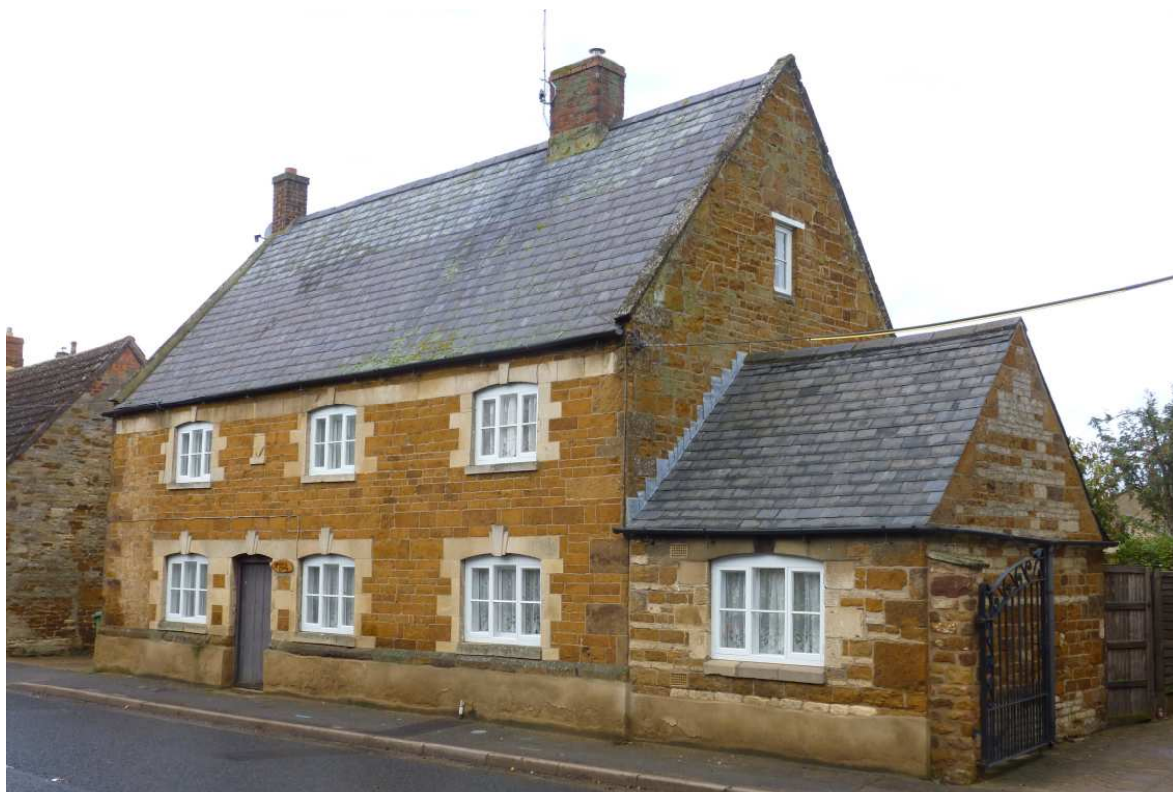
The E gable is partly blocked by the E extension. The raking line of an earlier, rather lower gable is visible to the upper part. Single attic window, probably fairly late. Coped gable parapet, plain kneelers and apex. The earlier gable line is also just visible on the W gable. Here there is a square plinth of slight projection, with render below. Above, the gable has various patched re-facing, with the upper part probably rebuilt in

The E extension front wall has alternating courses of ironstone and limestone (typical of 17<sup>th</sup> century buildings in the area). A window was inserted in the 20<sup>th</sup> century (not present on a photo of c.1910). Good quoins to SE corner, but none at the junction to the main building. The extension gable has mixed ironstone and limestone and a plain verge, with large triangular ironstone blocks. Good quoins to NE corner. The rear N wall had a doorway to the E end, now blocked by a modern extension, which fills in the corner.

View from the south-east

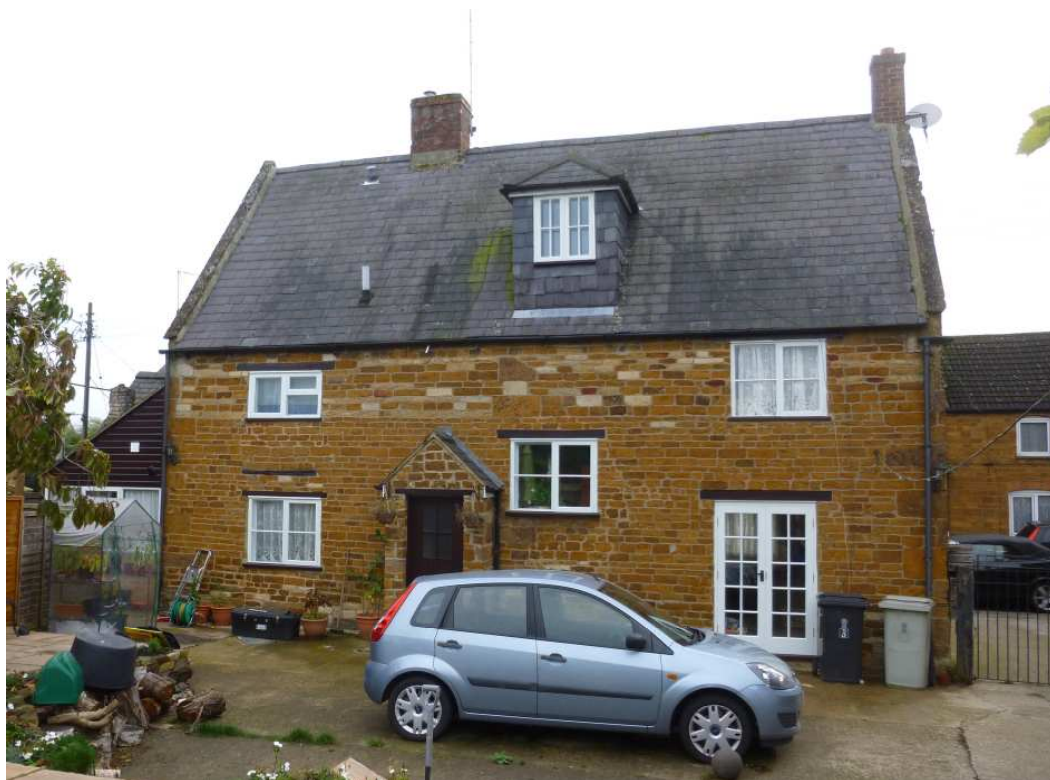
The rear N wall has less well-coursed ironstone, with some limestone, especially to the upper part added when the eaves was raised. Door offset to E, with modern porch. The ground floor has a 2-light casement window E of the porch, with indications that it was once a doorway, and also with a redundant old timber lintel, set higher up than the current lintel. Just W of the porch is another blocked doorway, with large jambs visible to the E, though none to the W. Above here is a large inserted stair window. To the W end, a set of French windows. Two further windows to 1<sup>st</sup> floor. This elevation has been much patched and altered, so the earlier appearance is unclear.

The rear north side

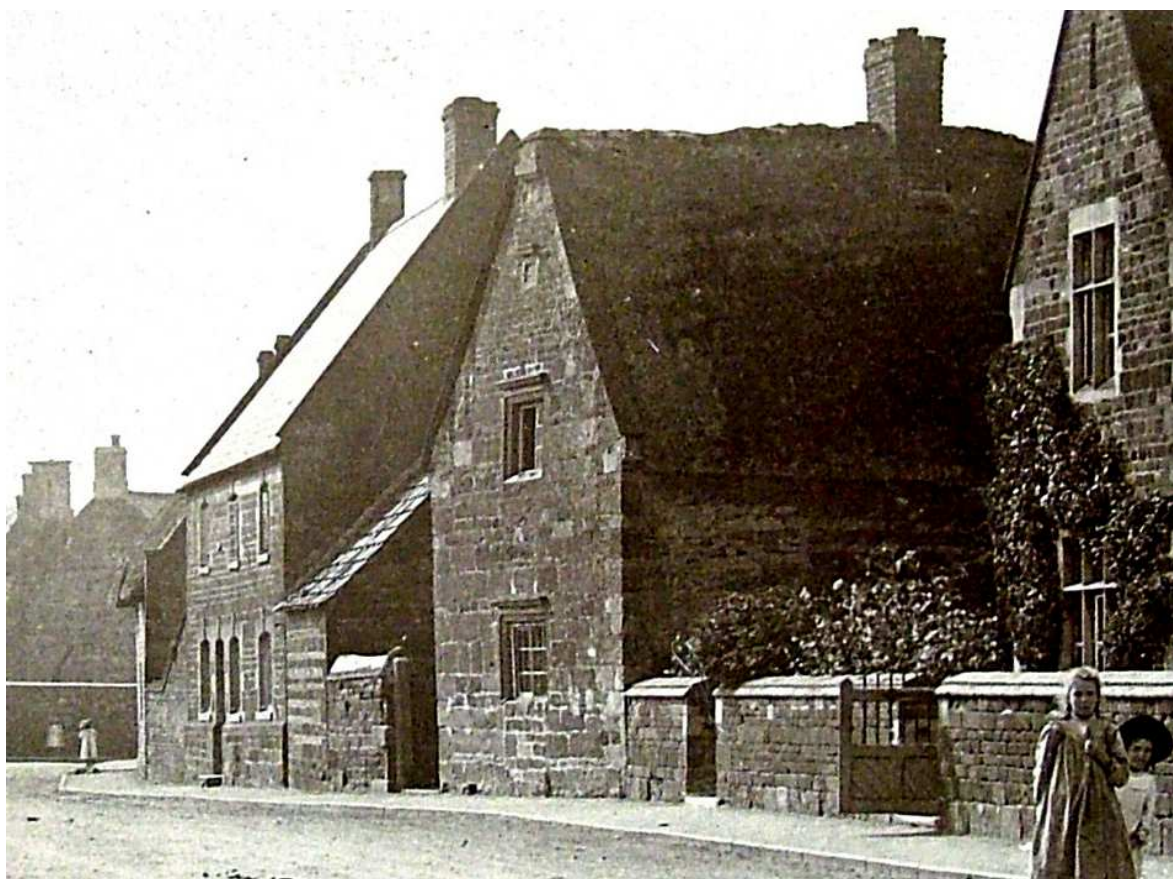
The 1800 enclosure map shows the building with the main range and a narrower width extension at the E end, as existing. The property is shown as a single plot together with the adjoining No 6. This single ownership is also indicated on the 1886 and 1904 OS maps. The 1886 1<sup>st</sup> edition OS map shows a very small extension also at the W end, now lost. This is visible as a lean-to on the photo of c.1910.

Photo of c.1910, showing No 8 with extensions to west and east

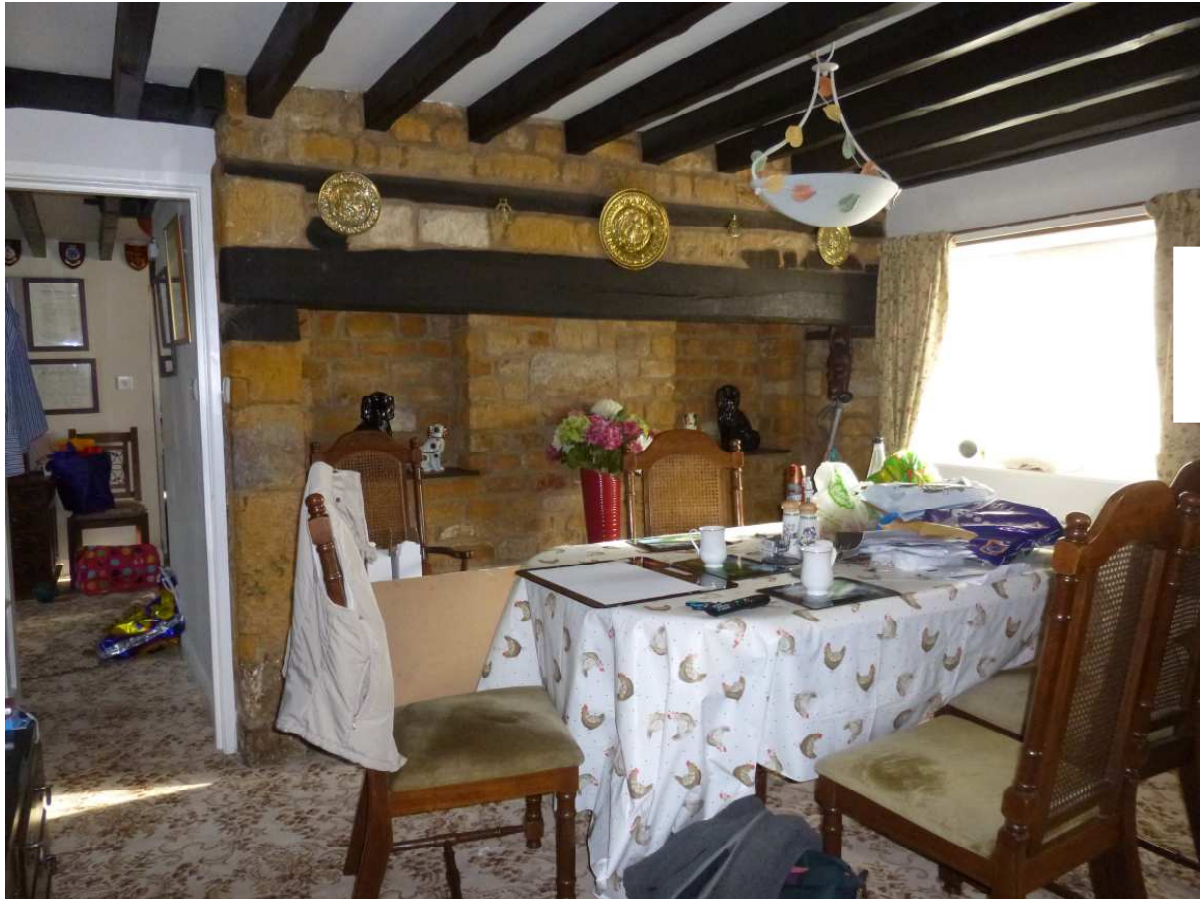
The front door leads into what is now a long room, occupying the two western bays of the house. A transverse ceiling beam must have been the location of a partition, dividing this space into two rooms – though there is no evidence visible for a partition. The beam has very fine chamfer stops to both ends, of ogee form with an additional bar, and carved grooves – an unusually elaborate stop for the area. Ceiling joists are modern throughout, though they fit into original mortices in the transverse beam. The E side of the room has a large inglenook fireplace, with straight chamfered beam, with run-out stops. Ironstone cheek to N, and rebuilt ironstone fireback. Above the ingle beam the ends of timber bearers are visible, supporting the masonry above. There is also a thin built-in timber plate. Inserted fireplace of modern stone to the W gable, and modern stair against the N wall.

The E room, which is quite narrow, also has an inglenook fireplace, back to back with the one in the main room, making a deep centrally-located chimneystack. Slightly arched beam, chamfered with run-out stop to S and no stop to N. The cheek, to the N side, is plastered. Modern floor joists. The E extension also has modern ceiling joists, and no fireplace.

Interior view, looking east towards inglenook fireplace

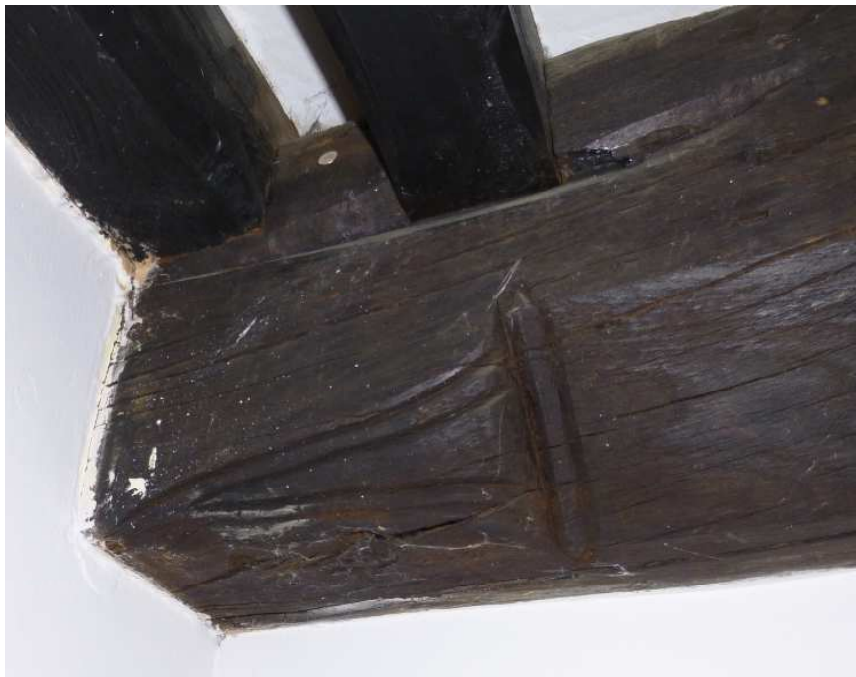
This house was originally built in the 17<sup>th</sup> century, as indicated by the surviving transverse beam, with stops of 17<sup>th</sup> century type. The original house was lower, of 1½ storeys, and probably thatched. It had a central hall, with entry door and inglenook fireplace. A partition to the underside of the transverse beam must have divided off the W room, which was an unheated service space. The E room was probably the parlour, though it is unusual to have an inglenook fireplace in such a room. Alternatively, it could have been in use as a kitchen. The location of the original back door is unclear. There was a full first floor structure for bedchambers above.

Finely carved ogee chamfer stop to ceiling beam

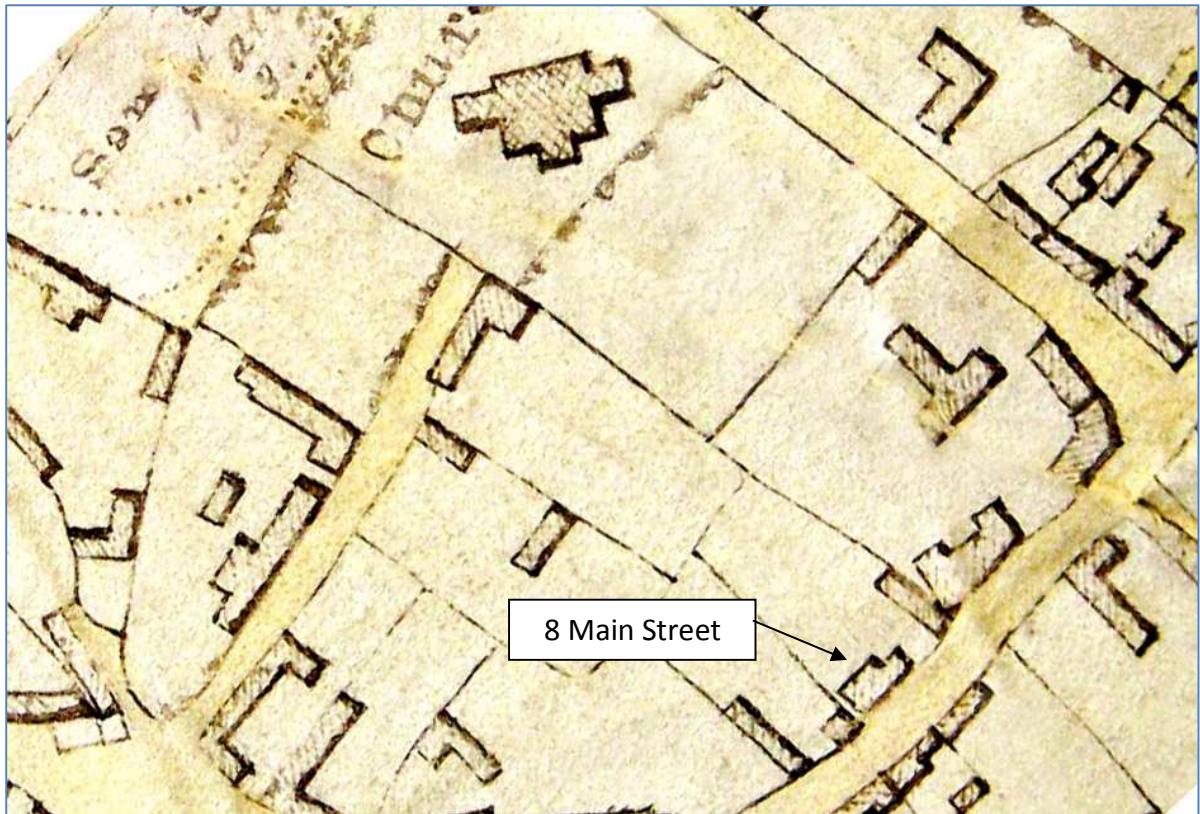
Caldecott Enclosure Map - 1800
