**Lyddington Manor History Society
Historic Building Survey**

**West Hill Cottage,
107-109 Main St,
Lyddington, Rutland**

HISTORIC BUILDING SURVEY REPORT

WEST HILL COTTAGE
107-109 MAIN ST, LYDDINGTON

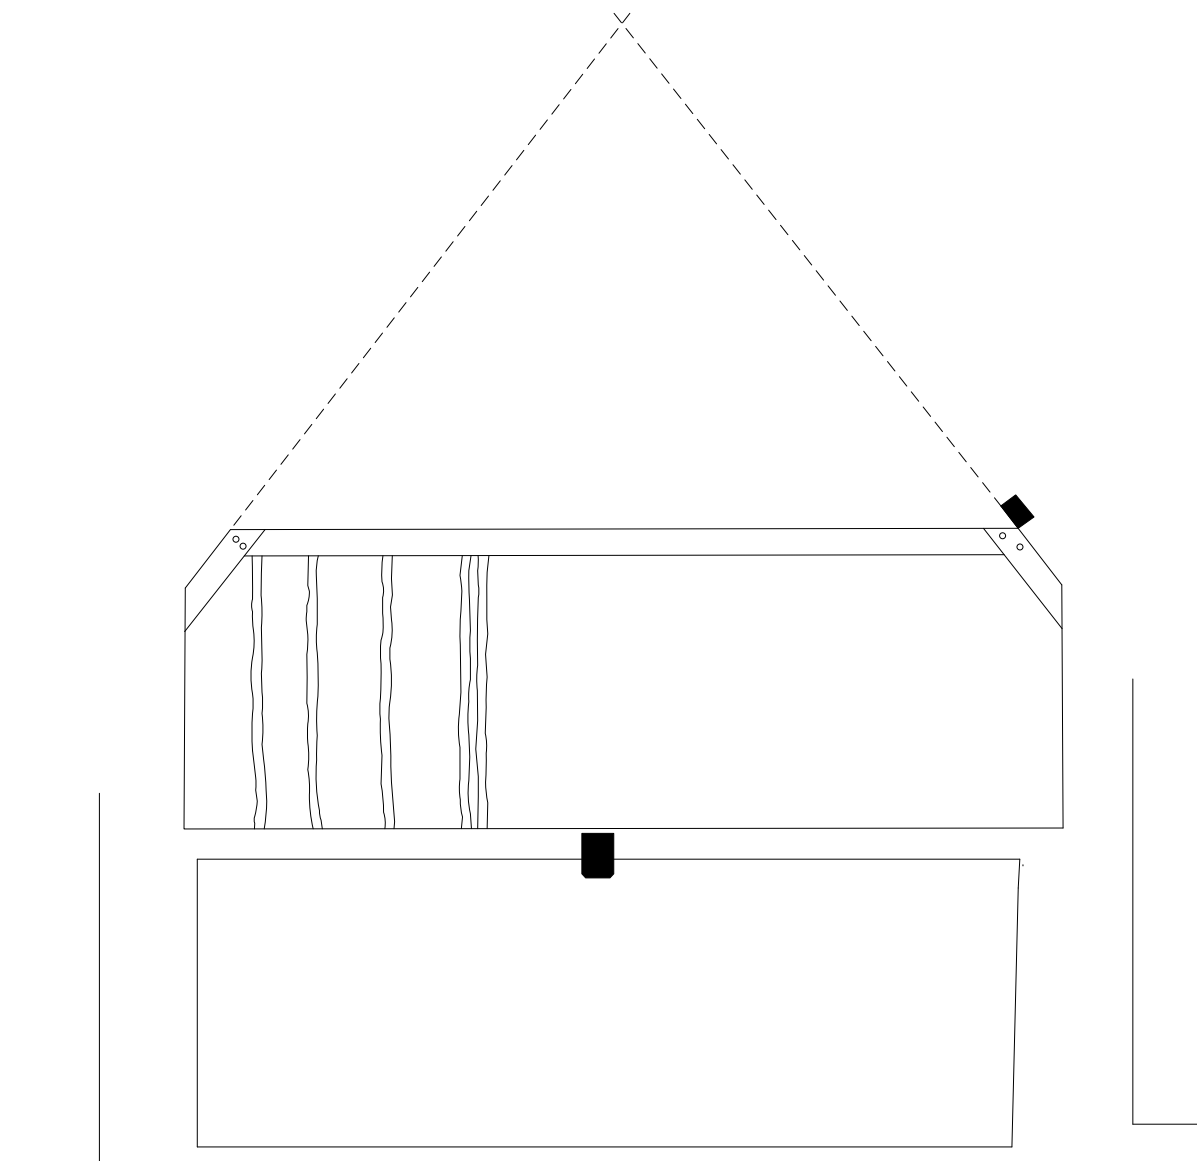
TRUSS T1 NORTH FACE

The roof has largely been replaced, except for the lower part of one truss. This was of A-frame form with principal rafters and a lapped collar. The collar projected to support back purlins. The upper part of the truss has been truncated, so the apex details are unknown. The truss was closed, with a partition of roughly shaped studs. The collar/principal joints have pulled apart, and have been reinforced with early blacksmith-forged iron straps, with nailed, Y-shaped ends.

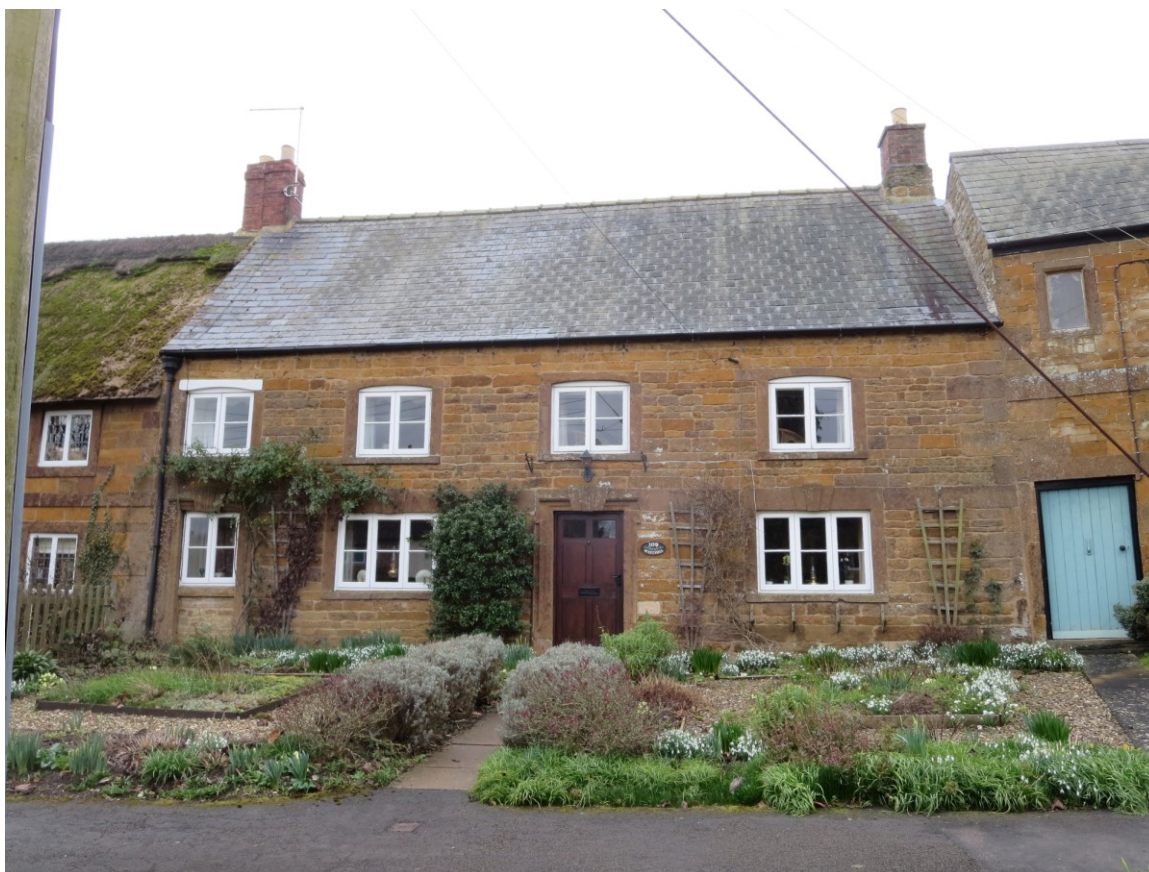
The east front

The E front is a good quality design, with finely detailed masonry features of brownstone, clearly built as two small houses. There are two front doors (the S one now blocked), both with finely moulded, eared surrounds with flat lintels and fluted keyblocks. At the foot, the moulded surround sweeps outwards, to terminate on a plinth block. Each of the houses has a ground-floor window with a plain surround and projecting keyblock. The door and window lintels are linked by a continuous, deep band course of brownstone, with good quality quoins at the corners. Four windows to the 1st floor, with plain brownstone surrounds and thin, segmental arch lintels. The N lintel has a central voussoir, but the two centre ones are of a single piece. The S lintel

has been replaced in painted timber. The timber casement windows and door are modern. Above the window lintels, several courses of newer masonry show where the roof has been raised. The quoining at the S junction shows that No 105 (with date-stone of 1741) was built before 107-109. At the N end, No 111 (with date-stone of 1774) has been built against 107-109.

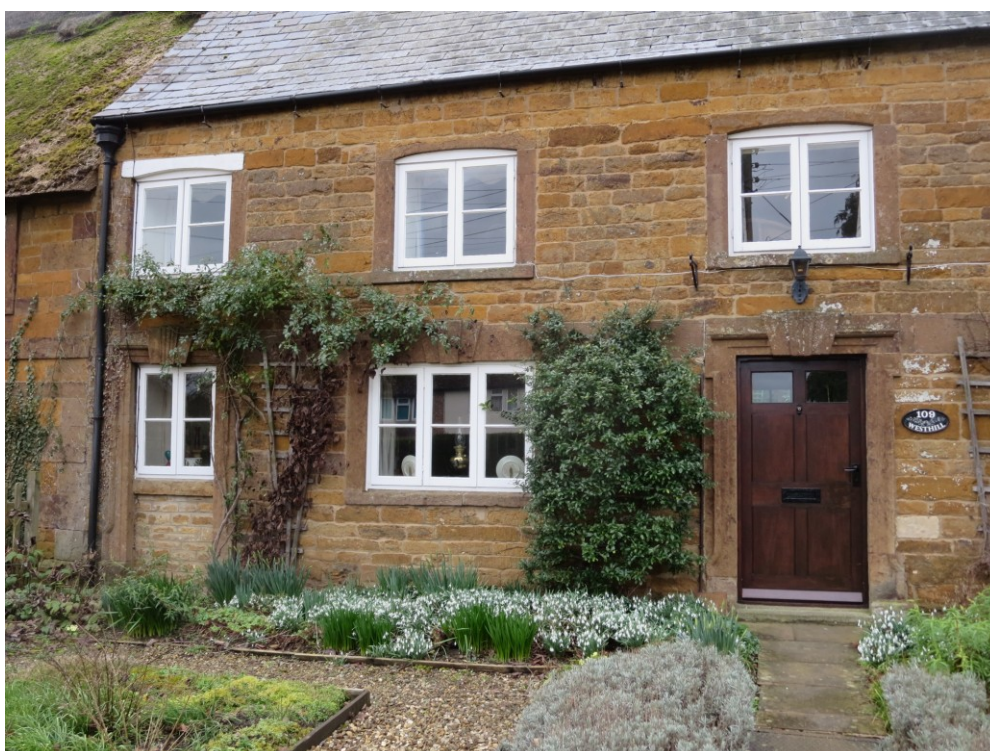
The east front with blocked doorway to No 107 to the left

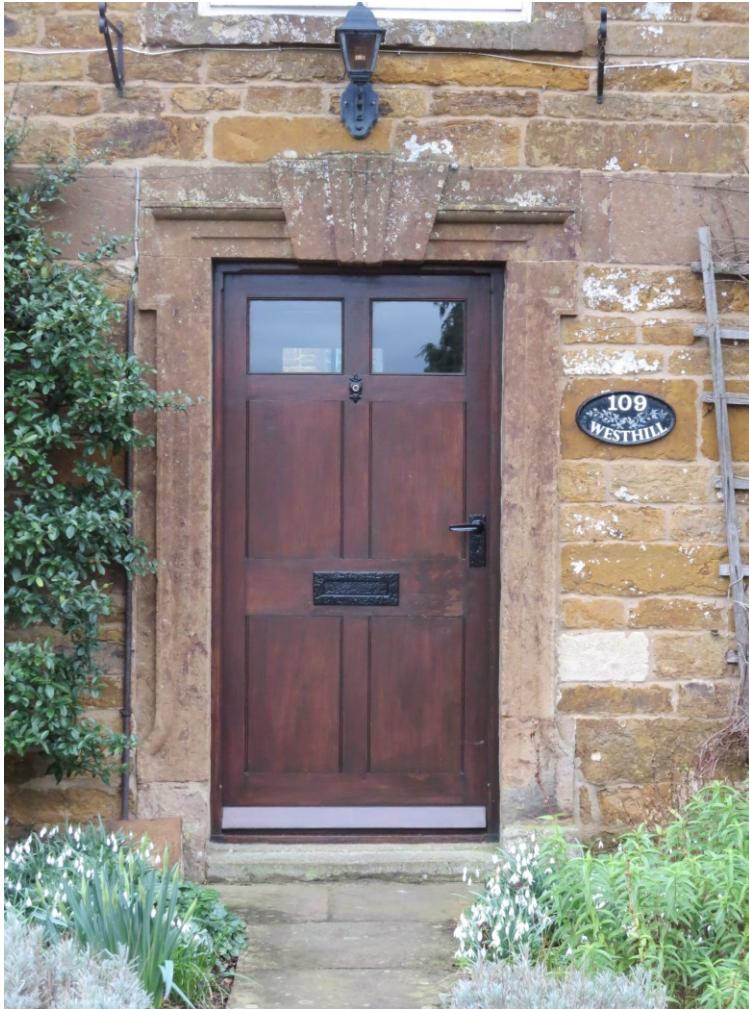
Front doorway

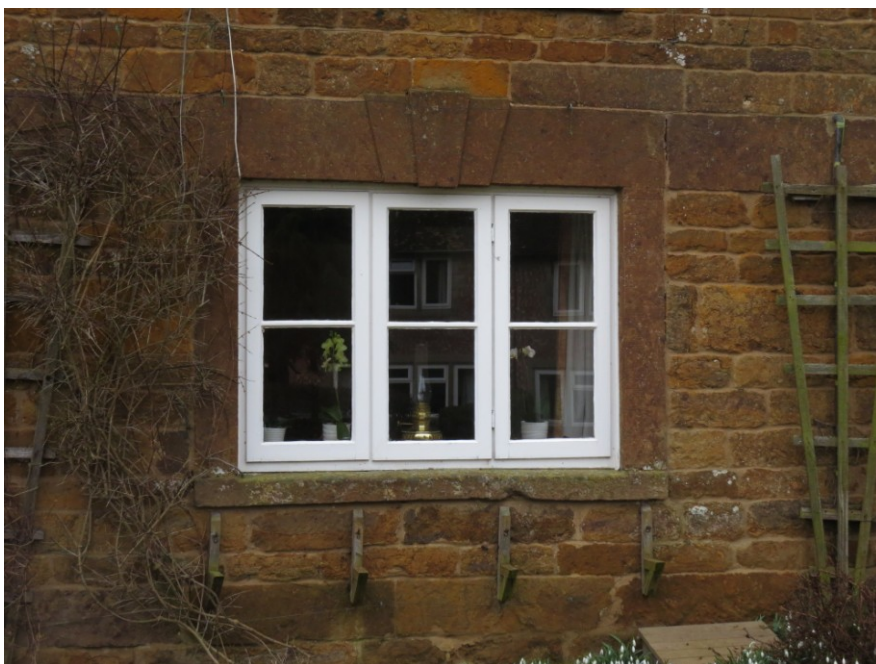
Ground floor window

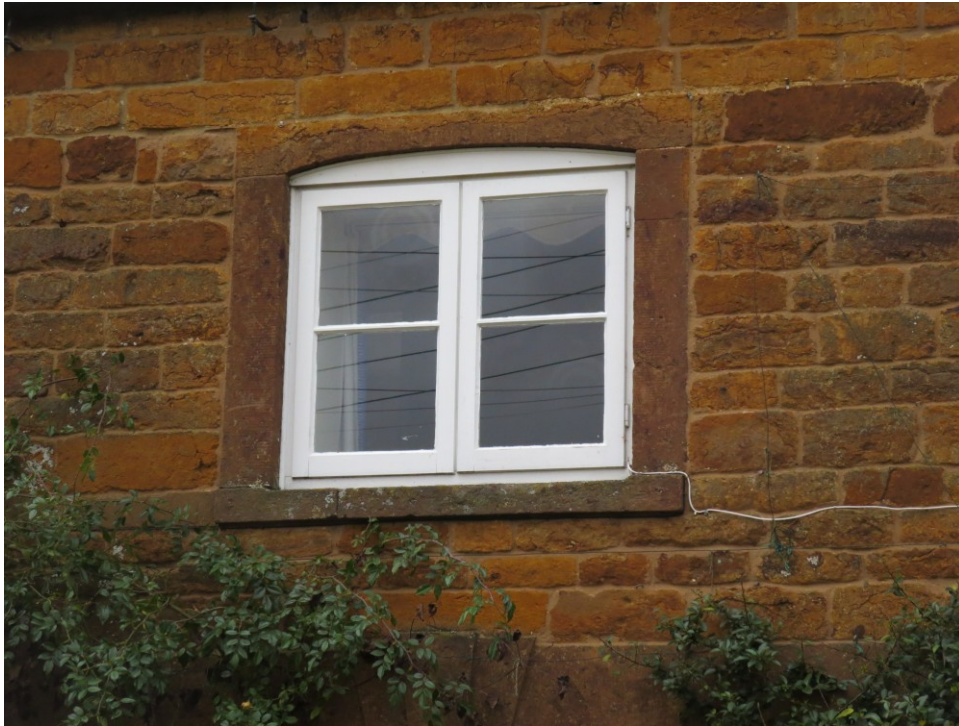
First floor window

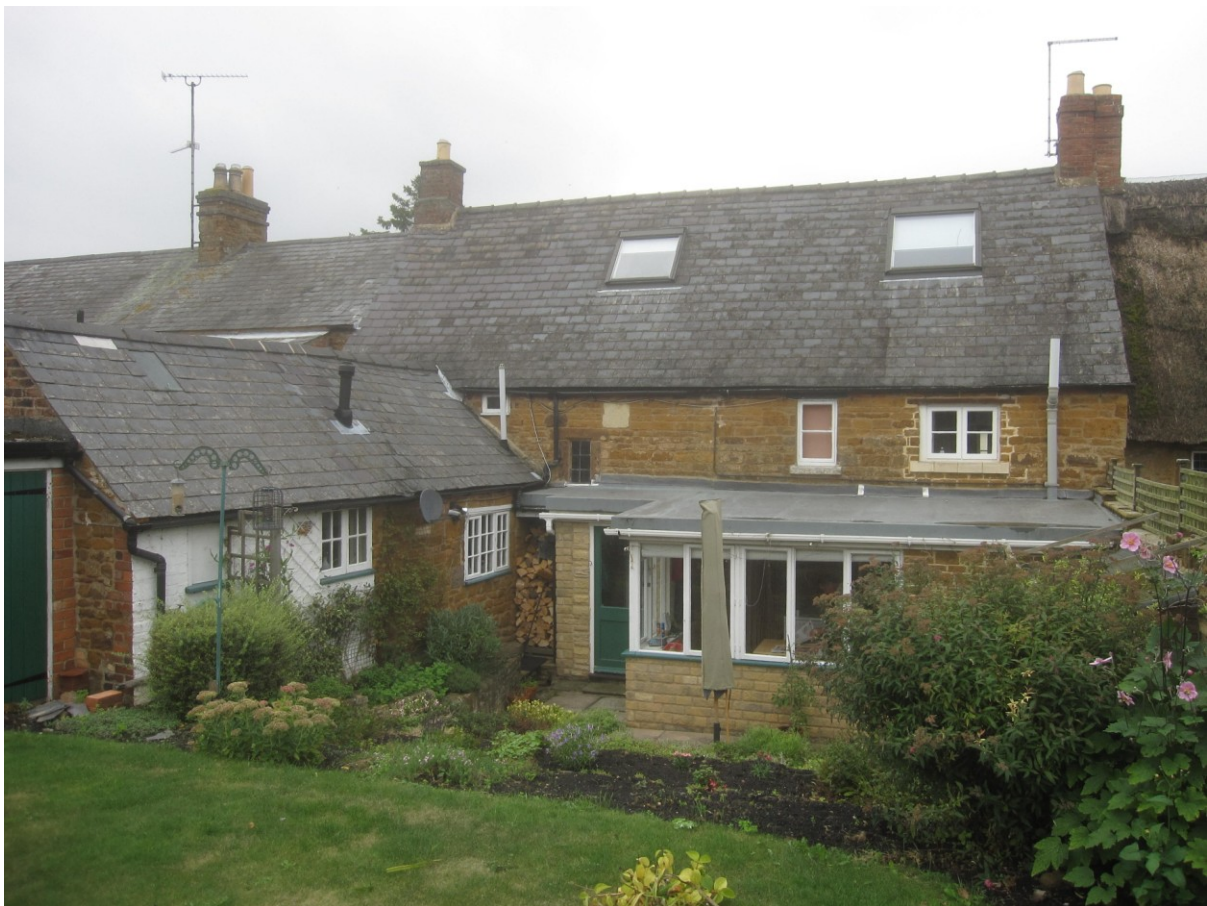
The rear west side

The external rear W wall is largely covered by later extensions. Coursed ironstone rubble to 1st floor, with a plain-chamfered brownstone window set at mid-floor height, to serve a stair. S of this is an inserted single-light window, and a 2-light timber window which has recently been re-set higher up. Single-storey extension rising up the slope, with stone walls to E, but some brick to parts of W section, Welsh slate roof.

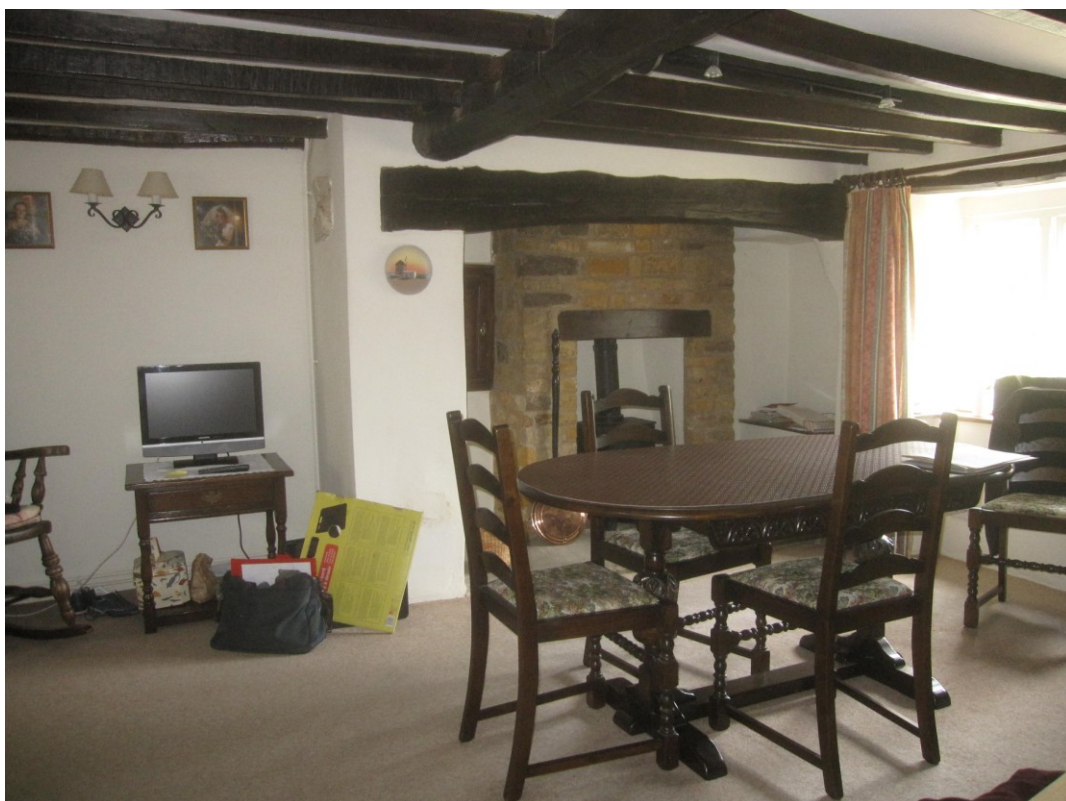
The north room, looking north

The current front door (for No 109) leads into a cross-passage, whose back doorway is clearly original, with good jambs and a chamfered ironstone flat lintel. The N room has an inglenook fireplace with roughly arched beam. Within the inglenook, an rather irregular recess to the E may represent a former oven or copper. To the W is a cupboard with panelled pine door on H-hinges. Re-set in the W face of the inglenook cheek wall is a fragment of carved limestone, with a cherub's head and wing – probably a former gravestone. There is a further such fragment lying in the rear yard. Spine beam with short ogee stops to the S end, oak floor joists with small chamfers. The W wall has an original window to the N, with a chamfered ironstone surround. It was blocked by the extension, but has been re-opened as a hatch. Further S in the rear wall, beside the modern stairs, is the dished recess of the original, winder stairs, with its stair window.

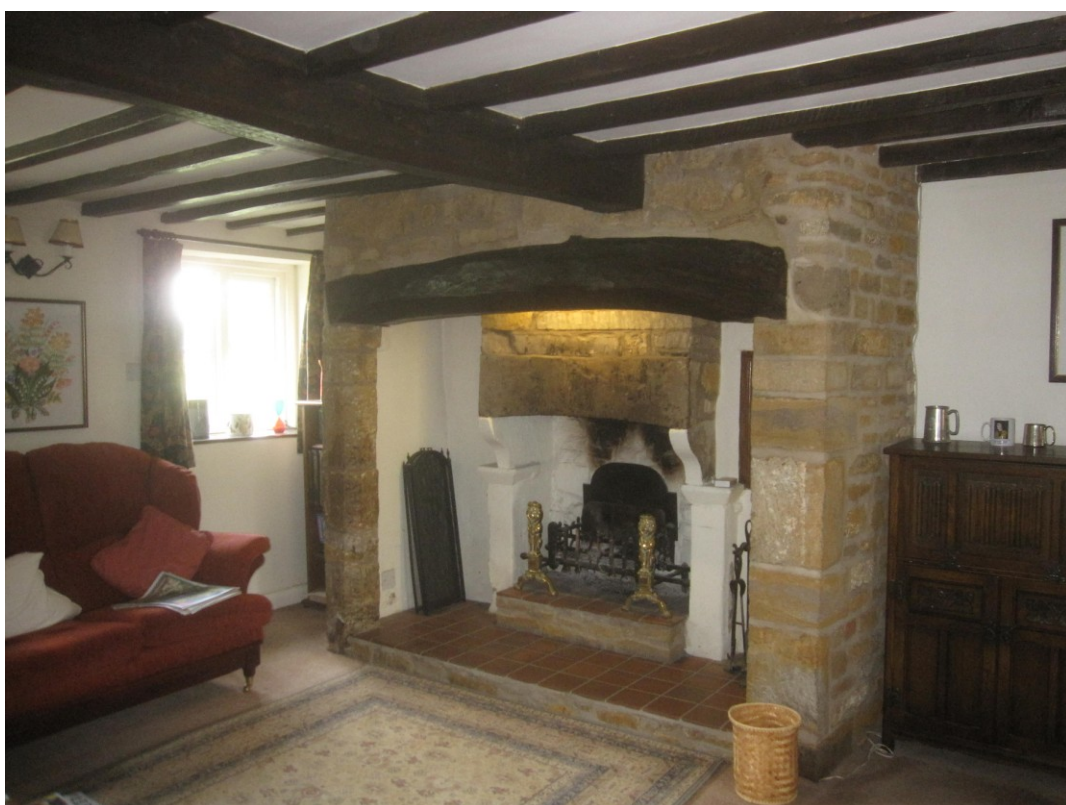
Inglenook fireplace to the south room

The S room also has an inglenook fireplace, with roughly arching beam. The E cheek, of ironstone, is unusually thin, with a return to the front – perhaps to allow more space for the front door to No 107. Inside the inglenook is a very unusual inner fireplace – stone jambs with a tall chamfered plinth support thin ogee corbels, which carry a deep brownstone lintel, with segmental arch. This masonry is clearly old, but cannot be original – perhaps the result of re-use of material in the 20th century. Cupboard with pine panelled door to rear W wall of inglenook. Spine beam with short ogee stops to both ends, oak floor joists. The joists to the W of the inglenook have been renewed, probably indicating a former stairs location. The W wall has two small original window openings with external stone surrounds. But the rear doorway looks inserted, with a modern lintel and disrupted jambs.

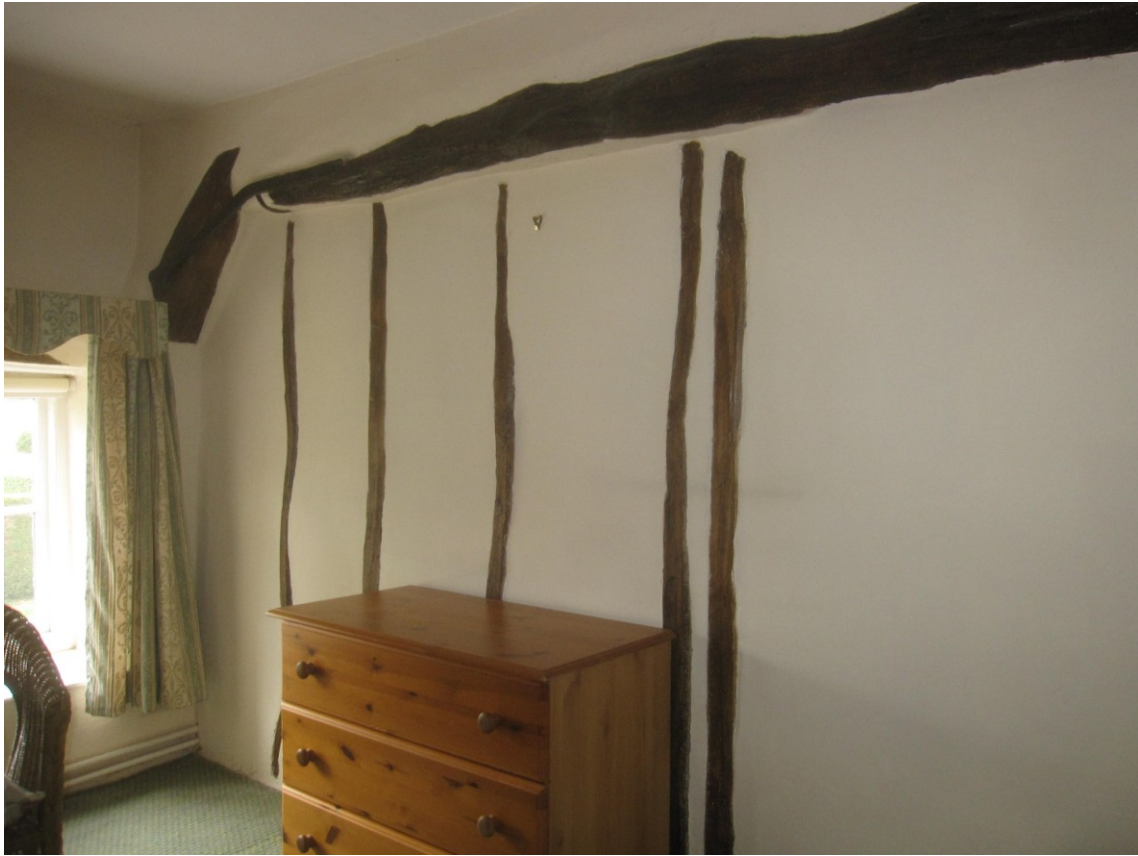
Truss T1 with stud partition, north face

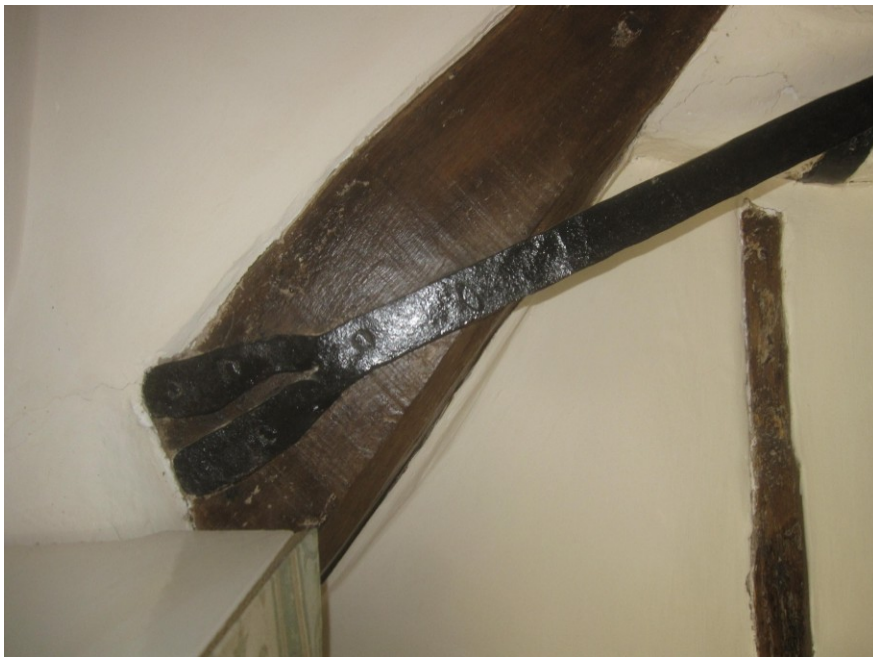
Detail of iron reinforcing strap to truss T1

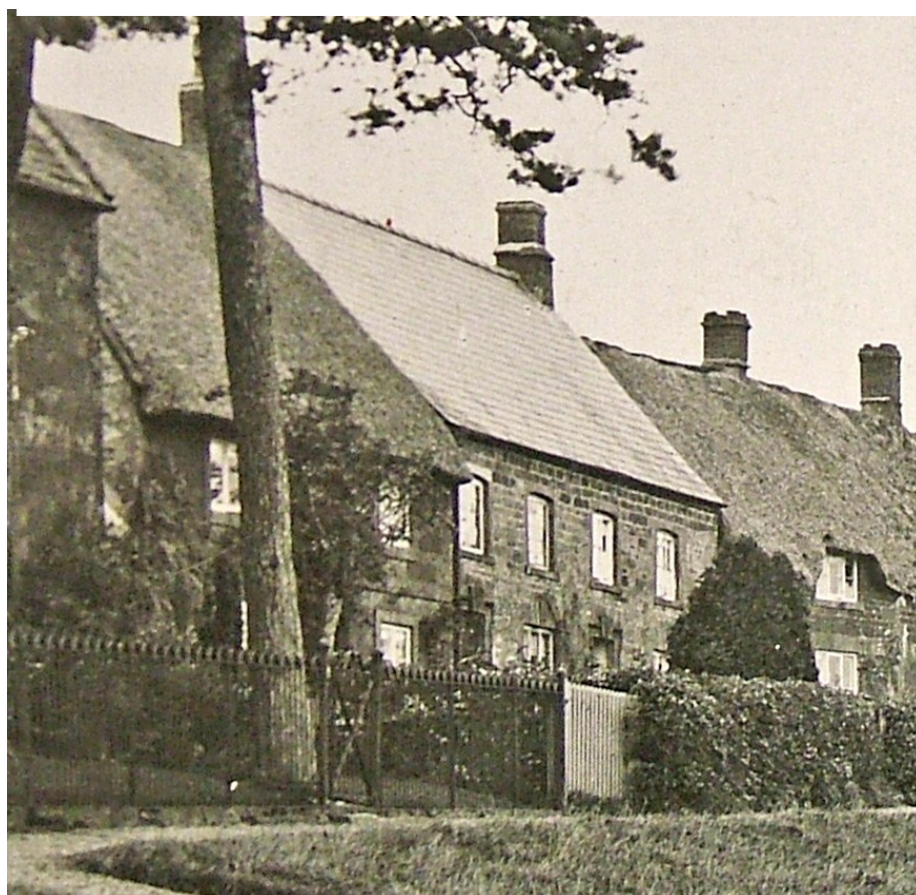
Detail of view of c.1905, with new slated roof

The smaller unit to the S (No 107) had a baffle front door entry, against the side of the inglenook. On the ground floor was a main kitchen/living room, perhaps again with a pantry to the NW, lit by the small window, and stairs to the SW. It seems likely that there was a central back door, near the existing location, though it is puzzling that the current doorway appears to be a later insertion. Upstairs there would have been two small rooms or a single larger one, with no fireplaces. Each of the houses had a rear yard with outbuildings, but the only access seems to have been through the house. When the outbuilding was added to the NW of No 109, the squint window here was added, as the original window here was blocked. A doorway was later cut through into the extension. The roof was no doubt of thatch originally, but it was raised and replaced in Welsh slate around 1900.

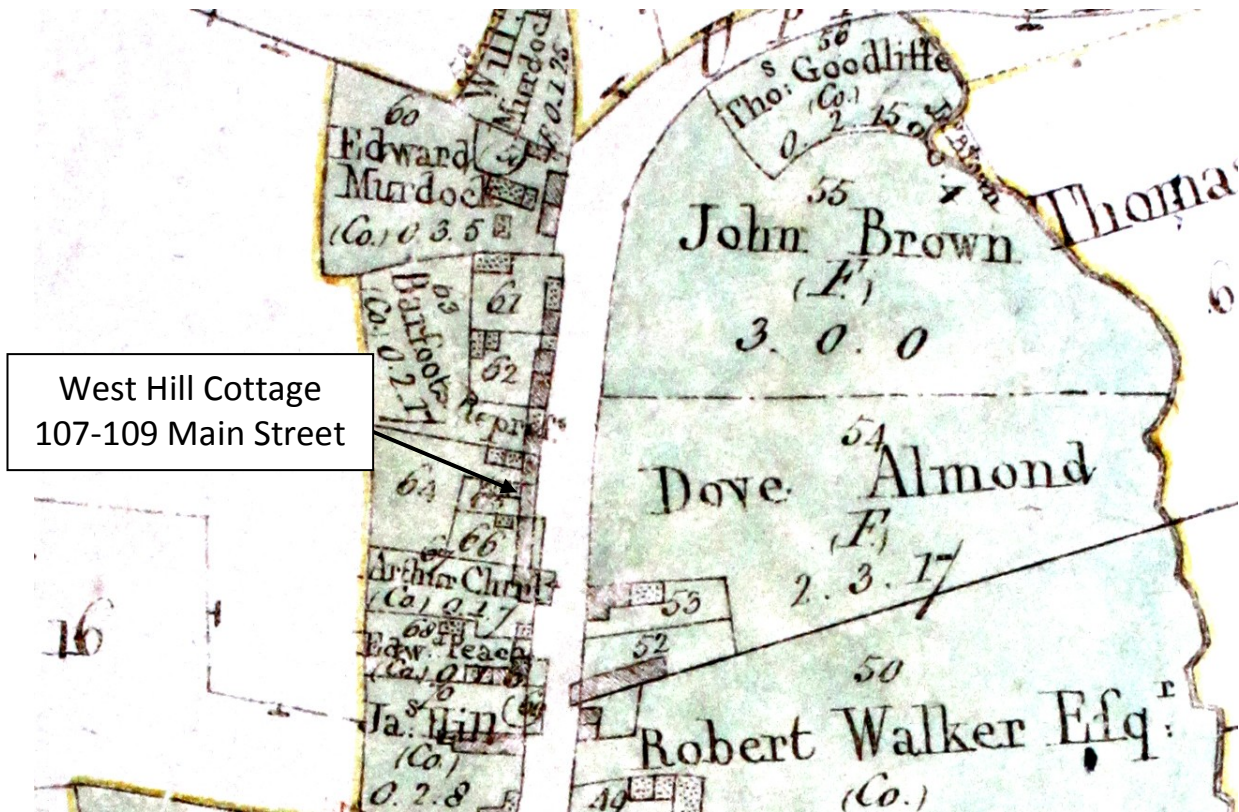
Lyddington Enclosure Map - 1804

The 1804 enclosure map and schedule shows the property as two plots, 64 and 65, though the buildings are indicated as being rather longer than is the case on the ground. Plot 64 (No 109) was 1 rood and 8 perches, with the copyhold owner as 'Barfoot's Representatives'. Plot 65 (No 107) was 13 perches, with the copyhold owner as Hugh Clark. A row of outbuildings extended W from the N end of each house. The land holding to plot 64 included quite a large area of ground to the W, extending S behind No 107.

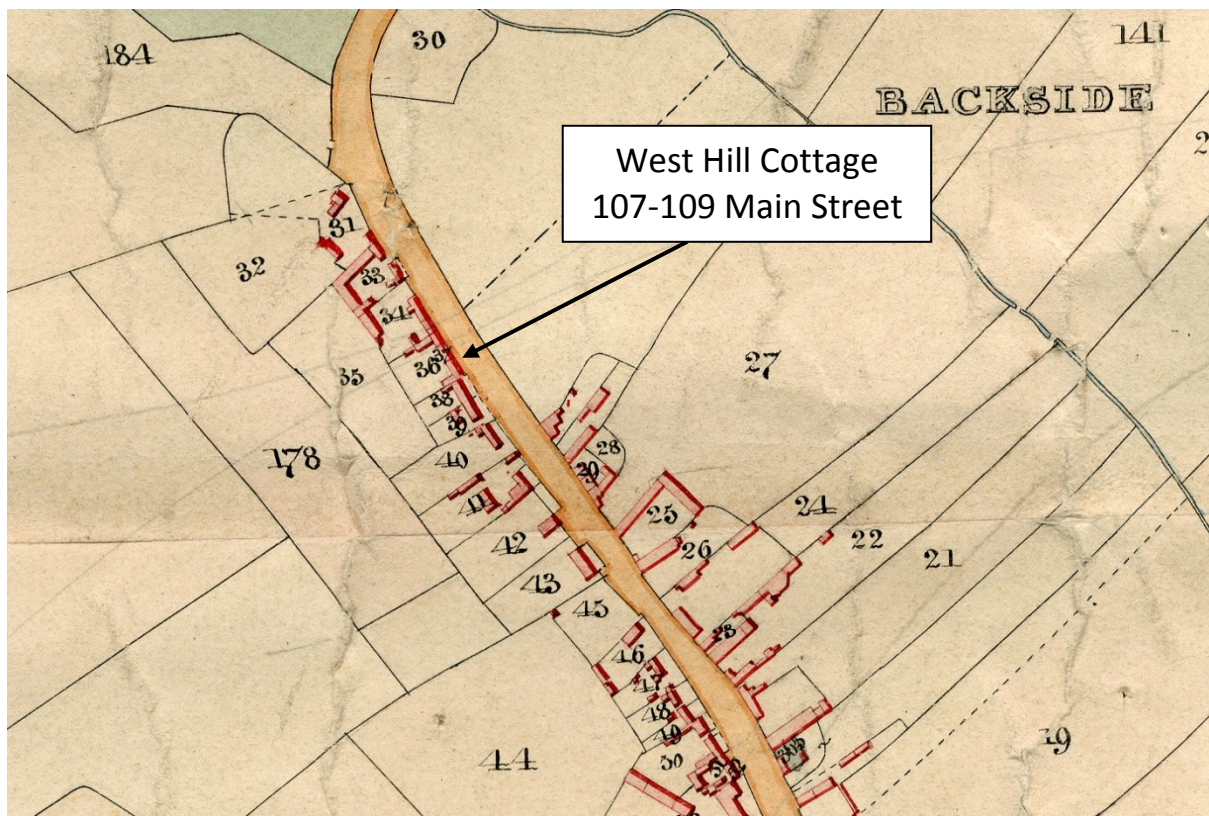
Lyddington Estate Map, 1848 (Burghley Archives)

The 1848 estate map and schedule show the property as plot 38, of 13 perches. The NW extension is indicated. The copyhold owner was John Clarke, the occupiers were Henry Dawson and Matthew Coleman, and it was described as 'Two tenements stable hovels yard and garden in front'. The land behind, forming part of 'Home Paddock', was now owned by Joseph Brown, who lived at No 111.
