Historic Building Survey

Ye Olde House 2 Uppingham Road, Caldecott, Rutland

HISTORIC BUILDING SURVEY REPORT

YE OLDE HOUSE 2 UPPINGHAM ROAD, CALDECOTT

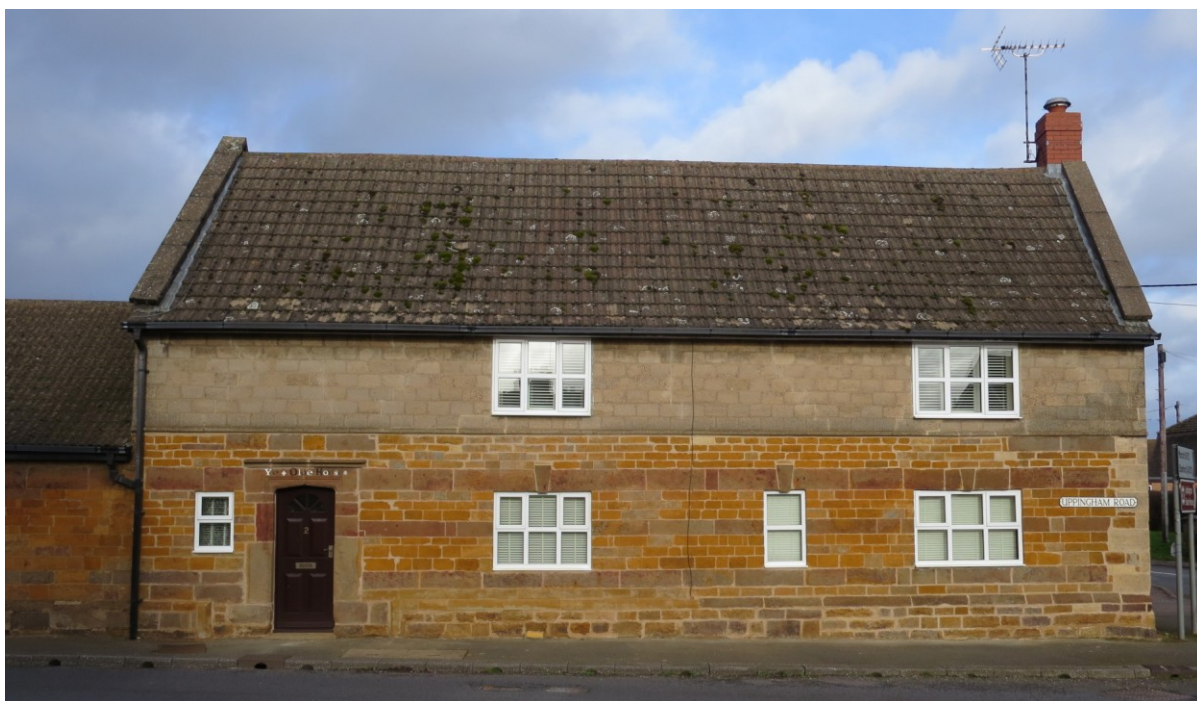
The south front of the main part

The S front has finely dressed ashlar ironstone with bands of brownstone. Good quoins of Weldon-type limestone to the E corner, to which the ashlar re-fronting joins irregularly. A plain chamfered plinth runs along the whole S front, including the single-storey W part. Two larger and one smaller windows to the E part, all with flat brownstone lintels and slightly projecting keystones. Good 17th century stone doorway, with 4-centred arch head, moulded jambs and cavetto-moulded cornice – all of old, original masonry. The plinth returns downwards to either side of the doorway, confirming it is in its original location. Small inserted window to W of doorway. The masonry frontage continues, with no break, into the W part. Two window openings, the W one blocked; both have flat brownstone lintels as to the E part, but cut from a

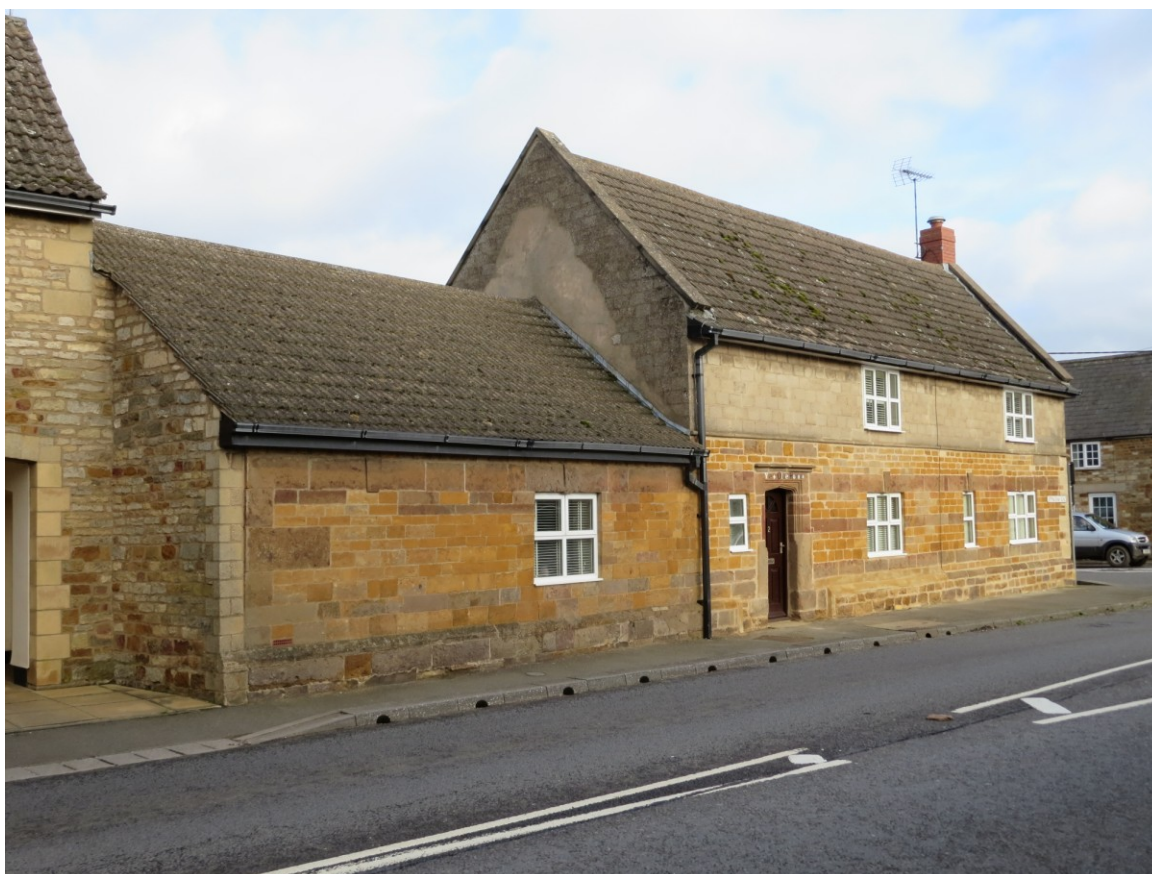
View from the south-west, with north end of reduced height

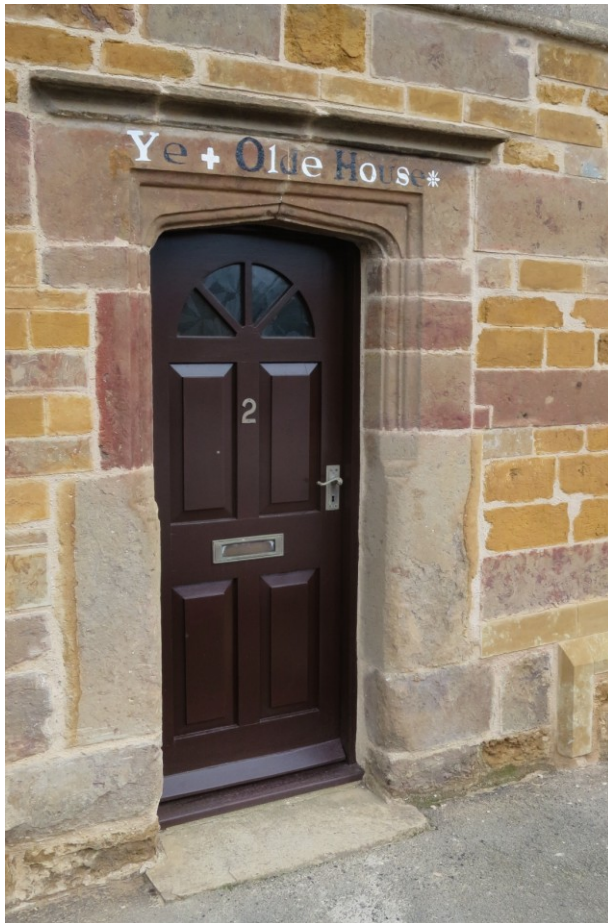
The front doorway

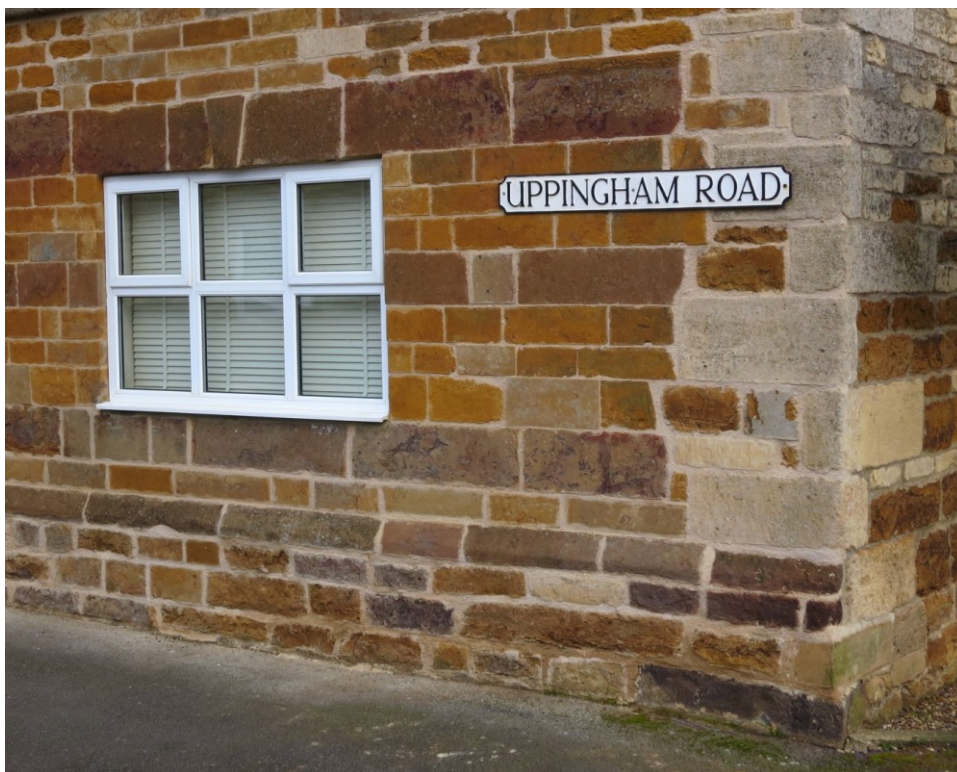
The south-west corner, with limestone quoins, chamfered plinth and later re-fronting

single stone block, including the projecting keystones. Good brownstone quoins to the W corner, beyond which the gable end wall has an outer face added, of 20th century date. All windows and the door are of late 20th century date.

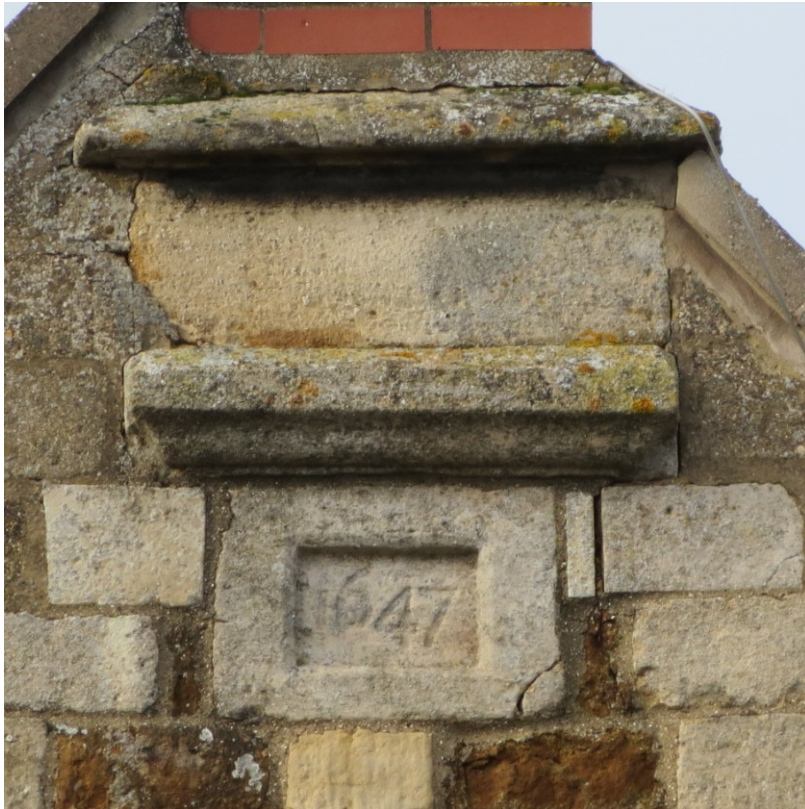
1647 date-stone and chimney stack plinth to east gable

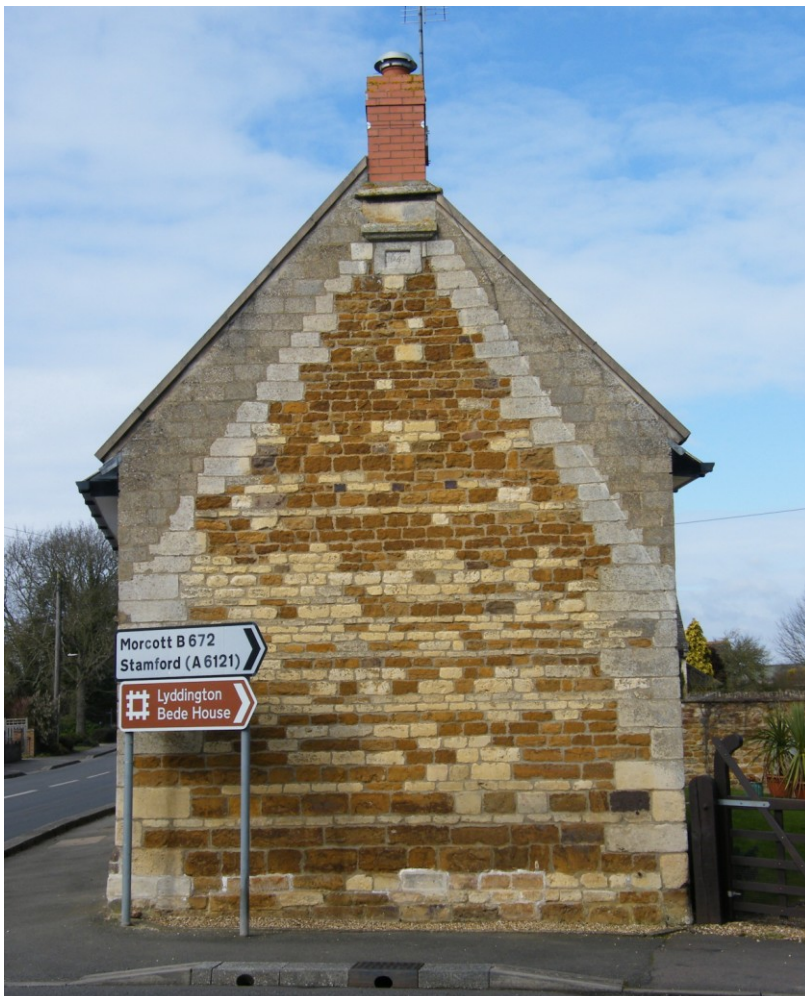
The east gable, with roof line raised in c.1950

The E gable has coursed ironstone with some alternating courses of limestone, but also much other limestone, which disrupts the polychrome banding. Good limestone quoins and stepped blocks for former gable parapet. The roof raising of concrete blocks has stepped seatings into the raking line of the limestone blocks. A photo of 1922 shows part of the original coped gable parapet, with a moulded corbel below the kneeler. At the gable apex is a date-stone: of Weldon-type limestone, well-formed lettering '1647' on a recessed face, surrounded by a small chamfer, with cyma-moulded cornice over. Above this is a large limestone ashlar block, surmounted by a chamfered limestone plinth – no doubt the base of a former stone chimneystack, but probably re-set. The stack was rebuilt in red brick in c.1960. An early 20th century photo shows the former stack here.

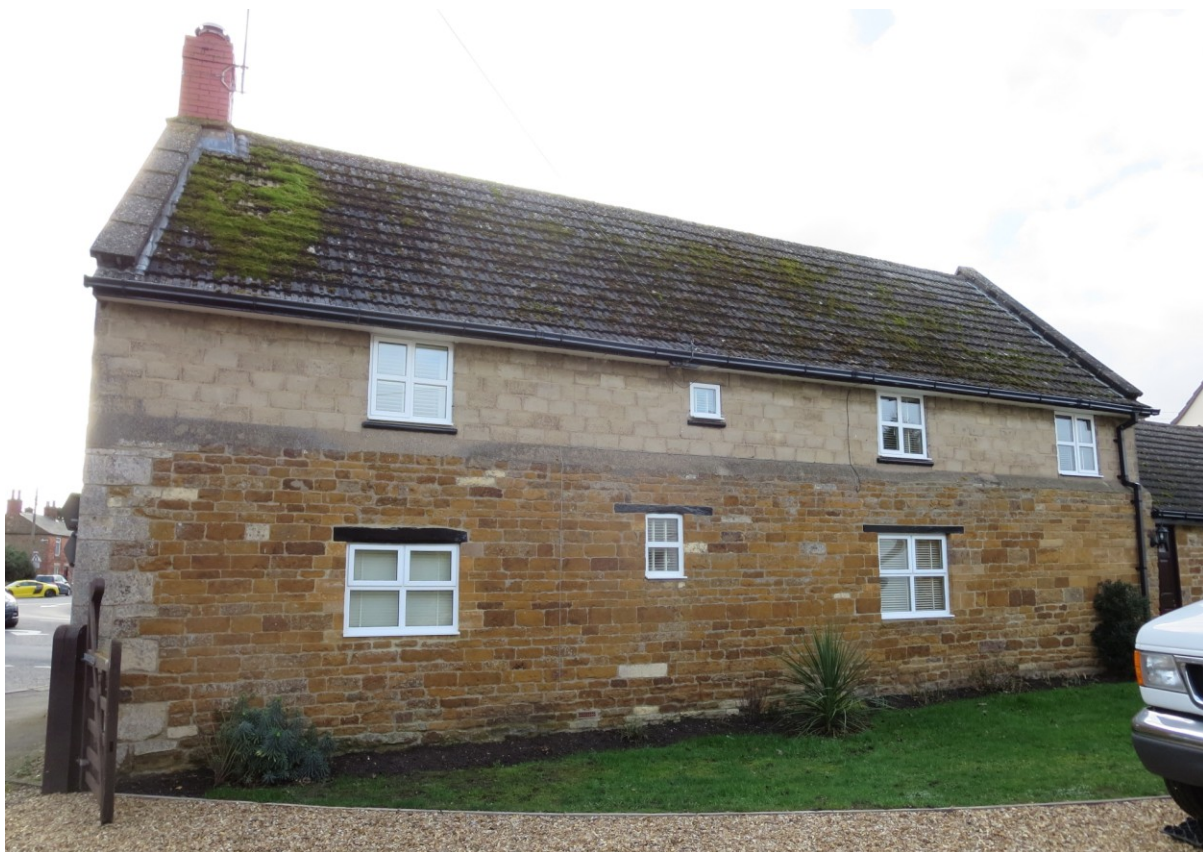
The rear north side of the main part

The rear N wall to the main E part has well-coursed ironstone rubble, which fits well to the limestone quoins at the NE corner. The E window has an old timber chamfered lintel. The smaller central window, also with a chamfered lintel, is set rather higher, for the stairs. The W window has good jambs, but the lintel has been replaced. At the W end of the main section, the quoins are small and fit irregularly to the main walling – clearly a later re-working. The N wall of the single-storeyed W section is set c.200mm back from the main part, with a line of small, square quoins to the W side of the full-height doorway and modern timber lintels to the two window openings. An abutting garden wall conceals the NW corner, so no quoins are visible. Although this rear N wall is of old, well-coursed ironstone, it appears to be a late rebuilding, as set out below. All windows and the door are of late 20th century date.

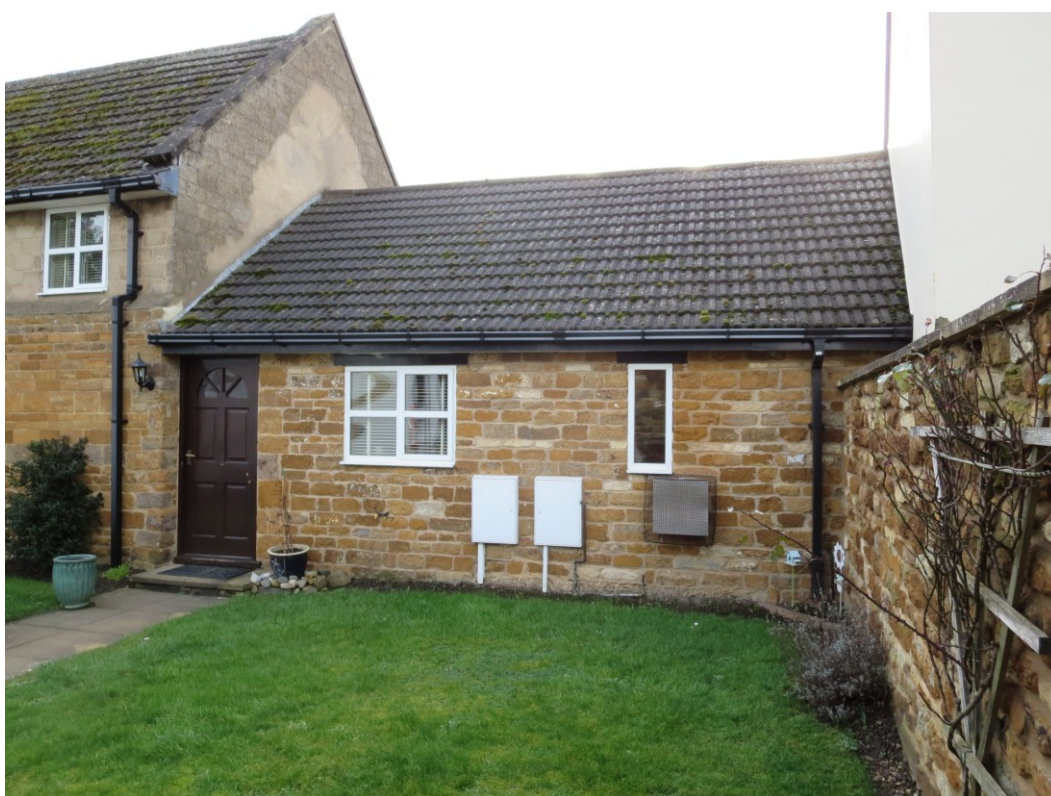
The north side of the west part, with rebuilt wall

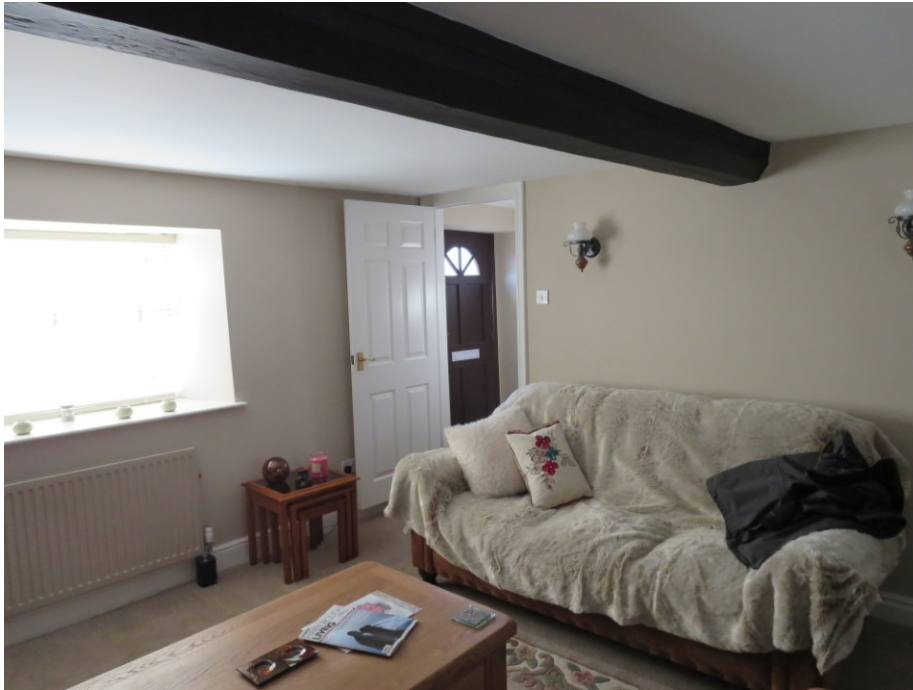
The central room, looking south-west towards the front door

Few early features are visible inside. The E room has a modern fireplace, set in a chimneybreast which projects 250mm – probably of brick. Both the E room and the central room have chamfered spine beams, but with no chamfer stops visible. The winder staircase is set partly within the wall thickness and retains a lower section of C18/19 newel post, but was largely replaced in c.1950. The cross-wall which separates the E and the central rooms is 320mm thick, probably of brick. The spine beam of the central room stops at a 250mm (probably brick) cross-wall, whose E face aligns with the E side of the front doorway. The cross-wall which separates the main E part from the W part is 420mm thick, with a pronounced bow to the upper S part.

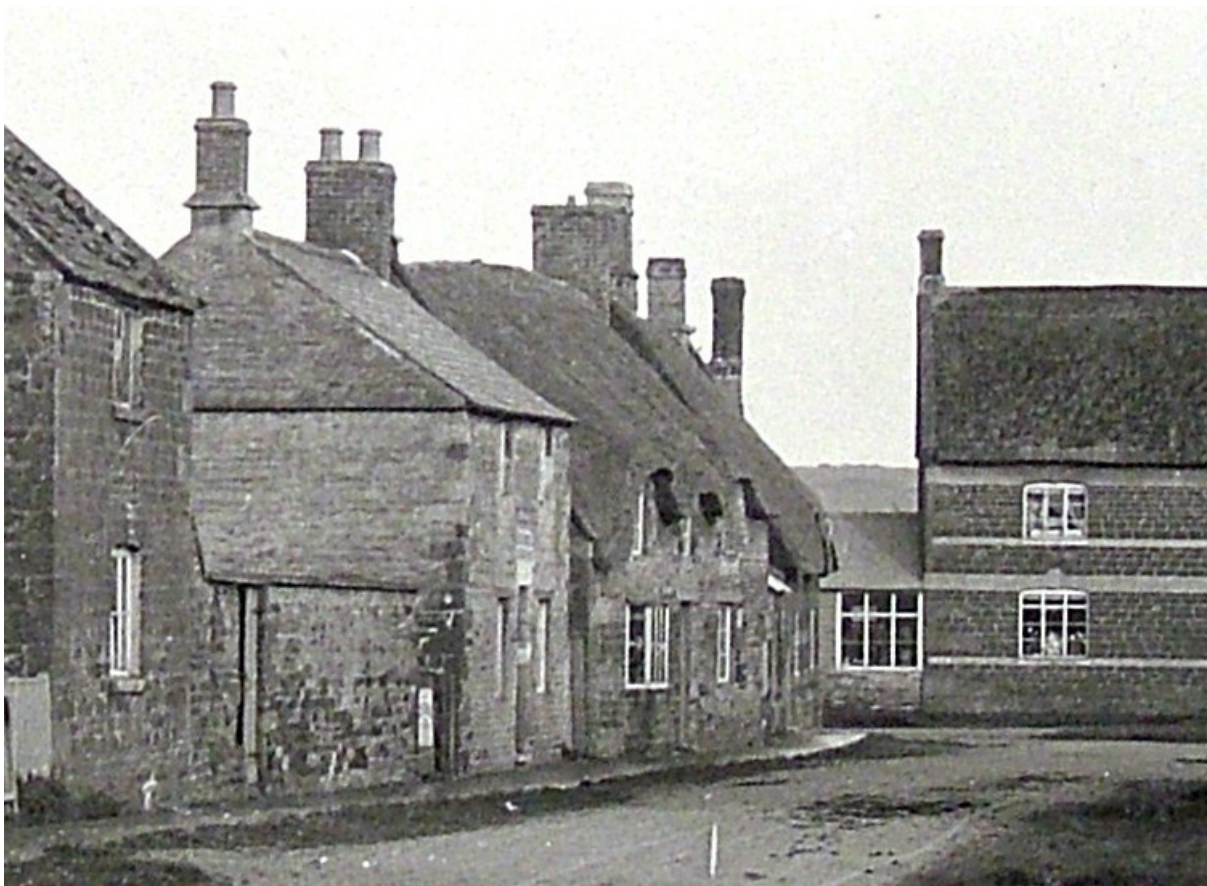
Detail of early 20th century photo, with chimneystack to east gable

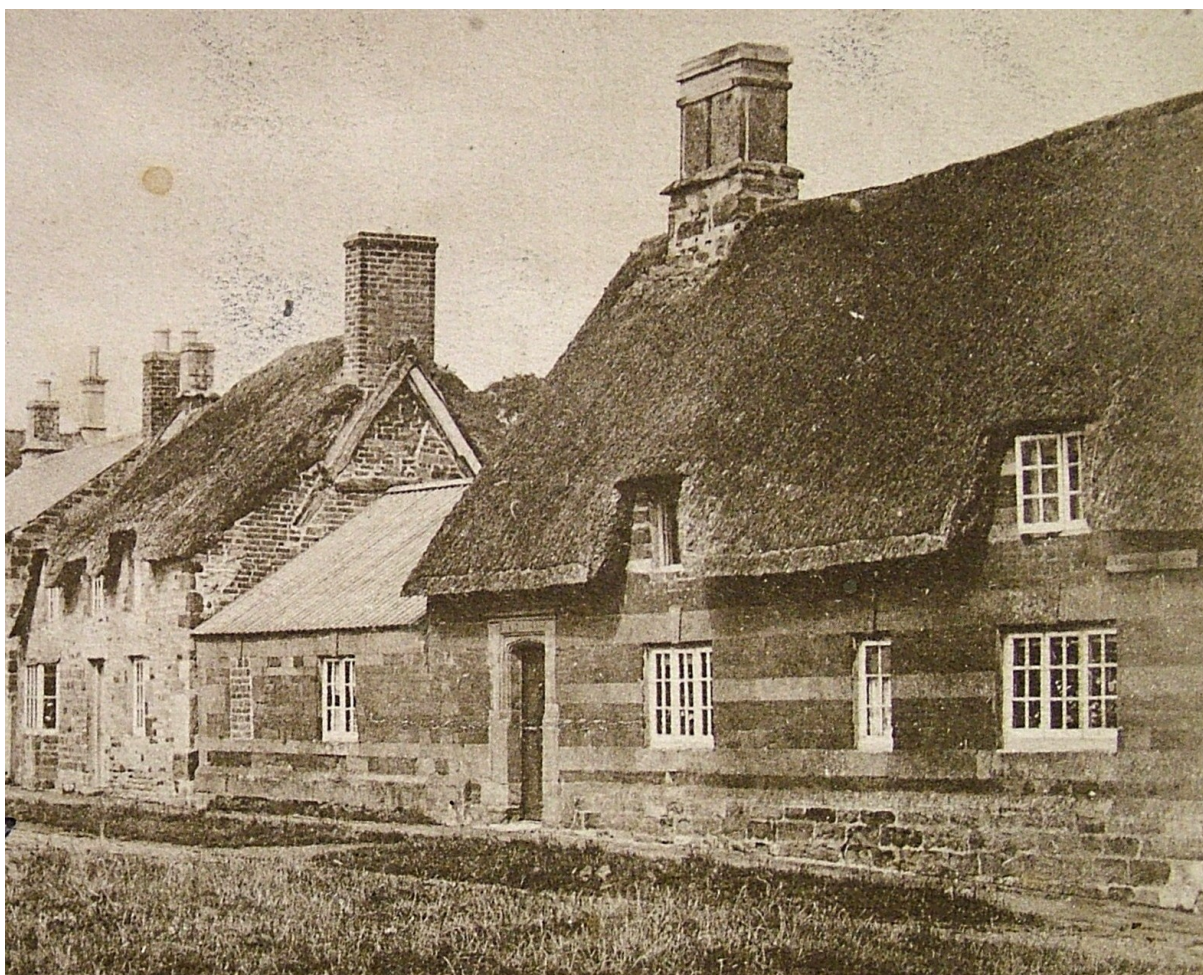
Detail from postcard of c.1910, with west part reduced in height

Early 20th century photographs provide vital evidence of the earlier house. A photo of c.1910 shows the E part before the roof raising, with two eyebrow dormers in the thatched roof. The W part was of a single-storey, with a low-pitched roof of corrugated iron. Partly embedded in the gable of the adjoining house is a roof truss, which indicates that the W part was formerly of the same, 1½ storey height as the E part. The roof truss is of typical local type, of A-frame design with a collar and lapped scissor-crossing at the apex, to carry a square-set ridge. Also visible on this photo is the former central chimneystack. It had a broad ironstone base with chamfered plinth, above which rose two ashlar slab flue stalks. The chimney top has a square-cut projection and blocking course, probably of stone. A key point to note is that the two flues are set W-E (not N-S) and a short distance E of the then-gable end to the W part. This indicates that the chimneystack served one flue to its E and one to its W, and did not form an end gable wall.

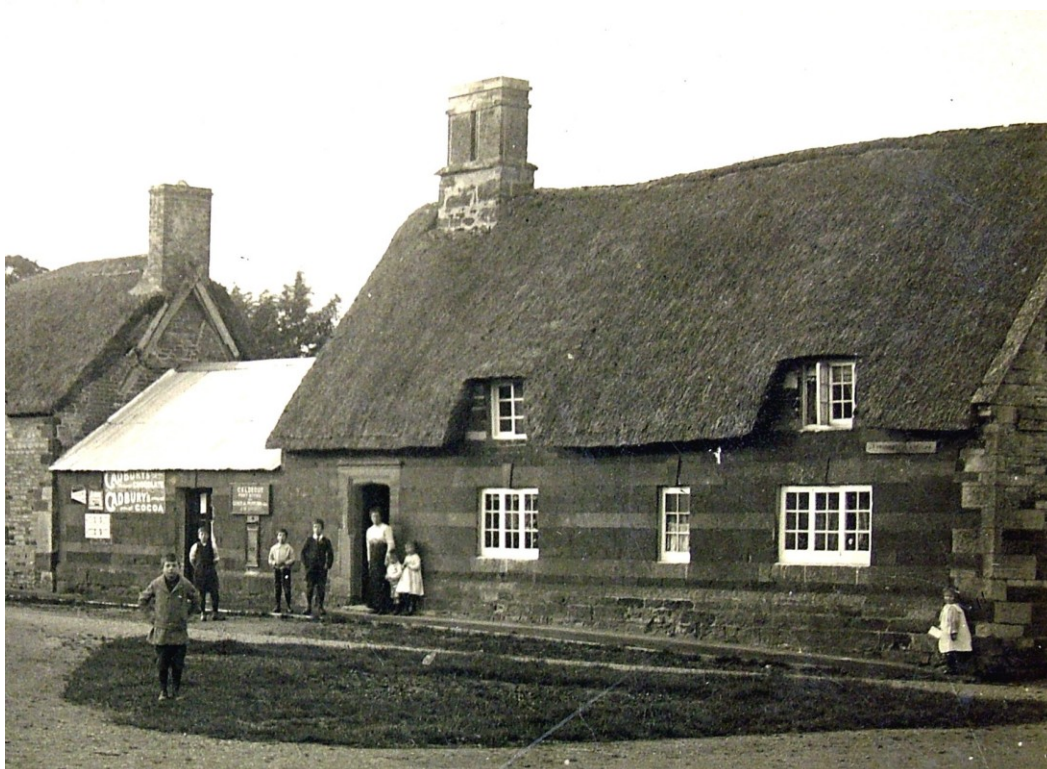
Detail from postcard of c.1920, with village post office in west part

A photo of c.1920 shows the same details, though the gable parapet to the SW corner is also visible, as noted above. By this time, the W part, still with its corrugated iron roof, was serving as the village post office. The E window here had been altered to form a doorway.
