**Lyddington Manor History Society  
Historic Building Survey**

**The Manor House, Mill Lane  
Caldecott, Rutland**

## HISTORIC BUILDING SURVEY REPORT

# MANOR HOUSE, MILL LANE, CALDECOTT

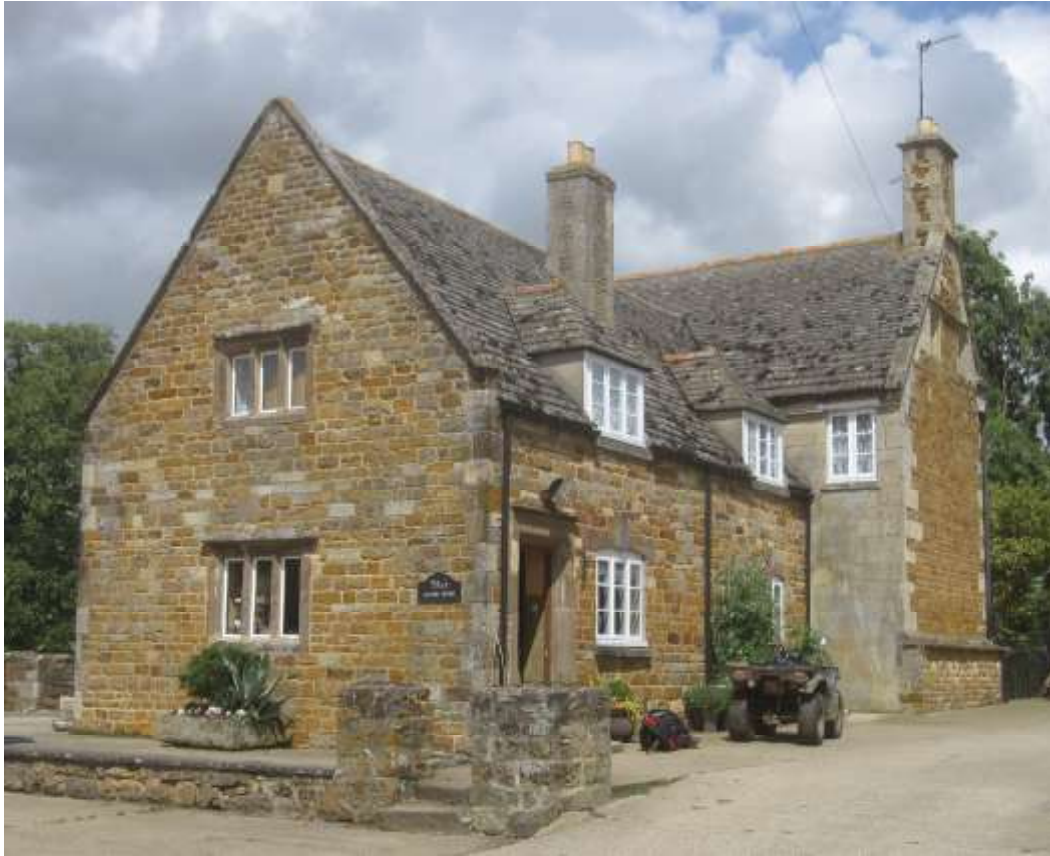
View from the south-west

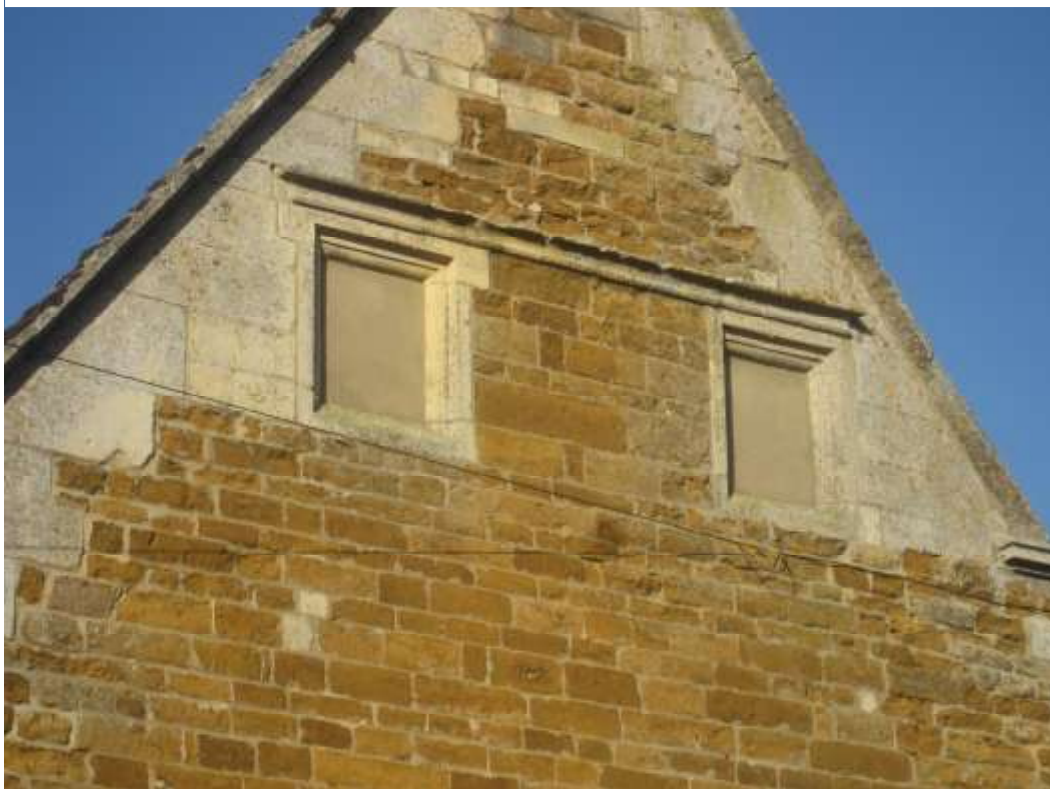
The main range S gable is of coursed ironstone with good limestone quoins. Chamfered ironstone plinth, and blank walling except for two attic windows, also now blocked with brickwork. This pair of windows forms a high quality design feature – single lights of ovolo-moulded limestone, set some distance apart (to allow for a chimney flue up the centre) and linked by a long cavetto-moulded cornice. The gable above has good limestone ashlar dressings below the coped parapet. The W side has a high quality shaped corbel, with big ogee moulding and a small cavetto above. The E side has been raised, for the C19 century parapet to the E front. The gable stack has been rebuilt in 1988, but was formerly a 2-flue stack of limestone ashlar, with chamfered plinth and moulded cornice – similar to the surviving stack at the N gable. The short section of return wall to the W side at the SW corner is, oddly, of high quality limestone ashlar throughout (except where refaced in render near the bottom). At the top, set just below the gable corbel, is a cavetto-moulded string course, which would originally have formed the roof eaves, though the eaves has been raised later. An inserted C19 window also cuts through the string course. The ironstone plinth of the S gable is cut off at the corner, and does not return onto the W return wall.

The linked attic windows to the south gable of the main range

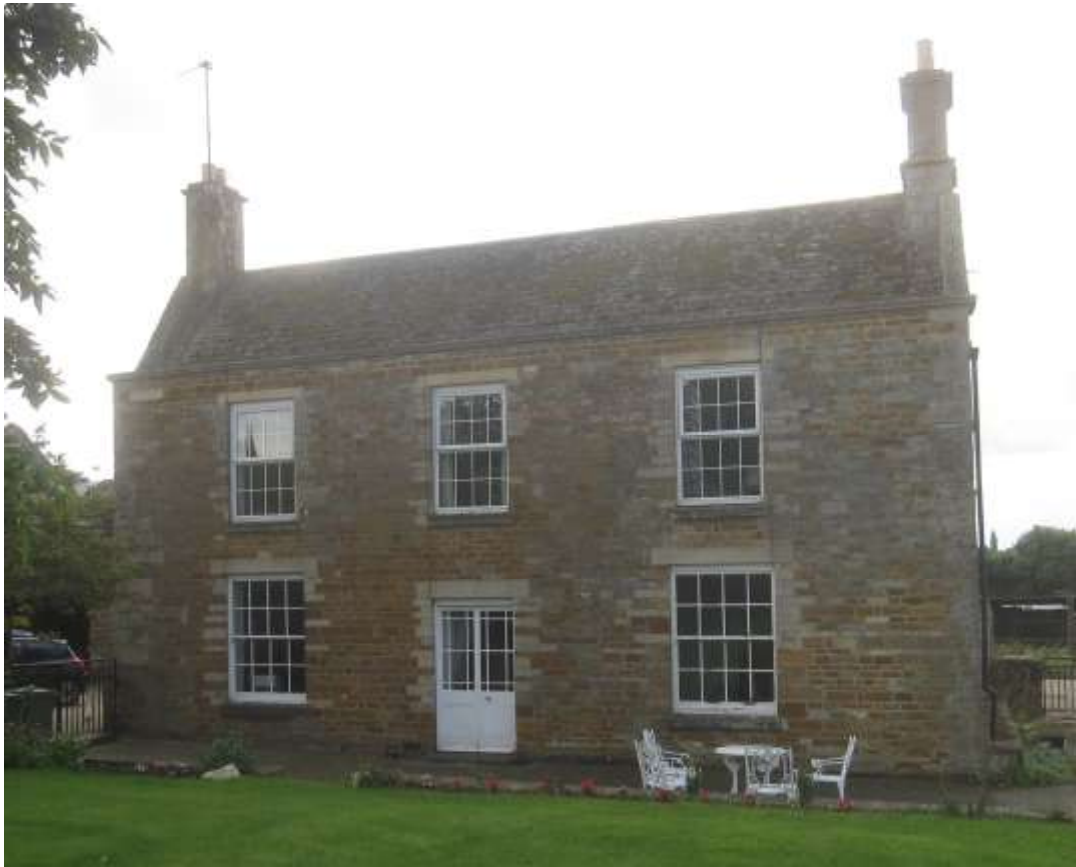
The E front of the main range was rebuilt in the C19. It now has a symmetrical double-fronted appearance, with a central doorway, large sash windows and a stone-coped parapet. The plinth of the S and N gables is cut off at the corners, and does not continue along the E front. Central double doors, the upper half glazed, with margin lights. Some of the windows have been replaced, but the two ground floor ones have 8/8 sashes with horns. At high level towards the N one course has brick on edge, rather than coursed stone. The stone lintels over the openings are replacements of c.1980. Near the SE corner at ground floor level is a blocked opening, with limestone surround, of a C17 ingle window, which would have provided light to a large inglenook fireplace inside. Straight-jointed scars between the central door and the N windows indicate a former abutting wall. An additional block is shown to the E here on the 1800 enclosure map, though had gone by the time of the 1886 OS map.

The east side of the main range

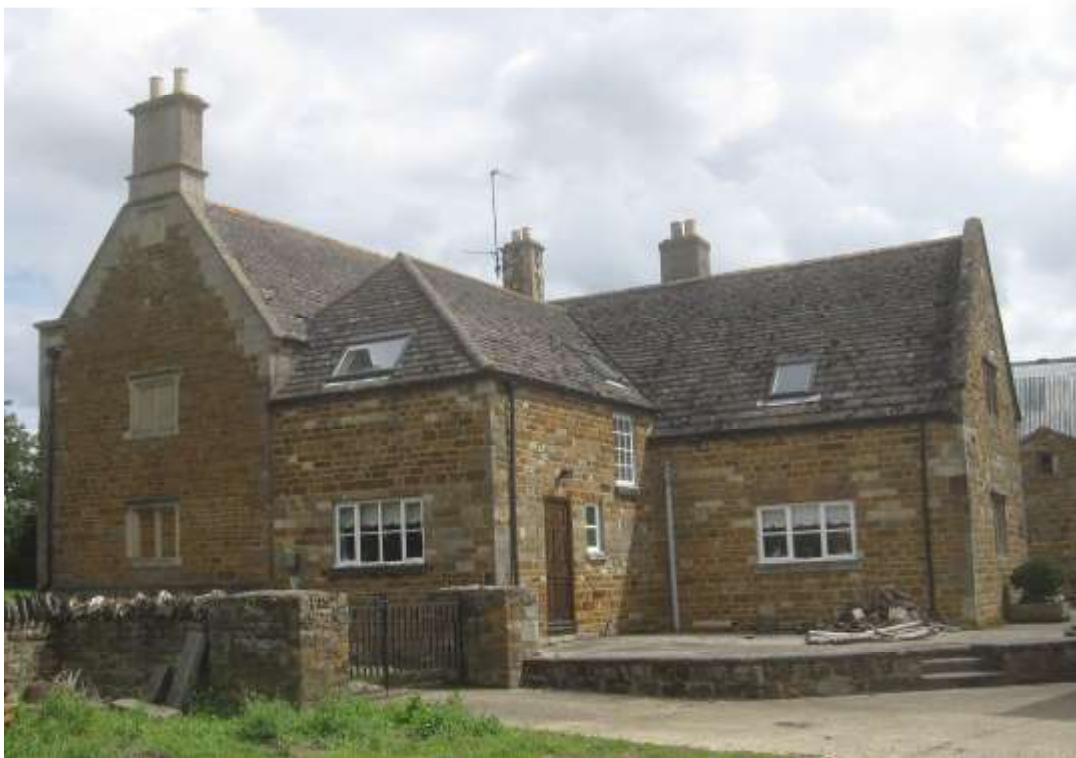
To the NW there were formerly various extensions, largely rebuilt in 1988. A stone-walled block, largely single storey, was set to the W of the main range. Part of this had an upper storey above, built of brick with a flat roof. A two storey brick extension, also flat-roofed, housed the main stair, with a tall stair window. To the W of the front range was a single storey lean-to of brick with the Welsh slate roof (demolished in 1988 and not rebuilt).

View from the north-west

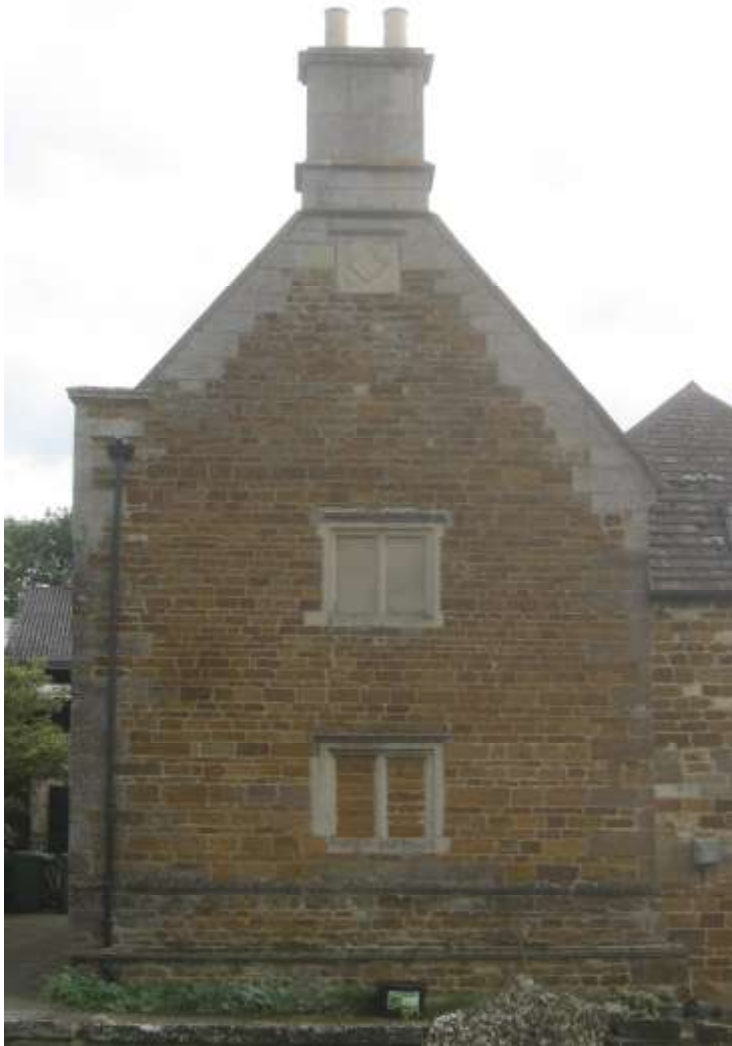
The N gable has a chamfered ironstone plinth like the S gable, which returned at the NW corner onto the W wall (though this is now covered by an extension). Blocked C17 window at ground and (original) first floor level, 2-light ovolo-moulded limestone, with cyma cornices. Good ironstone quoins, and a high quality gable parapet, with limestone ashlar blocks below it. The E side has been raised for the C19 parapet, but the W side preserves the kneeler and corbel, with the same moulding as that to the S gable. At the top is a large date-stone panel, with sunk spandrels, a central raised lozenge and a cyma cornice over. The date, legible when viewed (see photo) from scaffolding in 1988, is 1696. Above are 3 initials, the top central one unclear (?G), and the two lower ones J and E. Above is a good two-flue stack of limestone ashlar with chamfered plinth and cyma cornice.

The north gable of the main range

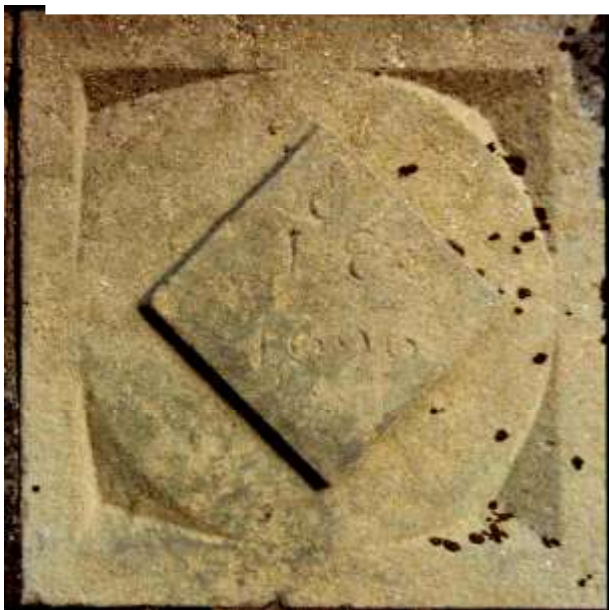
The main range was then added in 1696 (as date-stone), truncating the earlier front range and at a slightly skewed angle. Although the main range has been much altered, its features are consistent with the date-stone, and indicate a high quality building phase, with fine masonry features to both surviving gables. The S room would have been the hall, with a large inglenook fireplace on the S gable lit by an angle window to the E. The N room would have been the parlour, probably with a smaller corner fireplace, as indicated by the 2-light window in the centre of the N gable. The central section of the main range may have been the location of the stair, rising to ground floor and attic levels. The first floor has been entirely replaced at a higher level, but would originally have had two main bedchambers, both probably with fireplaces (as indicated by the two-flue sized chimneystacks). There was also an attic floor, as is evident from the pair of attic windows to the S gable and the arched collars of the two trusses, which allow headroom. There may have been dormer windows to provide lighting to the N end, though the attic may originally have had no partition divisions. In this phase, the front range would have continued to serve as the kitchen.

Date-stone to the north gable:

?G  
JE  
1696

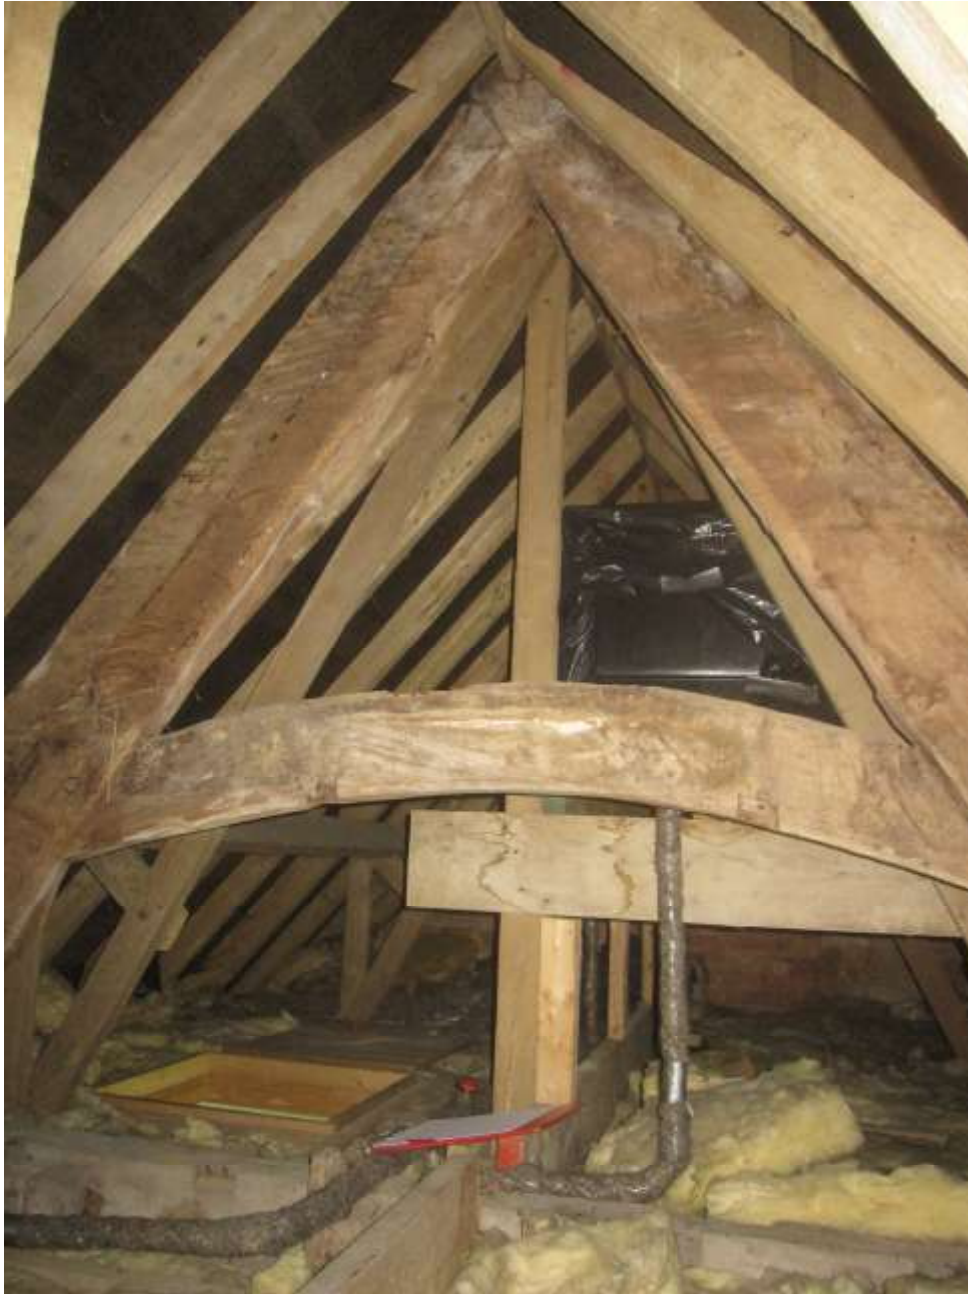
The roof had two A-frame trusses with collars, supporting side purlins and rafters, with no ridge beam. Truss T1 to the S has principal rafters of curved shape and an arch-shaped collar, lap-jointed and pegged to the principals. The purlins here were carried on the ends of the collar. The truss has whitewash on both sides right up to the apex, so was previously open to the attic room. It was also previously closed with infill, but this was probably not original. Truss T2 to the N has similar principal rafters but the collar is tenoned, not lapped, and the purlins here were tenoned to the principal rafters. The collar has a sweeping arch shape, though the arch is less pronounced than to T1. The top triangle of T2 retained an infill panel, of which traces now remain. The purlins were c.150x150mm in section, with spliced scarf joints beside truss T1. Rafters were of squared oak c.65 x 70mm, with pegged bridle joints at the apex. Although the roof is unusual in having trusses of two rather different types, it does all appear to have been of a single phase, dating no doubt from 1696. The current ceiling was inserted in the C19, with tie-beams also bolted onto the two trusses.

Roof truss T2 to the main range

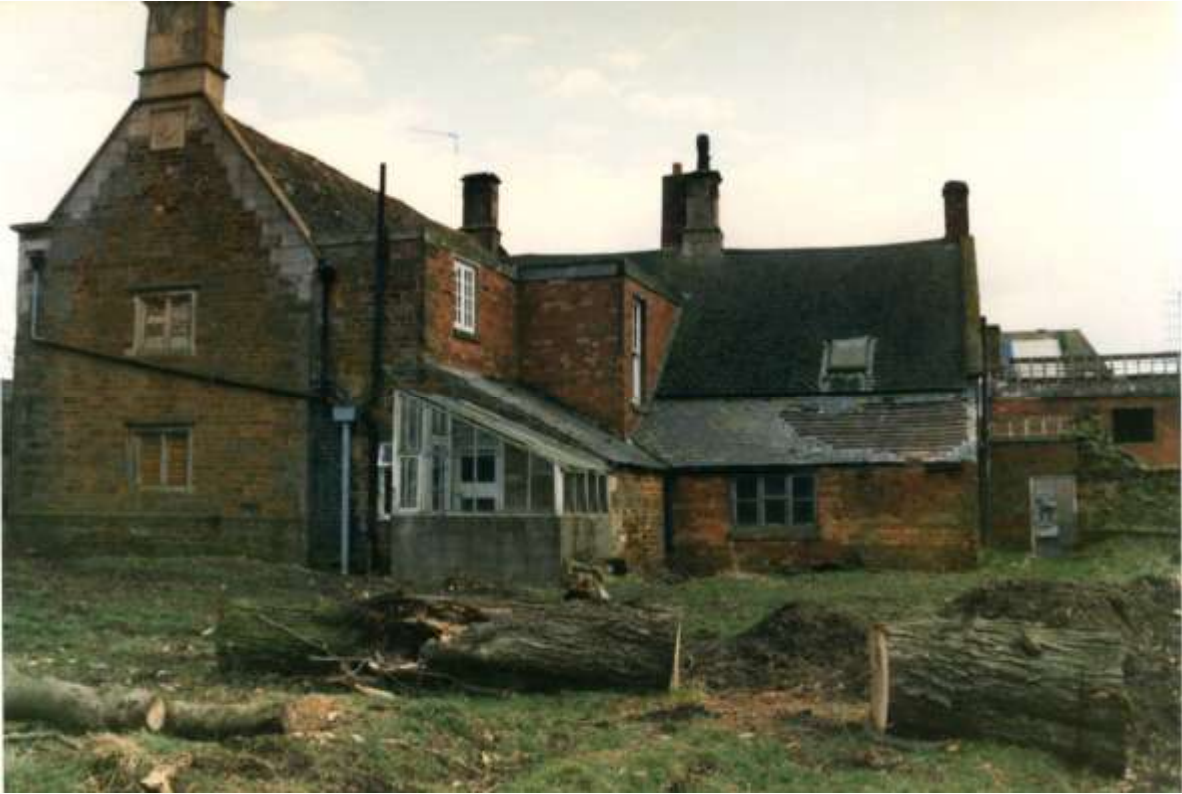
View from the north in 1987

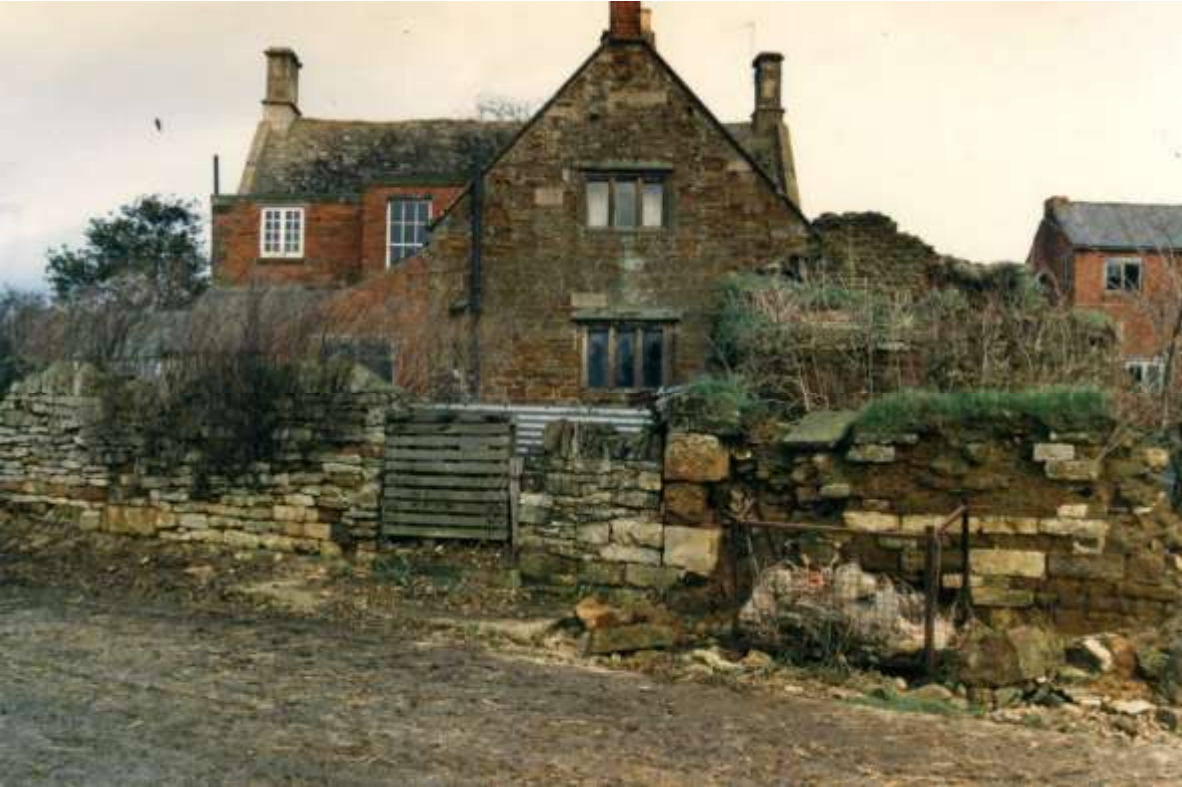
The front range is of one and a half storeys, and the main range, set at right angles to the front range, is now of two tall storeys. The front range was taken down and rebuilt in 1988, but survey plans and photos taken before the rebuilding provide good evidence of the original structure.

View from the west in 1987 before rebuilding of front range

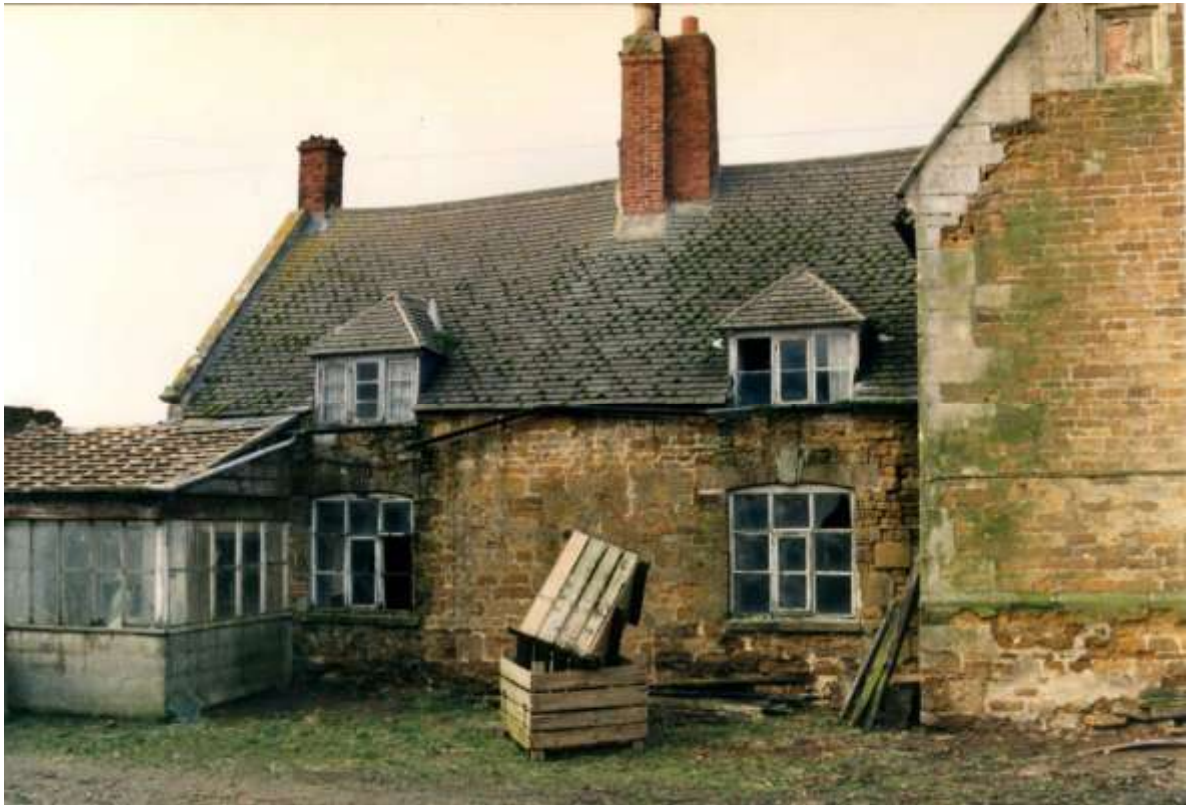
The front range S wall has coursed ironstone walling with some courses of large blocks. Doorway to the W end, ironstone, with moulded jambs and flat head (height increased in 1988), and cyma cornice. The listing description of 1975 notes an 'old 2-panelled door' here. Two windows with ironstone cambered arches with keystones. Two dormers over. The W gable has good quoins and a gable parapet with kneelers which have eroded finials. The gable parapet now rises to an apex, but formerly had a

seating for a brick chimneystack. Ground and first floor windows of ironstone, 3-lights, ovolo-moulded externally but plain chamfered inside, with quadrant cornices. The N wall has been rebuilt, and was previously covered by a C19 lean-to brick extension. The chimneystack to the front range has been rebuilt, but there was formerly a stone stack of ashlar with a chamfered plinth and cornice, to which two brick flues had been added.

The south side of the front range in 1987 before rebuilding

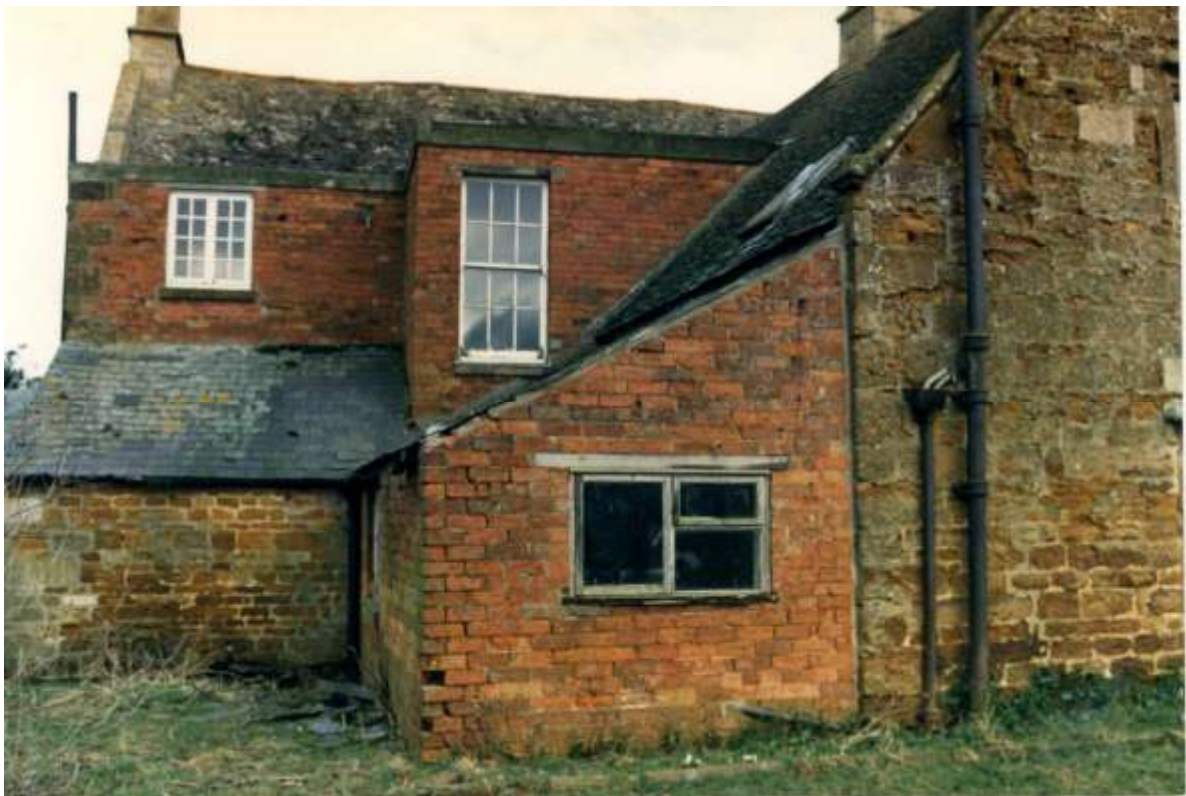
View from the west in 1987

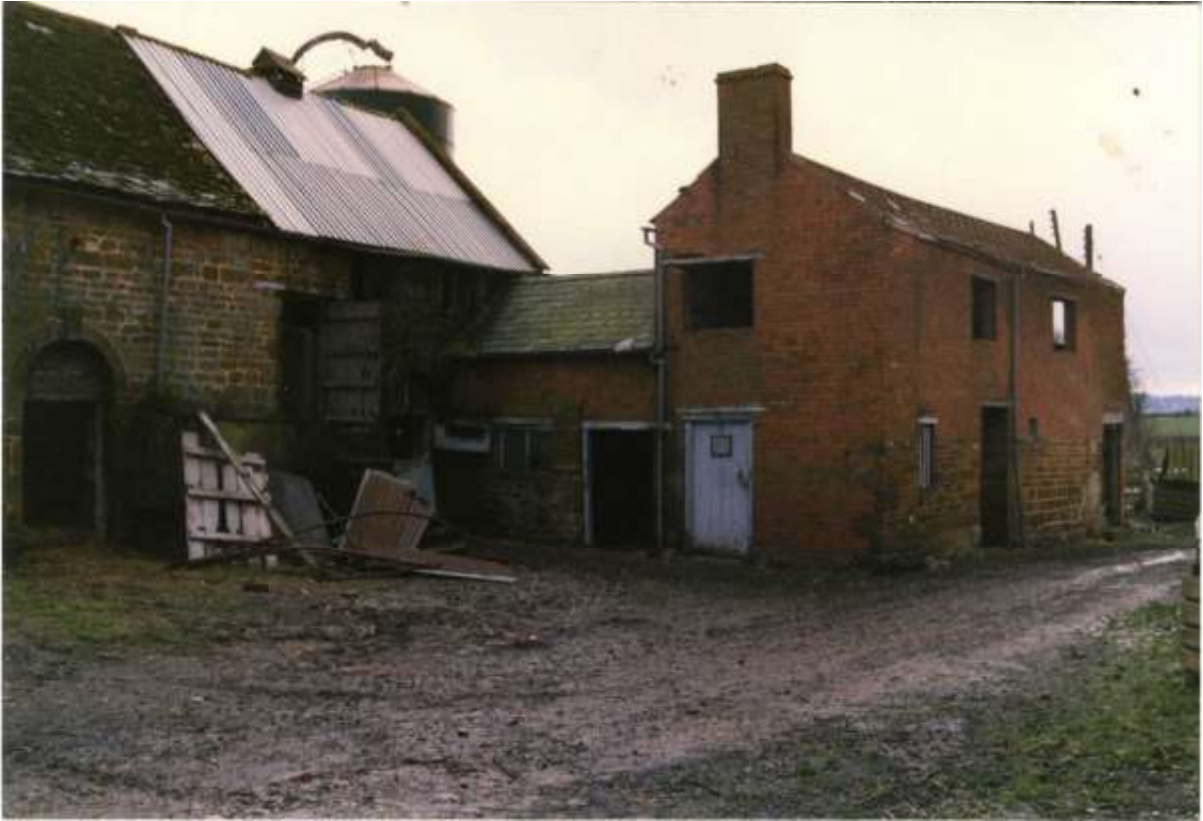
To the S of the house is a fine stone-built range with a barn and stable. The barn is of 4 bays, with large entry door and smaller rear door toward the SE. The SW part of the barn, unusually, has an additional doorway, with a semicircular stone arch and keystone. Although there is now a concrete block partition separating this SW section from the main part of the barn, there does not appear to be any evidence of an original subdivision, and there is no window here as would be necessary for stable use. Between the barn door and the arched door there is a loading hatch, at high level. The range continues to the SW, with a further compartment, entered by another stone-arched doorway. This section was a stable, with a hayloft over, approached by a set of stairs (now missing), which were partly external. The jamb of a window survives in the W corner, and the SW gable has been rebuilt, with a brick inner face and a re-set 3-light ironstone window check type. Old photos, the cut-off window opening and the roof truss position (now off-set) indicate that the range previously extended somewhat further to the SW. The roof is original, with tie-beam trusses and two sets of tenoned purlins to each side. The style of the arched doorways suggests a date of around 1750-1800.

The 1800 enclosure map shows the barn range with two projections to the NW forming a U shape. The N projection seems to have been replaced, in a slightly different location, by the current two-storey brick outbuilding of c1850-80, which wraps around the NW corner of the barn. Parts of stone walls which probably represent the other projection, to the S, can be seen on photos of 1988, by then absorbed within a brick building of c.1850-80. This extension was taken down c.1988 and rebuilt in stone in a different form and further NE. The 1886 map also shows a dotted circle outside the front of the barn – probably a horse-driven ‘engine’ for threshing etc, which would have driven machinery within the barn.

View of the barns from the north in 1987 before rebuilding

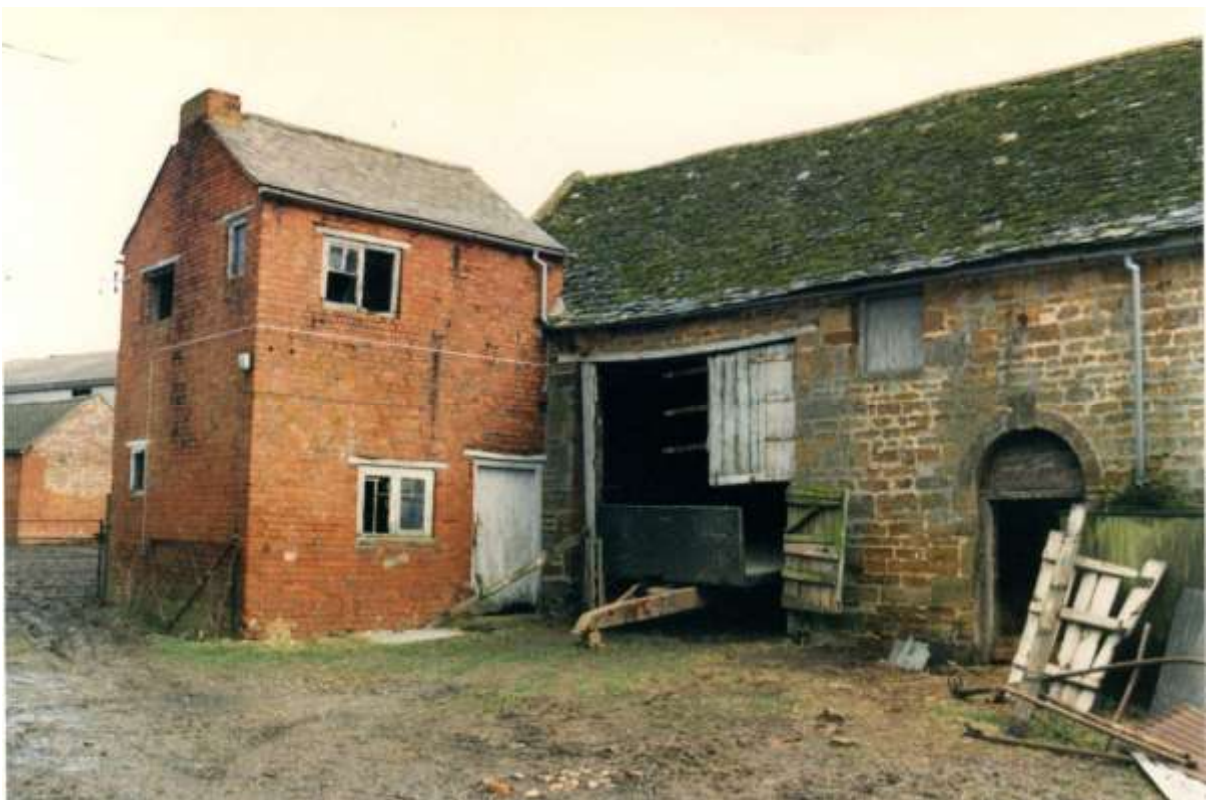
The barns in 1987
