**Lyddington Manor History Society
Historic Building Survey**

**Priest's House, Church Close
Caldecott, Rutland**

THE PRIEST'S HOUSE, CALDECOTT

Date(s) of survey: 27 June 2011
Surveyed by: Nick Hill

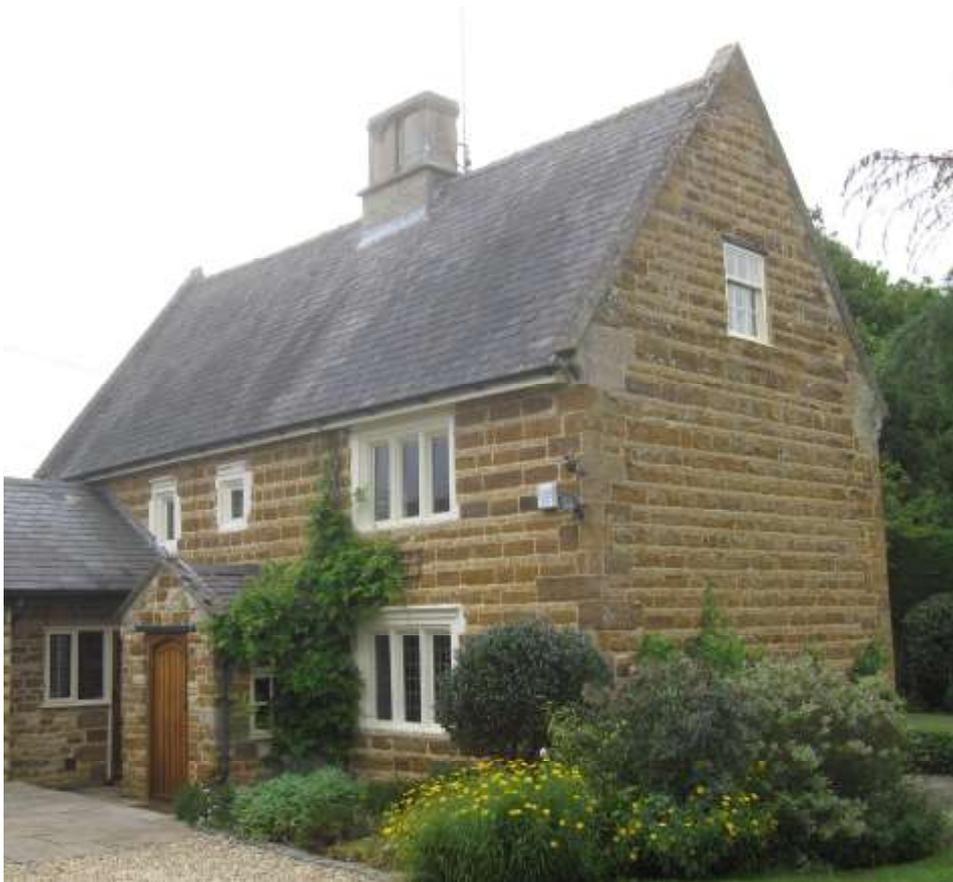
This is a high-quality house probably dating from the first half of the 17th century, with an unusual lobby-entry plan form. On the ground floor there is a hall and parlour, separated by a large central chimneystack, with two main bedchambers (both unheated) on the first floor. The masonry is of excellent quality, with precisely laid alternating courses of ironstone and limestone, and many moulded stone windows. The floor structures at first and second floor level are also original and of good quality, though the roof trusses resemble those found in houses of lesser status or later date. The location of the house, set well back from the street frontage, and with the farmyard at the front, is very unusual in the area.

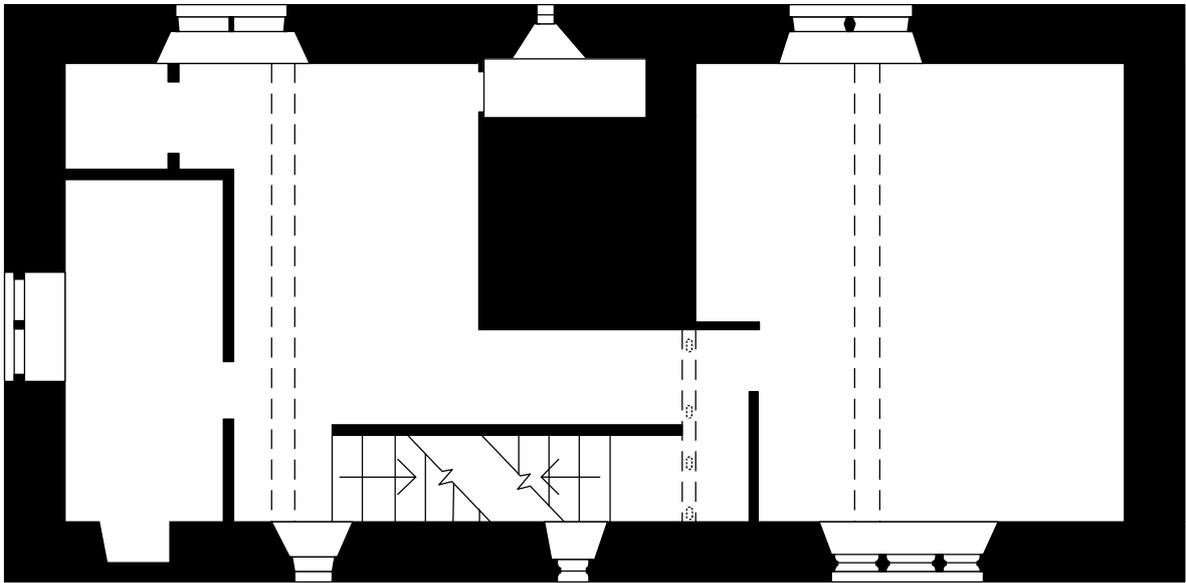
FIRST FLOOR

First floor has two main chambers originally, with various modern partitions. Each chamber has a transverse ceiling beam (the roof truss tie-beam), with chamfers and big ogee stops, and good quality original joists for the attic floor above. The N chamber has a so-called 'priest's hole', a small cupboard at the E side of the central chimneystack. This is in fact just a small closet, set about 1m above first floor level (to clear the large ingle fireplace below), and lit by the tiny round-arched stone window. It has an early oak door frame with pegged joints. In the NW corner, evidence indicates there was another small window, with a stone jamb visible from the outer W side.

The first floor had no fireplaces. An oak beam at the SW corner of the chimneystack has mortices for a former timber partition. This would have separated the original stair from the S chamber, though the doorway opening seems to have been only 650mm wide.

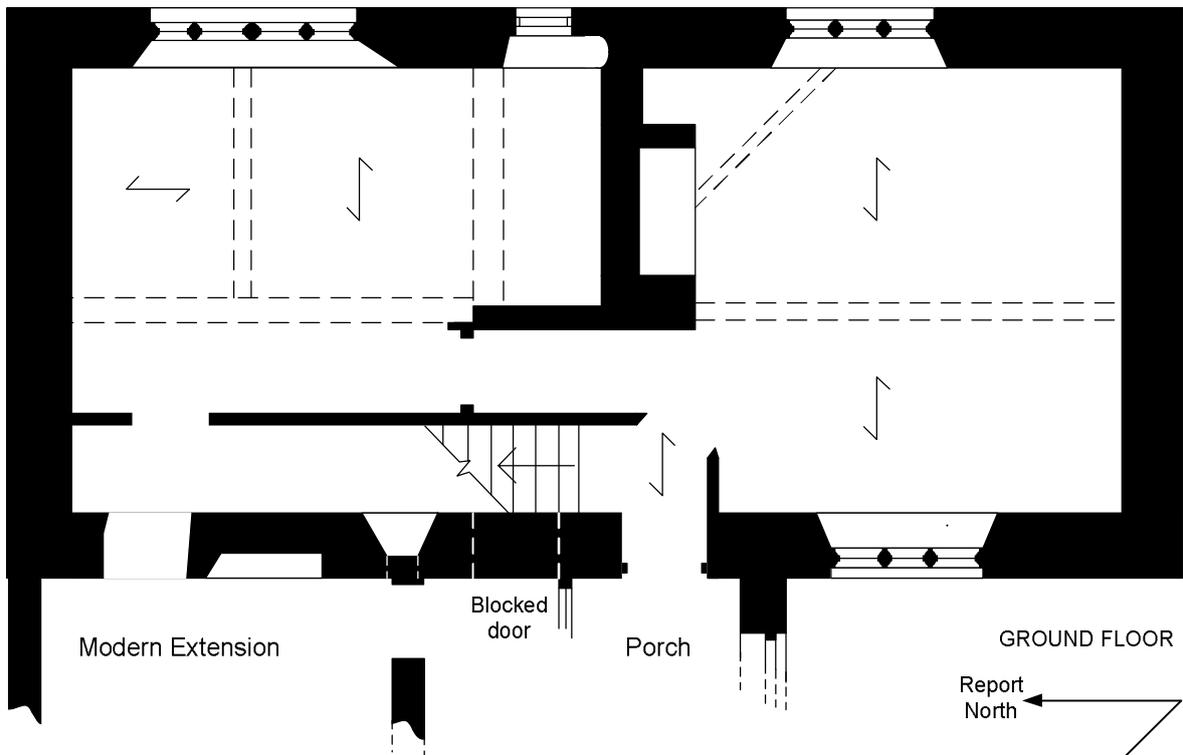
GROUND FLOOR

Two-room plan with large central chimneystack and lobby entry. The N room with the large fireplace was the hall, with the parlour to the S. The original position of the front doorway is unclear, as there is a blocked doorway, as well as the current doorway. But both of these opened against the stack. The stack is set back to the E, probably allowing space for an original winder stair in the lobby entry area.

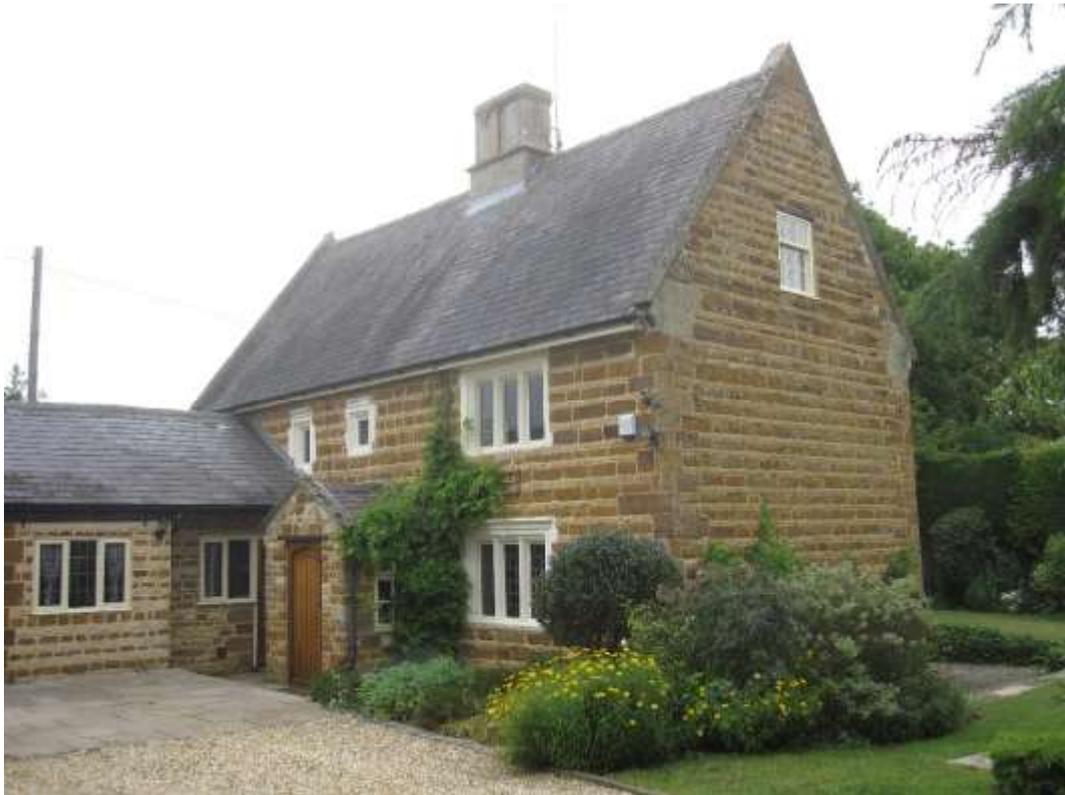
S gable is blank except for modern inserted timber window to second floor. The upper gable has moulded corbels, kneelers and gable parapet, with roll-moulded apex. The corbels have an unusual moulding, a bold ogee with a lower roll-mould, the whole with a slight taper from top to bottom. Many ironstone quoins have been replaced recently.

View from south-west

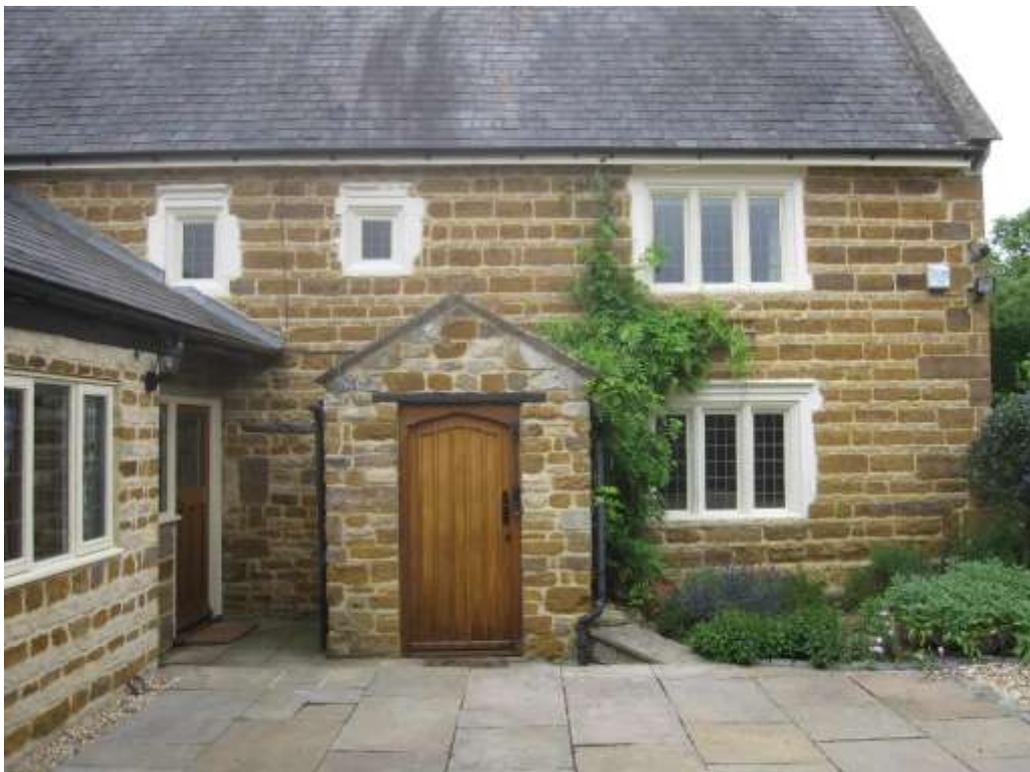
Two storeys. Front W wall is partly covered by later outbuilding and porch. The porch, behind which is the centrally-set front doorway, is a modern addition, though it has stone walls, gable parapet and low-pitched roof of Welsh slate. To S of the porch is a 3-light ovolo-moulded window with cavetto-moulded cornice. A similar 3-light window is set symmetrically above, on the first floor. On the N side of the porch is a blocked doorway opening, with irregular ironstone jamb blocks to the L and plain timber lintel; the R jamb is covered by the porch. Two small single-light stone windows to first floor, ovolo-moulded with cavetto cornice.

Central two-flue chimneystack, limestone ashlar. Splayed plinth with unusual rounded moulding to front edge. Two separate flues above plinth, with architrave above. The architrave has two stepped fasciae, with shallow concave moulding. The upper part of the chimney (which would have had a plain frieze and moulded cornice) has been lost, replaced with a plain blocking course.

The west front

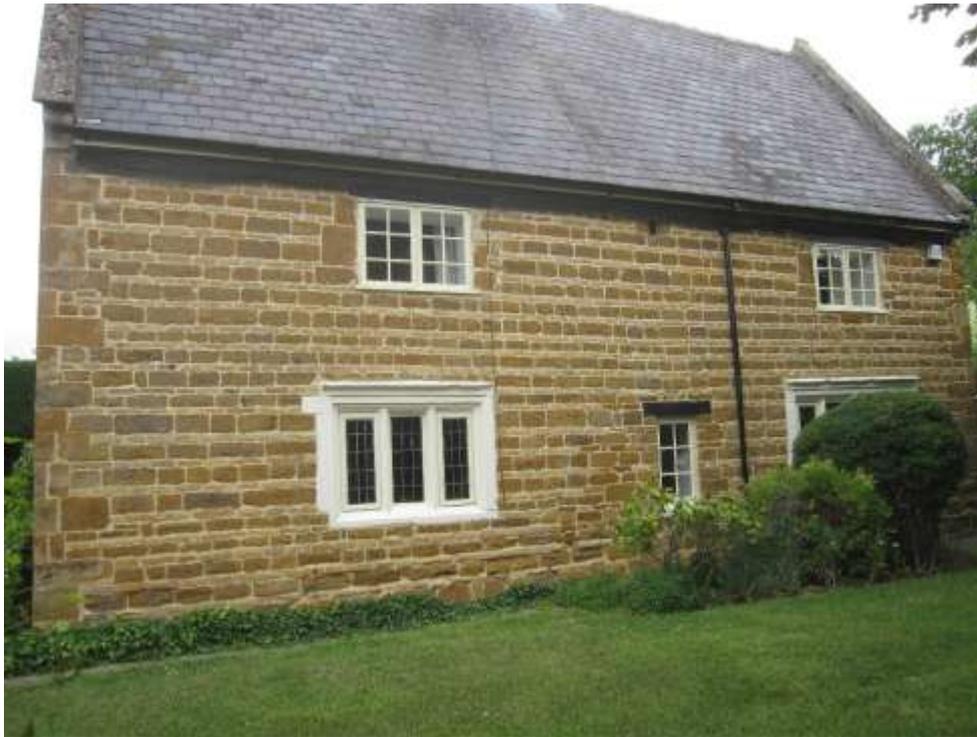
E rear wall has 3-light window to ground floor S and a 4-light window to N, both with same moulding as elsewhere. Between these windows on the ground floor is a smaller window with stone jambs; the masonry and modern plain lintel indicate this is an enlargement of an earlier, smaller in-gable window. On the first floor, two modern timber windows, with large irregular stone jambs to the S and modern stone jambs to the N; these seem to have been smaller windows originally, and of timber with stone jambs, not the stone-moulded type used elsewhere. Between the first floor windows is a tiny window with ironstone jambs and round-arched head.

The rear east

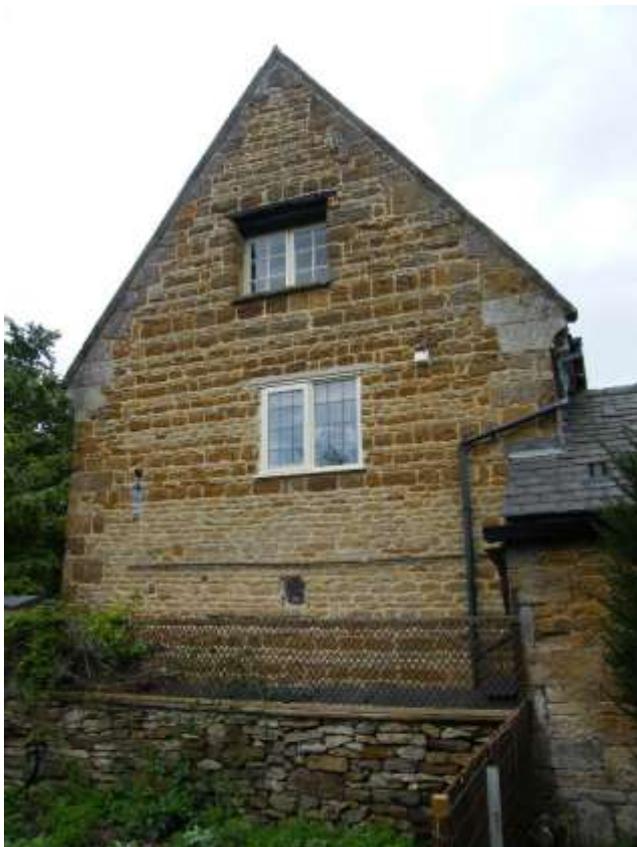
N gable has stripe-work except for a section of limestone rubble around first floor level, where the end of a first floor beam can also be seen. Upper gable as to S, with moulded corbels and gable parapet. Inserted window to first floor, with earlier opening to second floor.

The north gable

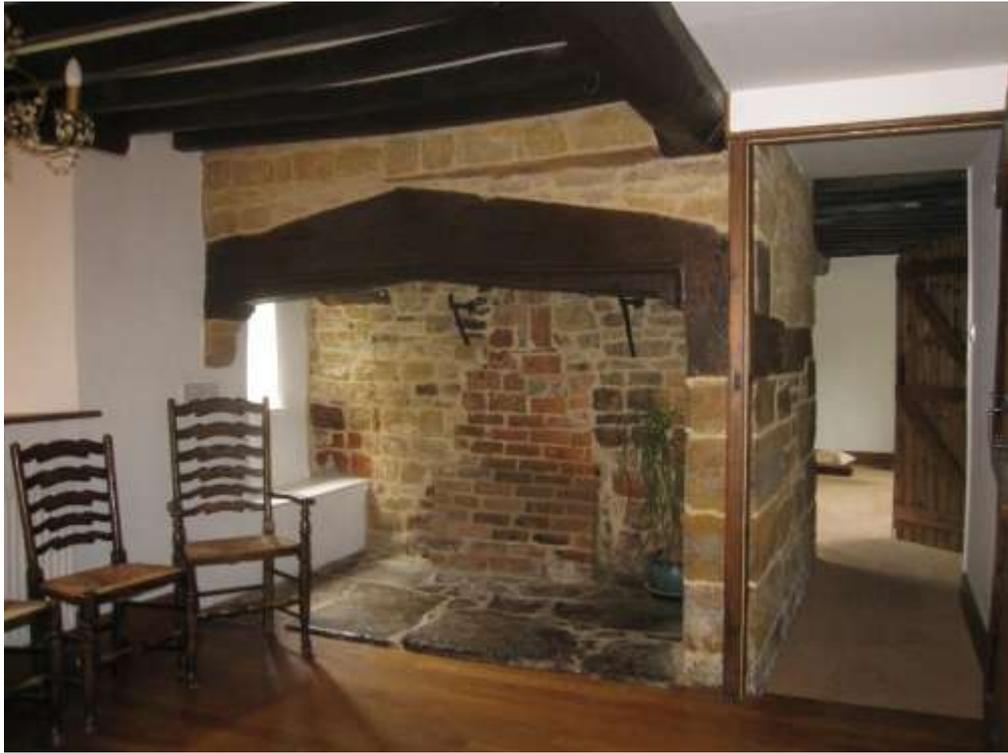
N room (hall) has large in-gable fireplace with fine beam, 4-centred moulded arch. Burnt, curved stonework to the E fireback indicates a former copper or bake-oven; two large iron brackets survive. Spine beam with deep (120mm) chamfers, big ogee stops. Original joists with small chamfers, haunched tenon joints to spine beam. To NE, mortices survive in the spine beam and window lintel for original joists, but a trimmer was later placed here (probably for an inserted stair), with later joists running N-S.

The hall, with inglenook fireplace

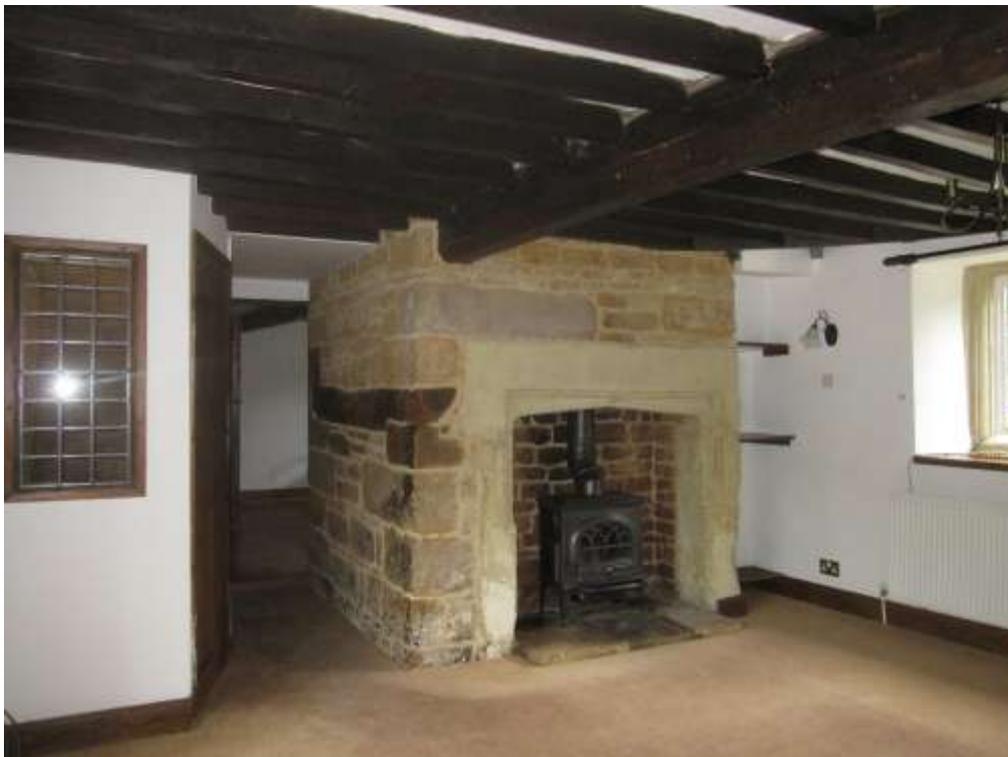
S room (parlour) has a good-sized limestone fireplace with 4-centred moulded arch, and moulded jambs with high-set stops. Spine beam with large chamfers (85mm), no stops to N and square-cut seating to S. Original joists, as to the hall. In the NE corner is an oddly located diagonal trimmer. This is an insertion, but its purpose is unclear.

The parlour, with stone fireplace

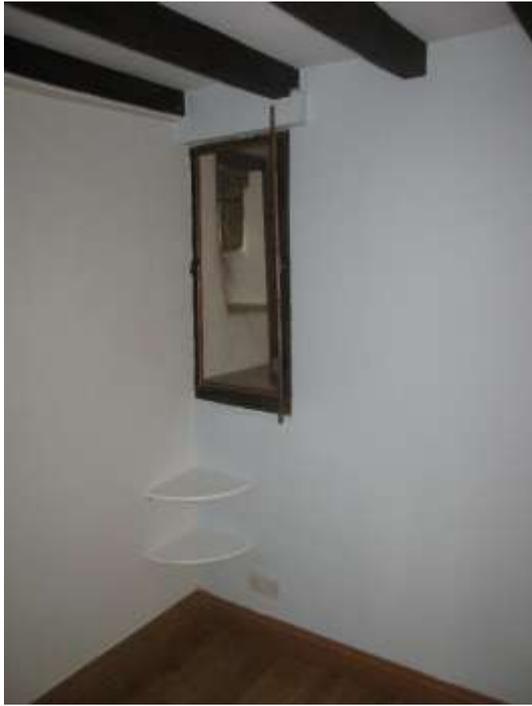
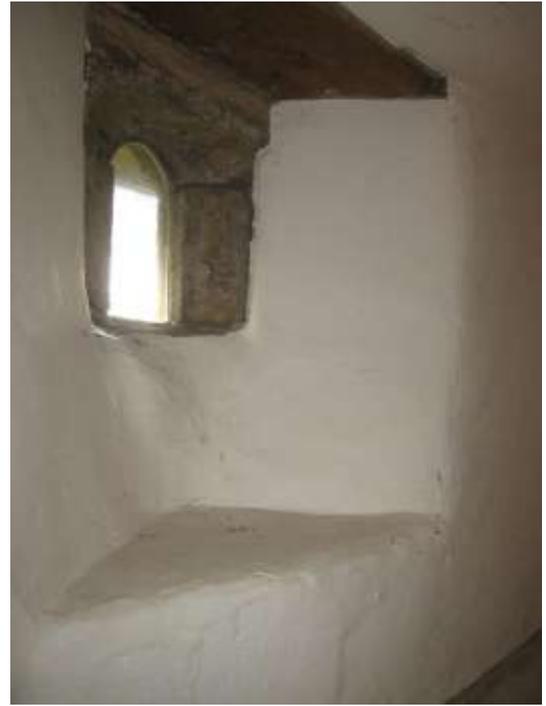
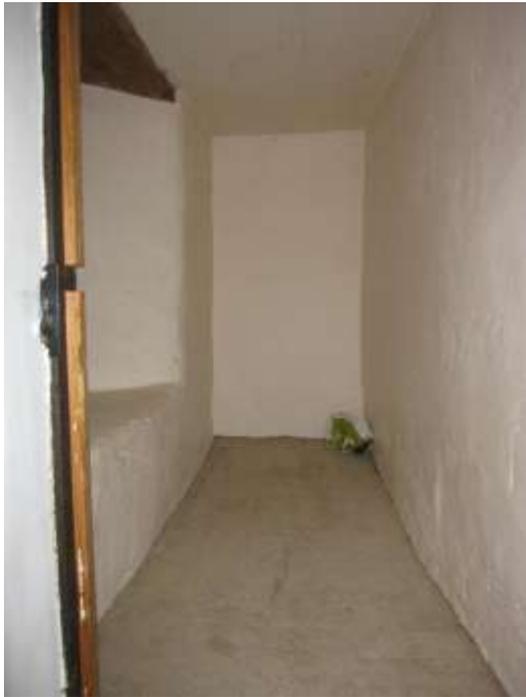
The cupboard to the first floor north bedroom

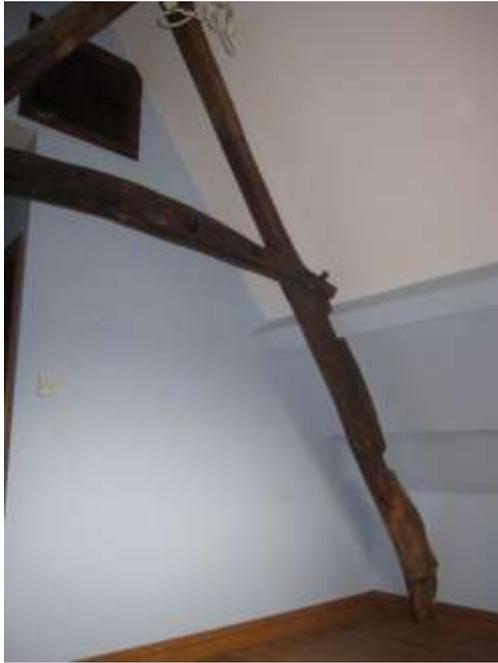
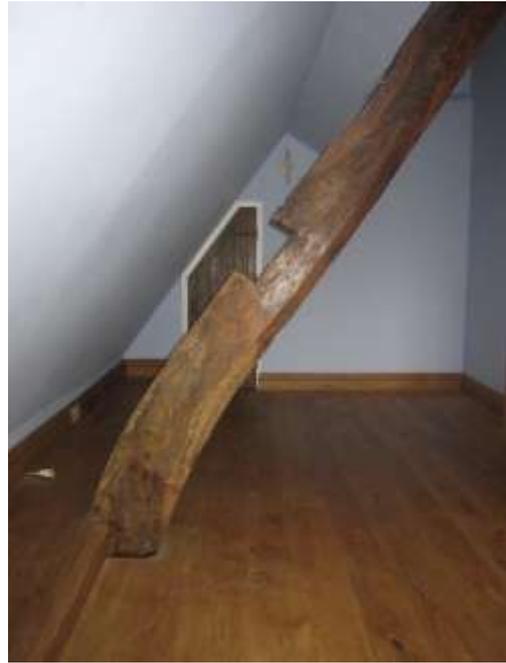
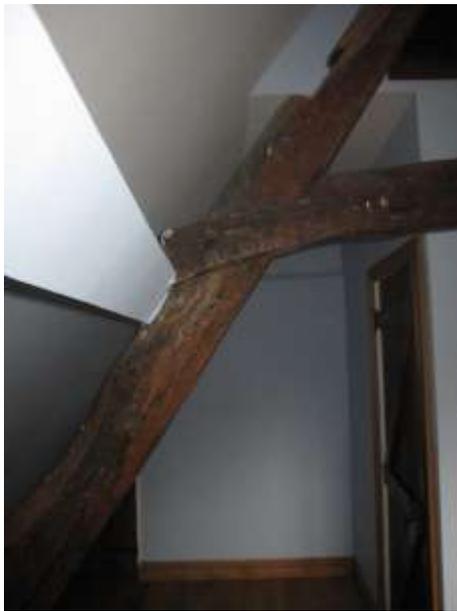
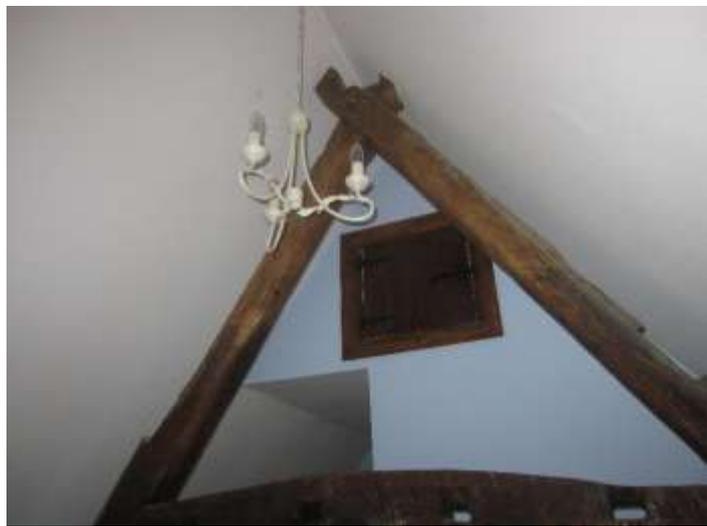
Two trusses with tie-beams and collars. Truss T1 to N has principal rafters with curved feet, but truss T2 principals are straight. Crude dovetail-lapped collars with skew pegs. Apex has scissors crossing with square-cut seating for ridge (now missing) and skew pegs. Trenches to the back of principal rafters for 2 sets of purlins (now missing). Later over-roofing of 20th century in softwood. No original rafters or purlins remain. Possible burn marks to truss T2 – check further.

Details of roof truss T1 to north

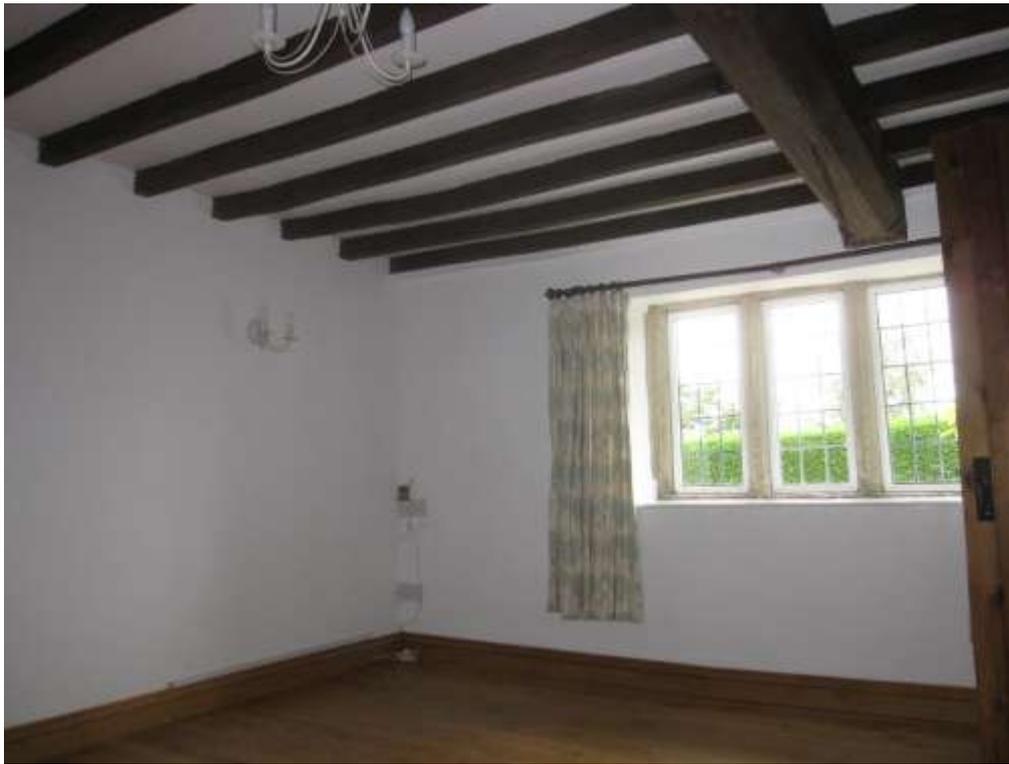
The first floor south bedroom, looking south-west

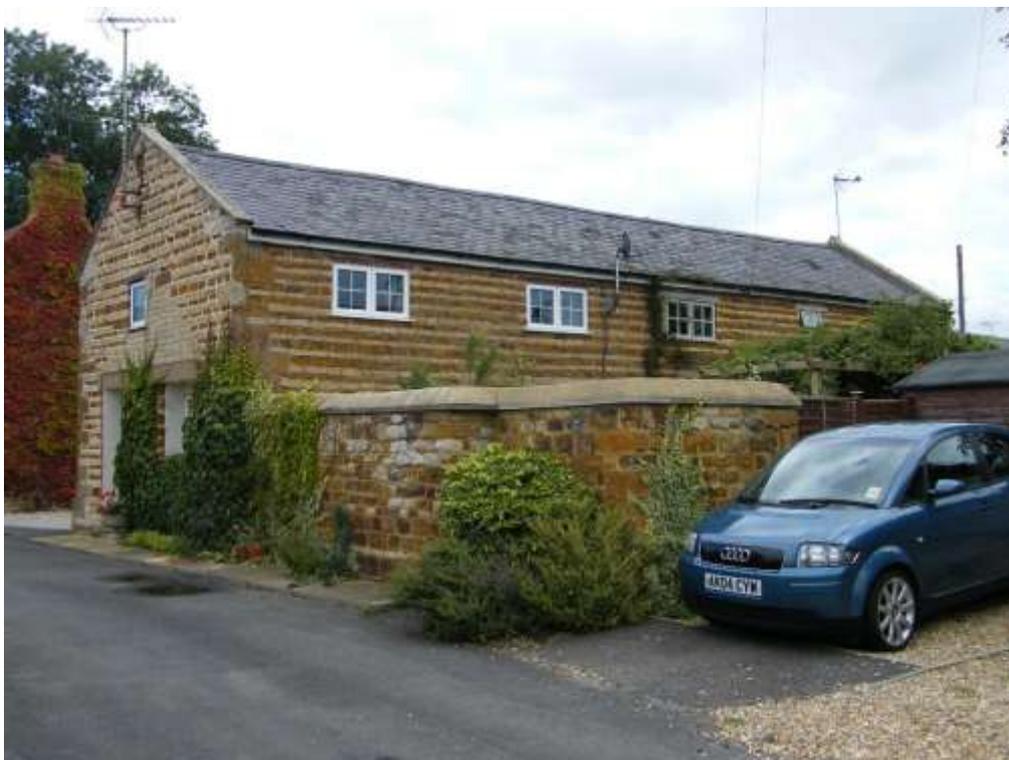
The extension abuts at the W end against an earlier farmyard building, shown on the 1800 Enclosure Map. This appears to have been a large barn, with fine stripe-work masonry to the front E gable and S wall. It seems to have been re-formed in the 19th century, perhaps extended to the E, and fitted with a Welsh slate roof at around 30° pitch. (The barn is in separate ownership and was not inspected in detail.)

The barn to the west
