**Lyddington Manor History Society
Historic Building Survey**

**Rose Cottage, 6 The Green
Caldecott, Rutland**

HISTORIC BUILDING SURVEY REPORT

ROSE COTTAGE, 6 THE GREEN, CALDECOTT

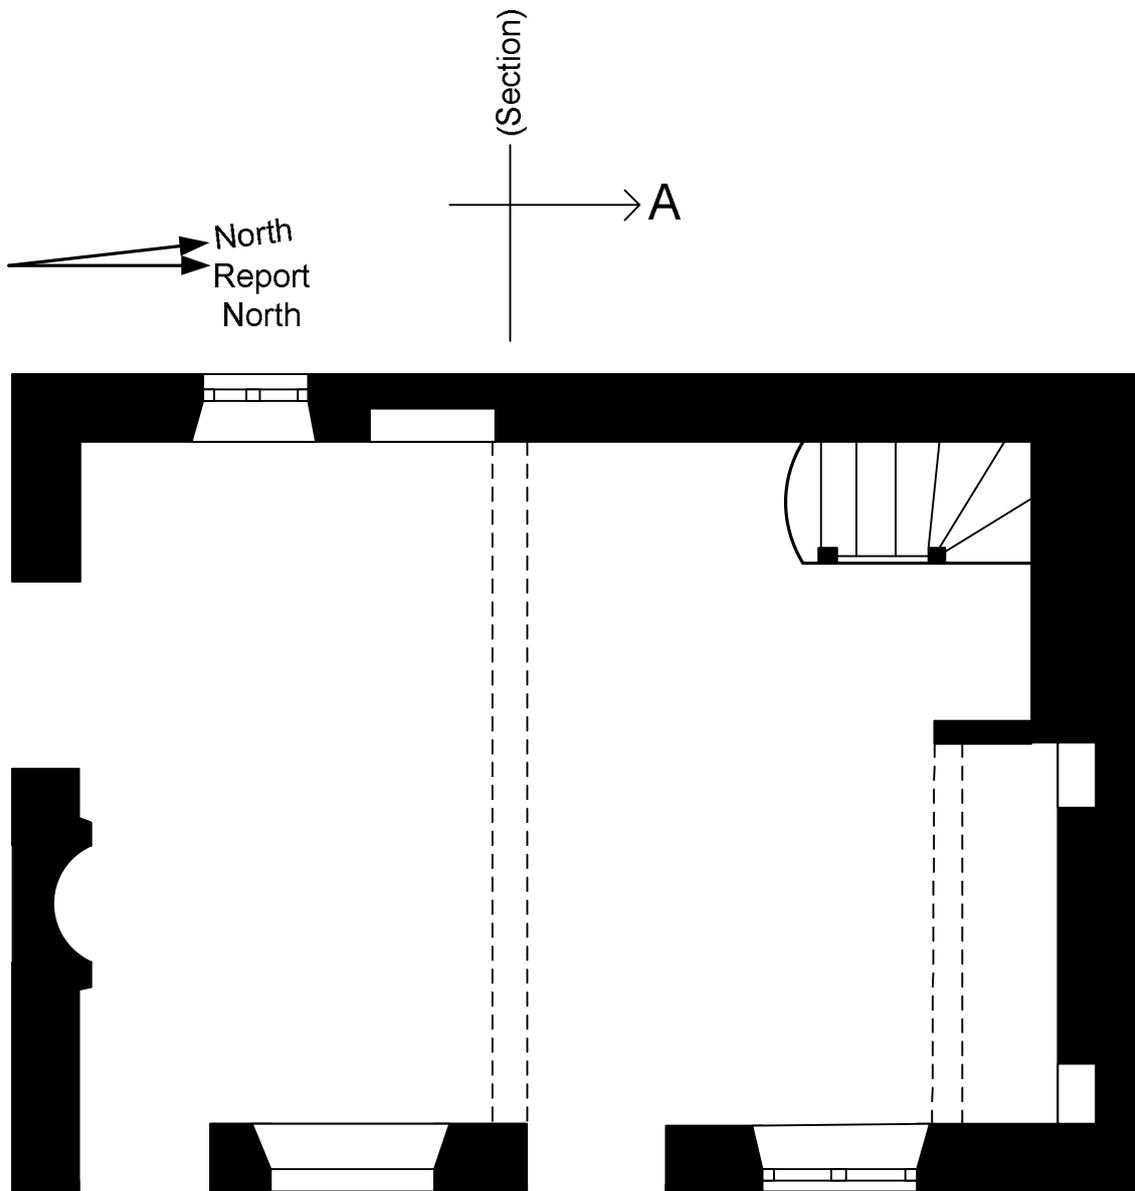
GROUND FLOOR

Compact two-room plan with central doorway, and stairs located beside the inglenook fireplace. Both the ground and first floor were divided into two rooms up to c.1980, according to former inhabitants. There was probably no doorway to the S gable until the modern French windows were inserted. The gables and ironstone quoins clearly delineate the extent of the original building. Wall thickness is c.500mm.

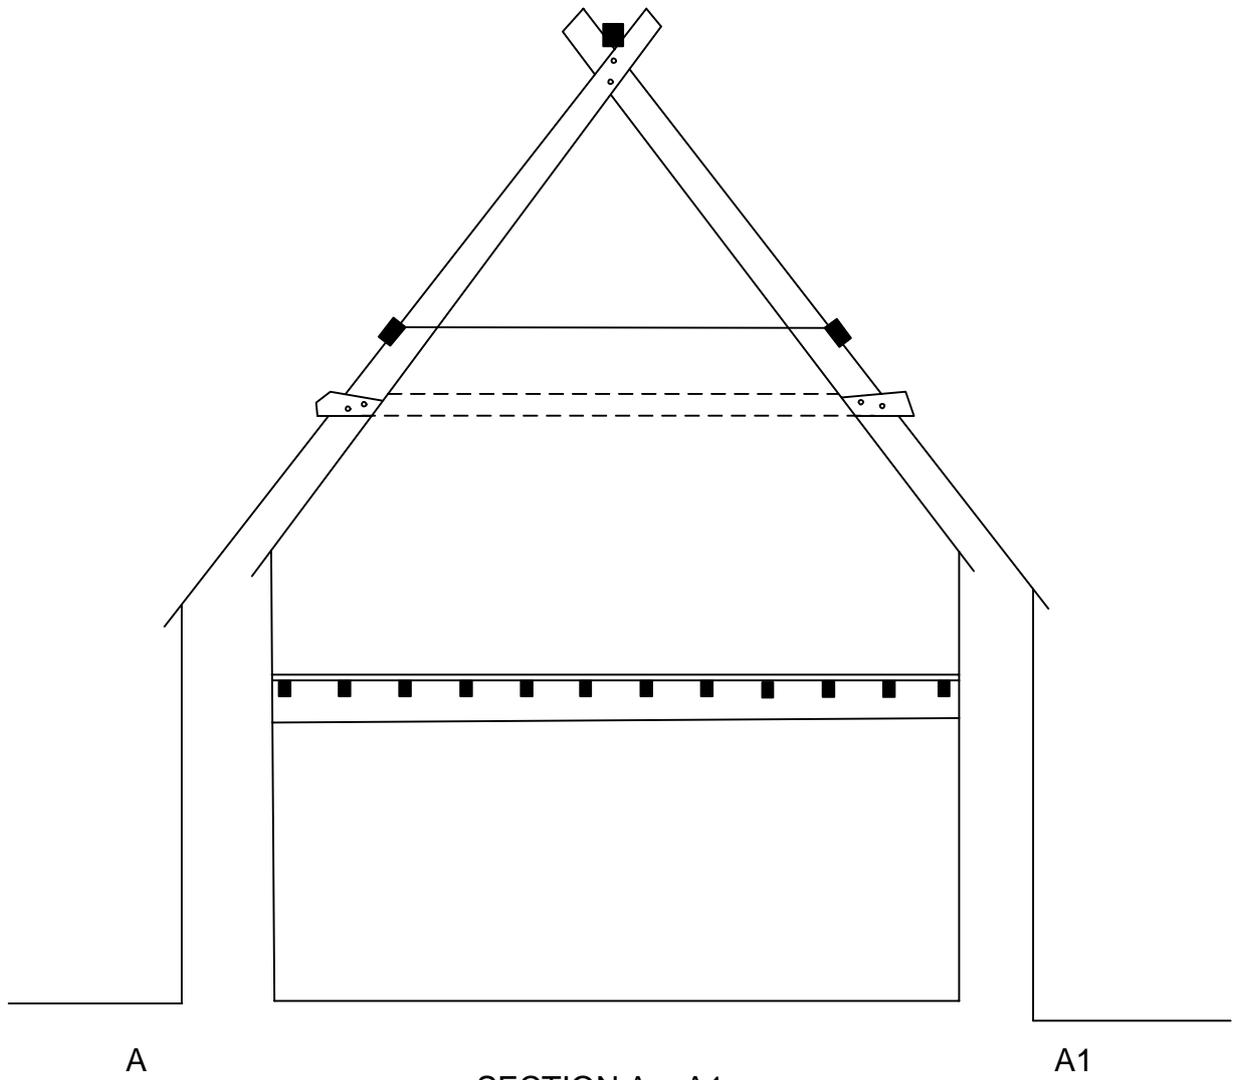
SECTION A - A1

The first floor also had two bedchambers originally, each lit by an eyebrow dormer, but the partition at the central roof truss has been removed. The slightly larger N room has the tapering chimneybreast for the inglenook below, but neither bedroom was heated. The single roof truss was of A-frame type with a dovetail-lapped collar, now cut out. The halved principal rafters rise to a scissors crossing at the apex, with skew pegs and a square-cut seating for the ridge. The purlins are slightly trenched into the back of the principals, with a pegged, straight-splayed scarf joint. The ridge is crudely trimmed with a splayed scarf joint. The carpentry is simple and plain throughout. The rafters (probably of ash pole originally) have been replaced in modern softwood.

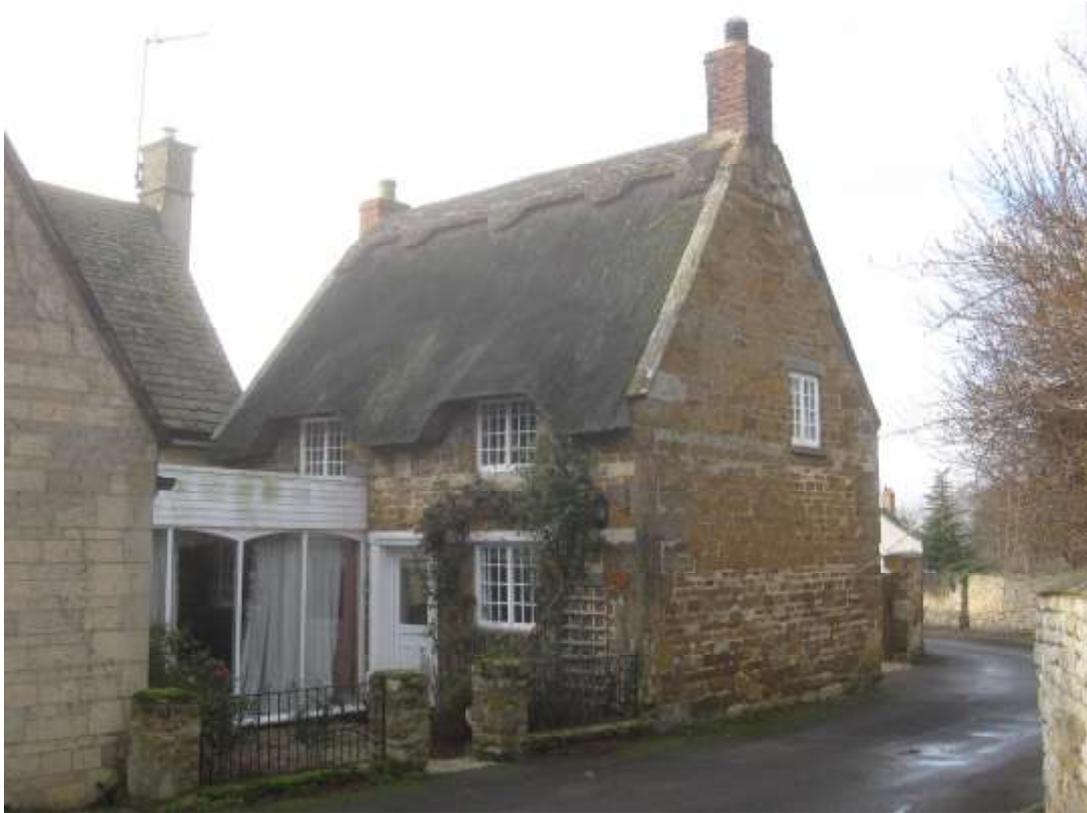
One and a half storeys originally, with two eyebrow dormers to E front. N gable has parapet with kneelers and copings, and large ironstone block dressings below. At the apex, the coping has a seating for a single stack, though the copings here are now of brick. Chimneystack of C19/20th brick. The gable window to first floor is probably a later insertion.

The E entrance front is now partly obscured by a modern extension. Limestone ashlar band course below dormer window cills, and another on the line of the ground floor window lintels. Central doorway with timber doorcase, which has bolection moulding and roundels to corners – of early C19th style, but may be of modern date. Set above the door is a limestone date-stone: WS 1887. Windows arranged symmetrically, with notched chamfered timber lintel to the visible ground floor N window. The windows have small-paned timber casements, but the central mullions have pintle hinges, which probably carried earlier iron casements with leaded lights.

View from the north-east

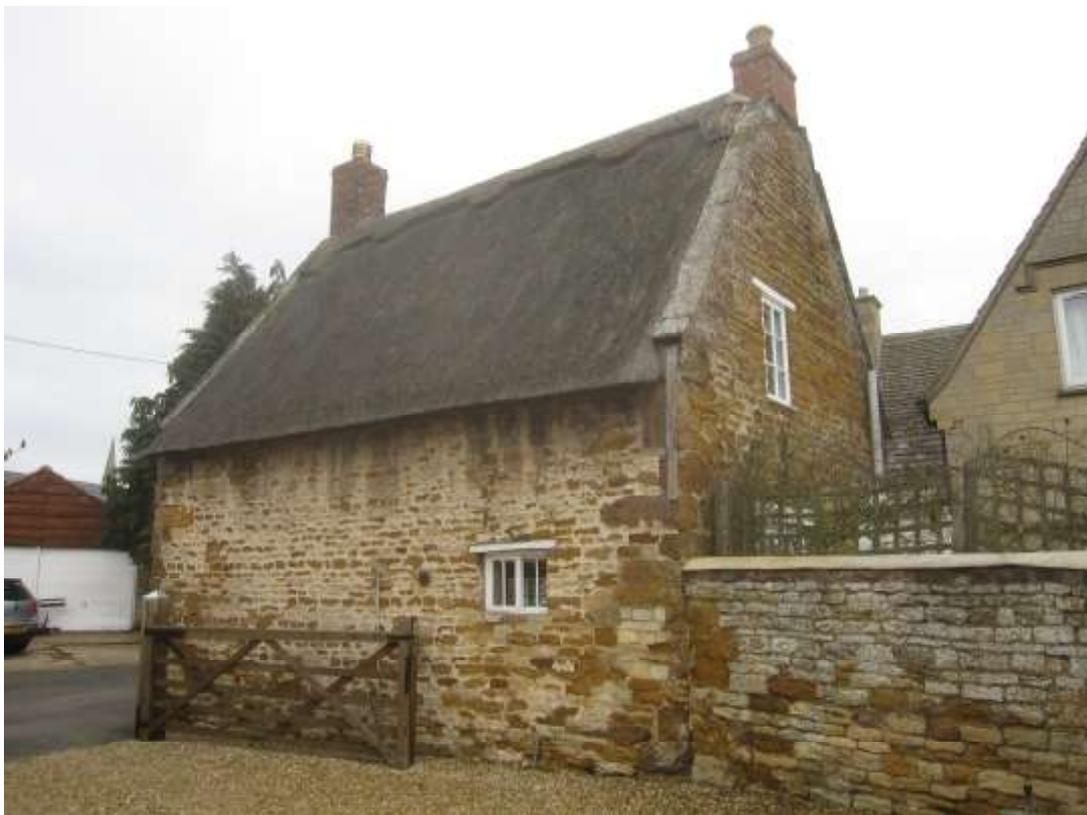
The S gable is similar to the N gable, with a gable parapet and seating for a single-flue stack, of brick. The French windows to ground floor and the first floor window are both later insertions. The rear W wall is blank except for a low Yorkshire sliding sash window to the ground floor.

View from south-west

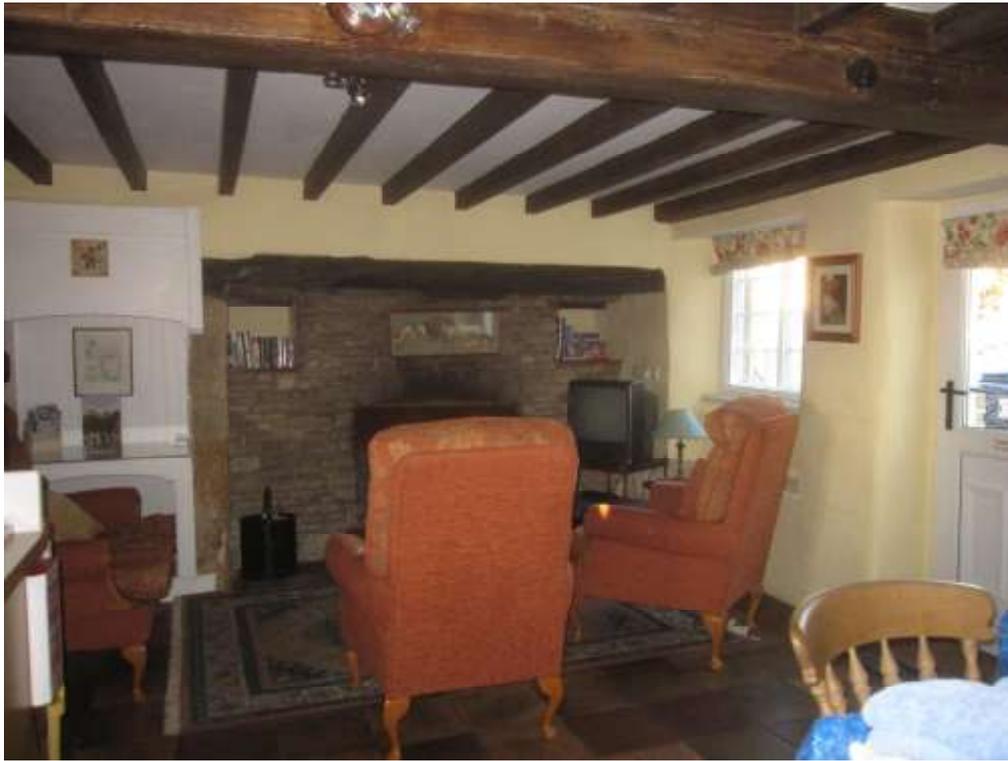
The ground floor is now a single undivided space, but would have had a partition on the line of the transverse ceiling beam. There are no mortices for a partition, which was presumably nail-fixed. The beam has a neat beaded moulding, rather than a chamfer, but may be re-used as it has some blocked mortices on its S face. The first floor joists appear to be modern replacements. The N wall has a large inglenook fireplace with a slender stone ashlar cheek wall and plain, unchamfered oak lintel. The lack of a chamfer suggests the beam was not originally exposed. There are two niches to the rear wall, and a modern stone fireplace. The front windows have deep window seats.

The main room with inglenook and transverse beam

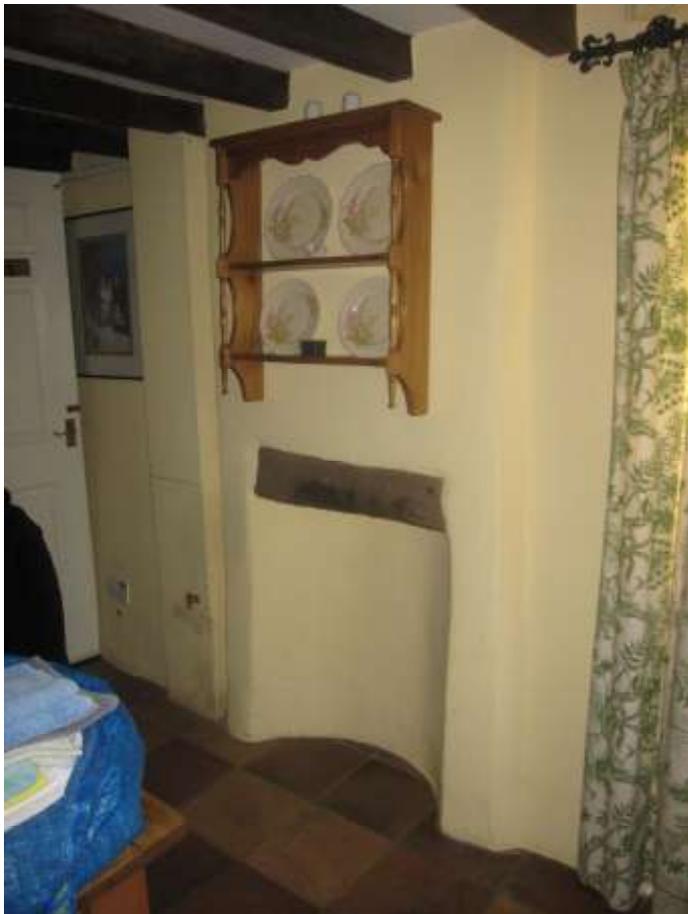
The S wall has an odd fireplace feature, with a shallow chimneybreast projection, and a small fireplace opening with a plain ironstone lintel and curved fireback. The stone lintel has several fixing holes, so there must have been some sort of surround or other fixture. It seems likely the fireplace had a grate or stove, or similar type of fitting.

The shallow chimneybreast and fireplace with curved back to the south gable

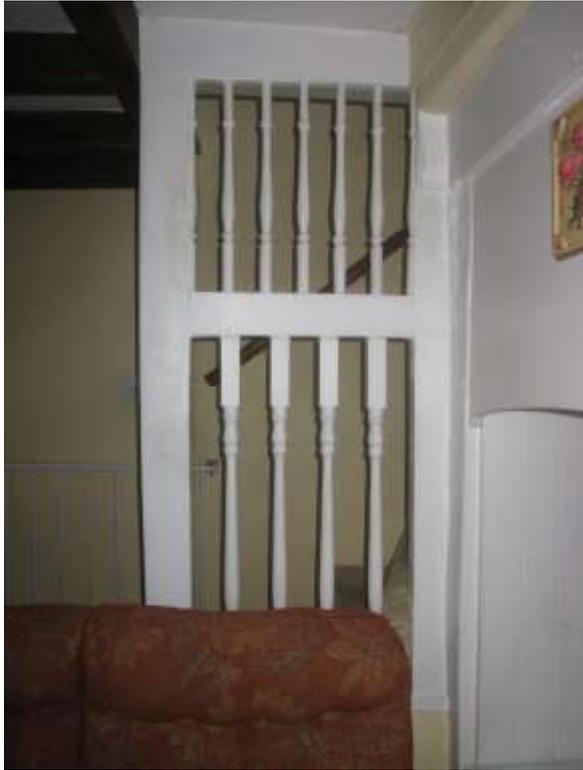
A winder stair near the inglenook leads upstairs. This has an unusual double tier of balustrading to one side. The balusters are turned and of vase type, with different patterns to the upper and lower tiers. The balustrading is well worn, and it seems likely it is in situ rather than being imported.

Double-tiered balustrading
beside the stairs

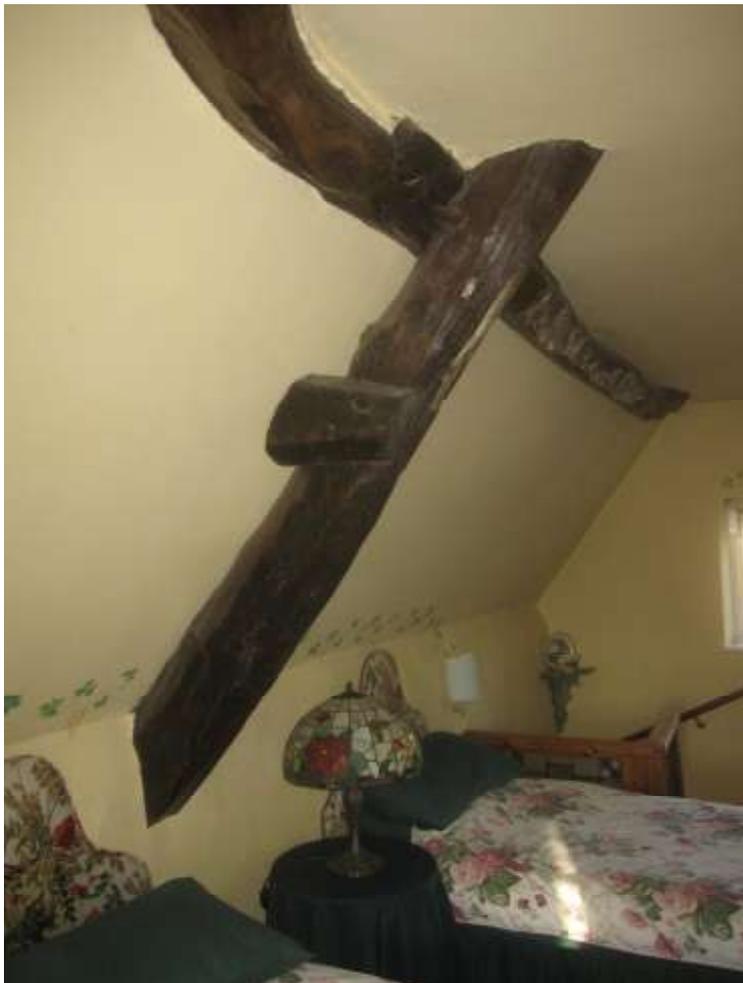
A-frame roof truss with dovetail-
lapped collar, now cut out

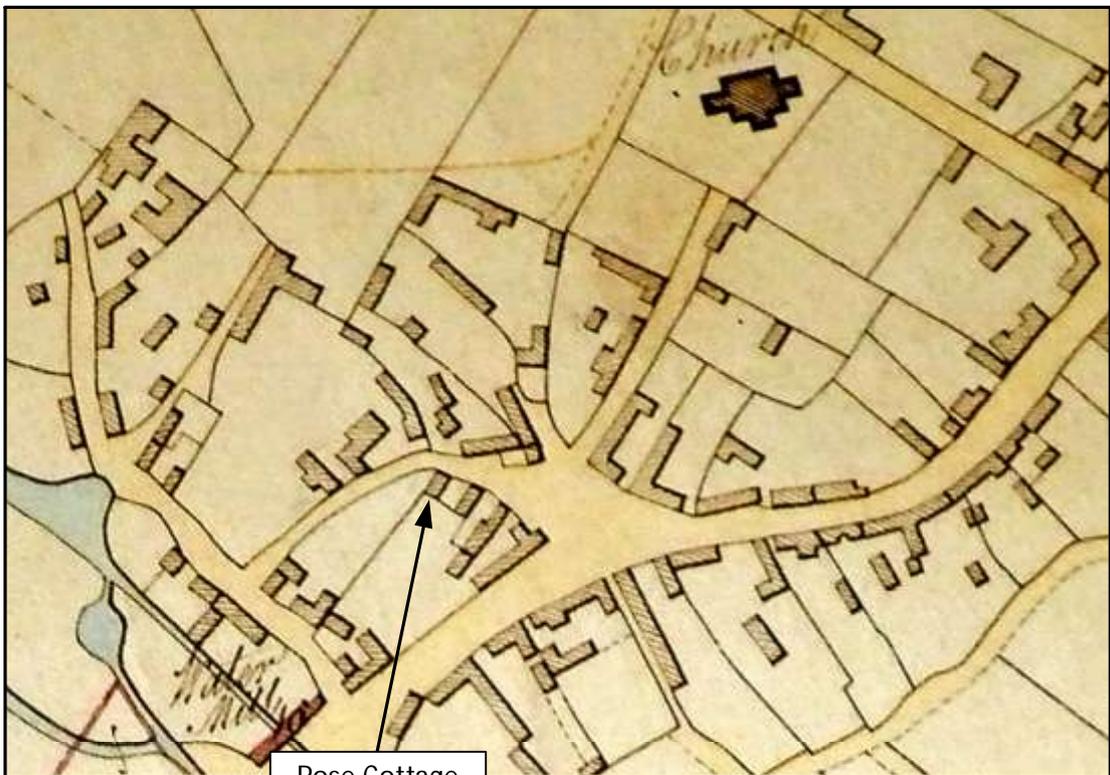
Caldecott Enclosure Map - 1800

The house is shown on the 1800 enclosure and 1886 OS maps, together with another small house to the E (now rebuilt and enlarged). The extent of the plot or associated outbuildings is unclear, and may have been very limited.
