**Lyddington Manor History Society  
Historic Building Survey**

**3 The Green  
Lyddington, Rutland**

### 3 THE GREEN, LYDDINGTON, RUTLAND

#### Summary

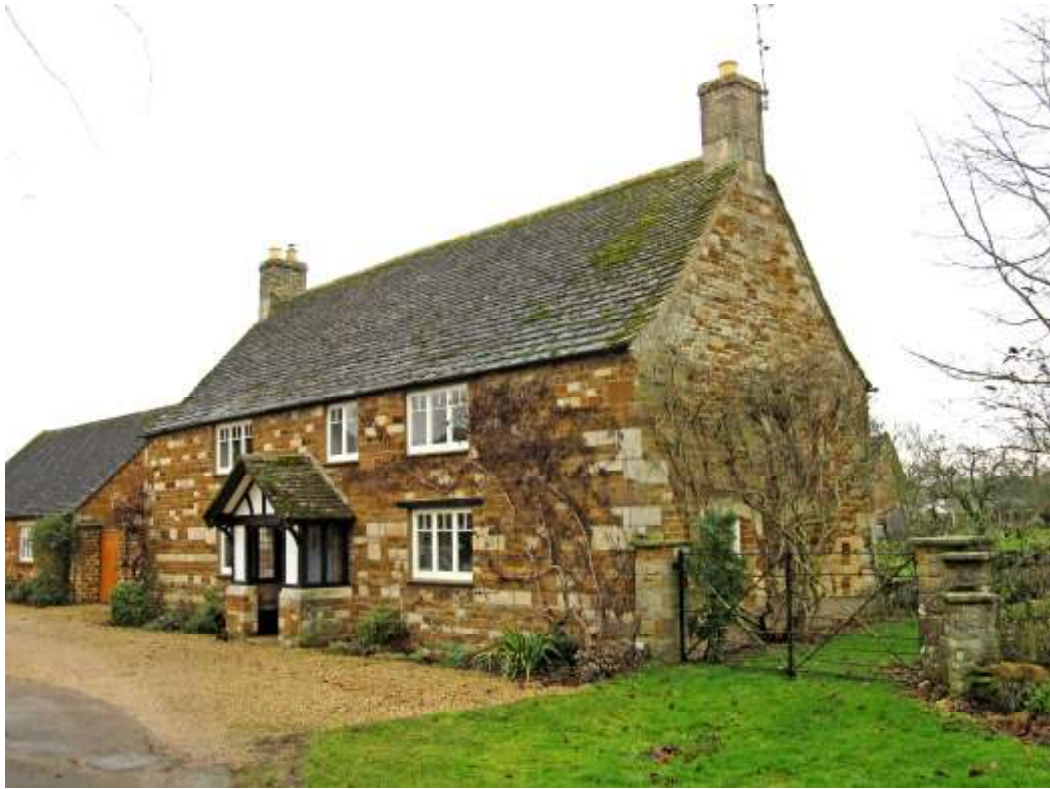
View from north-west

Front N wall of ironstone with various good limestone blocks, roughly formed plinth set quite high. Windows with timber lintels, symmetrically arranged. Modern added porch. Projecting drain chute at low level towards E end.

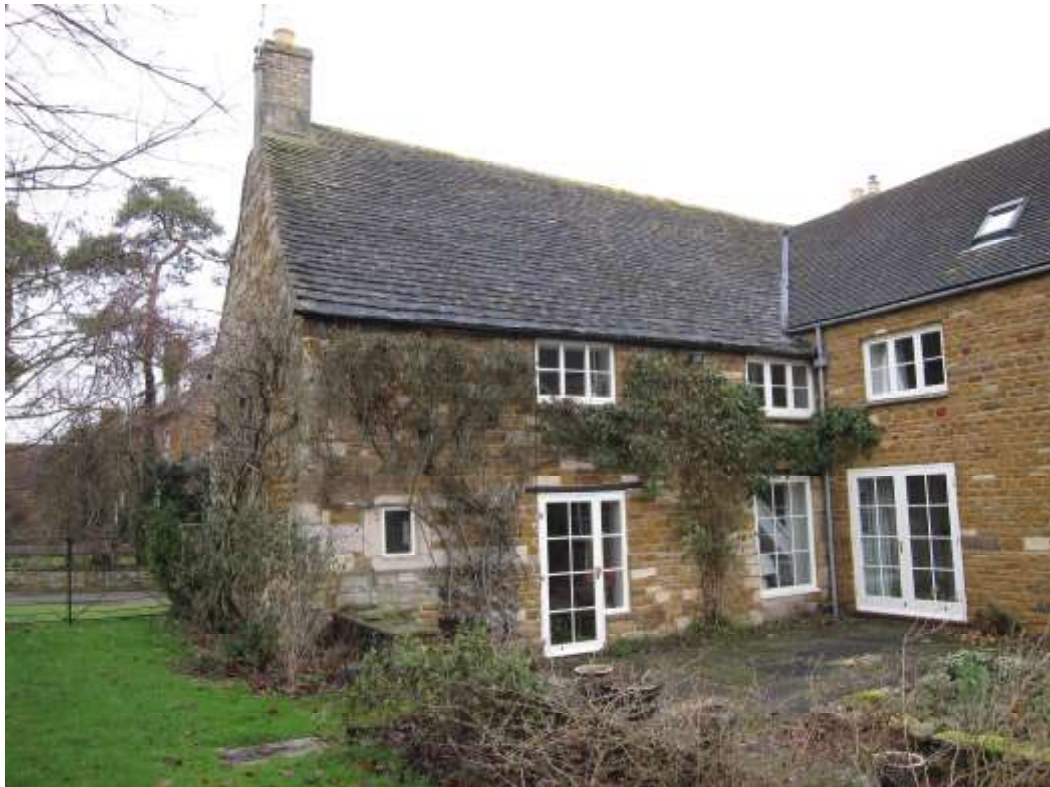
View from south-west

Rear S wall is covered by 1978 extension to E. Walling similar to front N wall, with ironstone rubble, some limestone blocks and rough high-set plinth. Symmetrically arranged windows, central door (now a window), timber lintels. Ground floor window to W has been lengthened to form a French window/door. Ingle window to W end, chamfered limestone. The former doorway has fairly continuous good limestone block jambs.

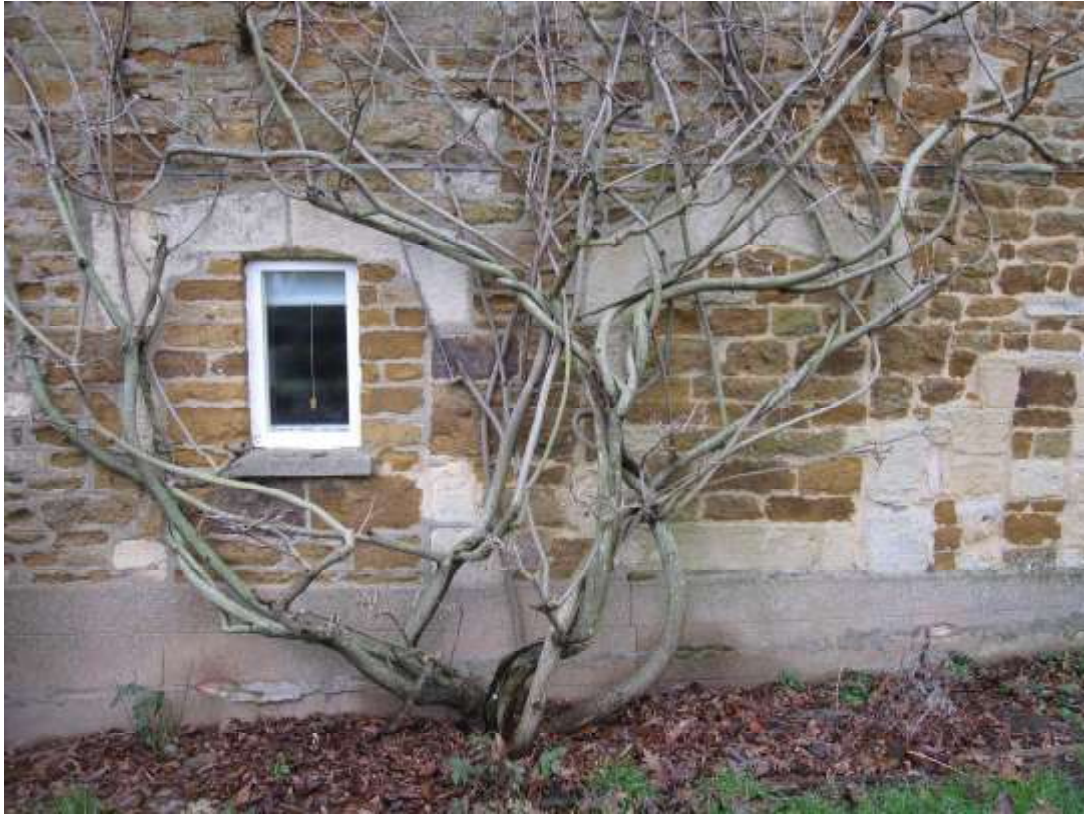
West gable with blocked medieval service doorways and slit opening to south

The west gable survives from a late medieval structure, with a characteristic pair of service doorways. Set side by side, such doorways are a standard feature of medieval houses (though a very rare survival for Rutland). They would probably have led into two service rooms (typically a buttery and pantry) on the east side of the gable wall, occupying roughly the location of the present west room. Although little of the detail of the doorways can be seen, it is evident that their front face was towards the west, finished unusually with a square edge, not chamfered. The rebates of the doors and their pintle hinges are presumably still buried in the wall thickness, with the doors opening inwards to the existing room. One would expect that the doors faced onto a cross passage, with an open hall to the west, though no evidence of this now survives. A narrow blocked opening to the right of the gable wall, set quite low down, is a strange feature – too narrow for a hatchway, and set too low for a slit window. The jamb of a former doorway above indicates that there was a first floor chamber over the service rooms, the doorway perhaps giving onto a gallery over the cross passage. The shaping of the door-heads, with a well-formed 4-centred arch, fairly steeply pitched, suggests a date around the second half of the 15<sup>th</sup> century.

W gable of coarser ironstone rubble, bands of limestone to upper part, no plinth. Good quoins of limestone/ironstone, plain verge, stack base of plain limestone ashlar, with modern brick above. Ground floor has two blocked doorways with Tudor 4-centred arch heads, each formed of two large limestone blocks, jambs of plain ironstone/limestone. The doorway detail is square-edged, not chamfered. No hood mould evidence. The doors are 950mm wide and spaced 700mm apart. The N door is slightly less tall than the S door, though ground level is now rather raised. To S, a blocked narrow 290mm opening, limestone head with square opening cut out of a single block, limestone jambs, no chamfer or moulding visible. The head is set too low for a normal window, and the jambs run on towards ground level, though disappear into render covering at lower level. At first floor level, an irregular straight joint indicates a probable former doorway towards S. Also a blocked small window opening at first floor level, probably a later insertion. The wall is only c.600mm thick – not as thick as expected for a medieval wall, so perhaps refaced to the east side.

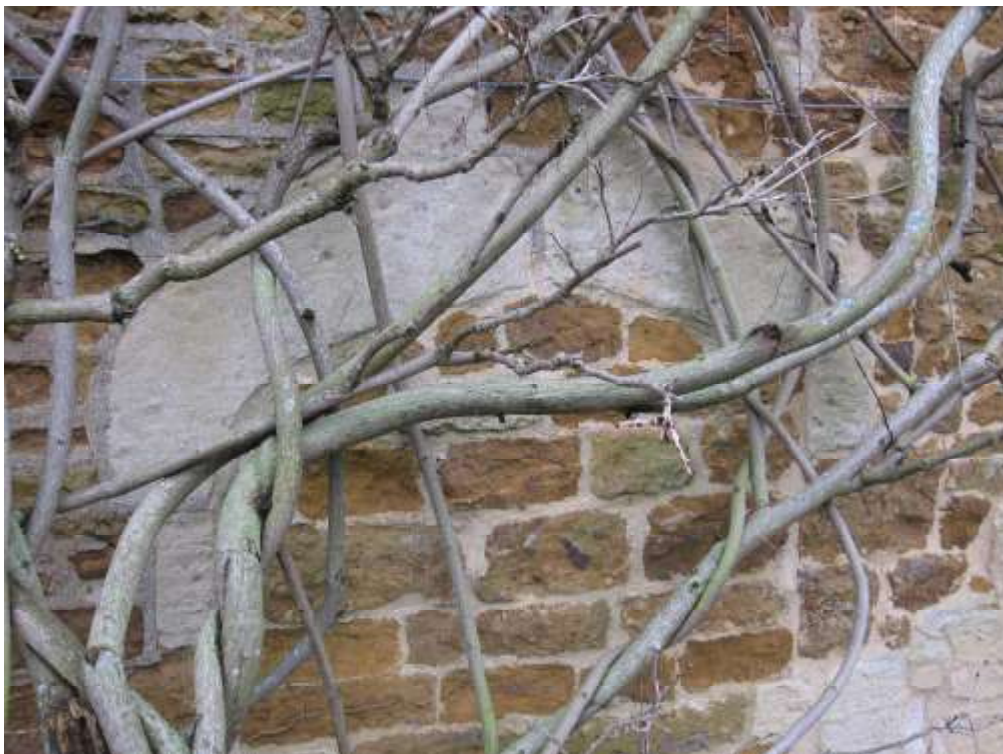
Detail of four-centred arch head to southern doorway

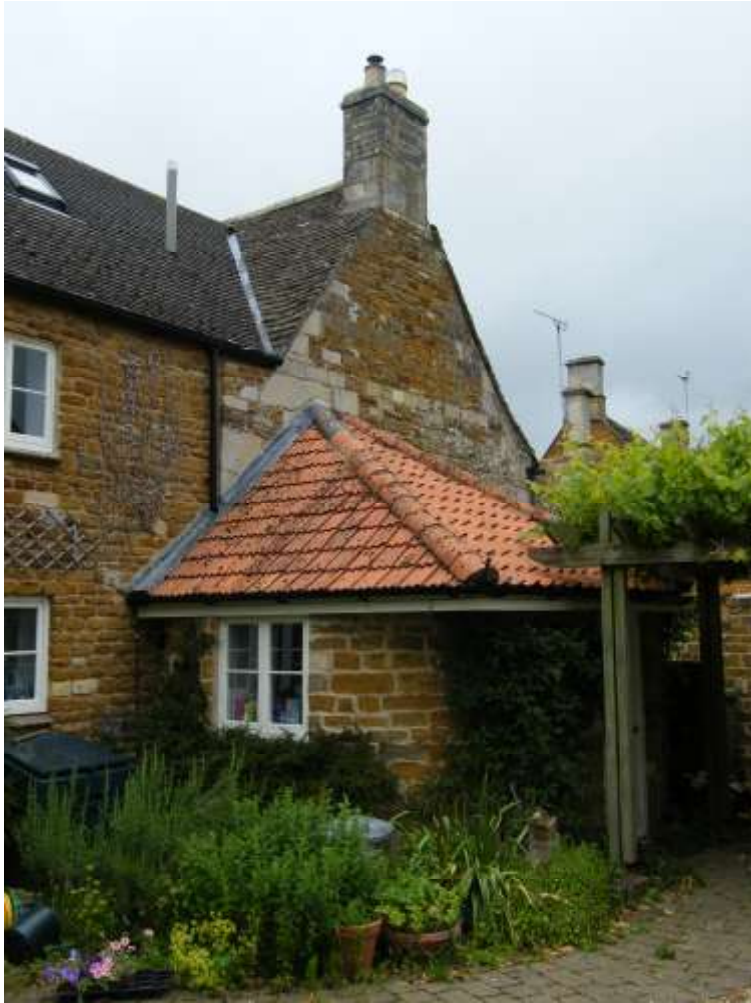
View from south-east with bake-house addition

Around the late 18<sup>th</sup> or early 19<sup>th</sup> century, a much larger and purpose-made bakehouse was added at the east end. It has walls of a rounded half-octagonal form, and a low-pitch hipped roof, which must always have been roofed with tiles, rather than Collyweston slates or thatch. The whole space would have been filled by a large round oven with a domed roof. The firing doors and oven doors would have been formed in the earlier gable wall, at the back of the inglenook recess. There would have been no other doors or windows, the current openings having been added when the oven was removed. A similar village bakehouse exists at 14 High Street, Great Easton, dated between 1810 and 1832. This also forms a large rear addition, and has a surviving large oven, though there is also a first floor store above. As a bakehouse is documented here in 1802, it seems likely that the existing bakehouse was added in the late 18<sup>th</sup> century.

The added bake-house covers part of the E gable, though it is offset to the S, projecting S beyond the main house corner. Coursed ironstone, irregular rounded corners/half octagon shape, with low-pitch lean-to hipped roof.

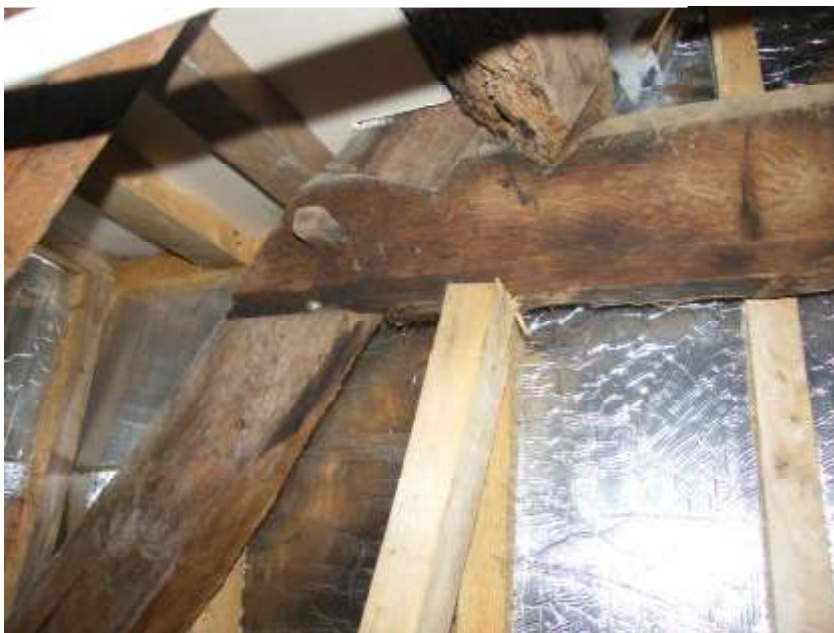
Clasped purlin truss near east gable

The second late medieval feature is the roof structure. This has been altered in recent years, and very little of the remaining structure is visible. The roof is of clasped purlin type, with rather slightly-built trusses, whose principal rafters are only a little larger than the common rafters. The collar to the truss is dovetail-lapped, not tenoned, and it appears there may have been a second collar at the apex, with a ridge beam. A similar clasped purlin roof, with light trusses and dovetail-lapped collar, has been found at 11, Stoke Road, Lyddington. The roof cannot be closely dated from surviving evidence, but probably dates from around 1450-1550. Such late medieval roof structures are very rare in the area, and most other examples have stouter trusses, with tenoned collars. Although there is smoke-blackening to some timbers, other timbers are clean. Together with the presence of at least two empty mortices, this

suggests that the roof has been heavily repaired or rebuilt. As noted above, the surviving evidence of the west gable suggests a service end with first floor chamber above, separated from an open hall to the west by a full-height stone cross wall. If this is the case, smoke-blackening would not be expected over the service rooms. It therefore seems likely that the current roof structure was built in the 17<sup>th</sup> century, re-using some timbers from a former adjoining open hall to the west.

Attic rooms inserted by previous owner in c.2000, with alterations and damage to the earlier roof. Only a very small section of the roof can currently be seen, to E end, also an oblique view of the rafter ends along the N side. . The E end has one truss and several pairs of rafters. The roof is of clasped purlin type, with common rafter couples supported by the purlin. The principal rafters (130x125mm) to the remaining truss are only slightly larger than the common rafters (110x90mm), but also have a dovetail-lapped collar (160x100mm), which supports the purlin (130x130mm). There was formerly a series of trusses with collars along the length of the building, now removed. Photographs of c.2004 from Rutland County Council indicate that there was a high-set collar at the apex and a ridge beam, also a straight-splayed scarf at a purlin joint. The carpentry is of high quality, with a chamfered collar, well-squared sawn oak timber and knife-cut setting out marks, but no visible carpenter's marks. The N principal rafter of the E truss has a sloping mortice in its E face, just beside the clasped purlin, which indicates this is a re-used timber. Another such mortice showing re-use, in the side of one rafter near the apex, is visible in a Rutland County Council photo.

The timbers have some smoke-blackening, but the pattern of this is curious. Sooting to occasional rafters, but no sooting to many others, which lie in between the sooted ones. The collar of the truss has some sooting, also the purlins, but the N principal rafter appears fairly clean, though the rafter adjoining it to the E is quite heavily sooted. It could be that sooting has disappeared from some areas, or that later repair timbers have been inserted. But the most likely explanation, taken together with the two mortices identified of re-used timber, is that the roof timbers are re-used from an earlier, late medieval roof, incorporating some new (unsooted) timber.
