CORBY WORKS SERVICE RESERVOIR
1940.

CORBY WORKS SERVICE RESERVOIR 1940
General View.

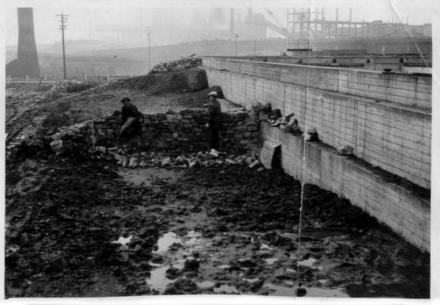
Showing mass concrete construction. Wall thickened at deeper depths, and sloping dry stone toes.

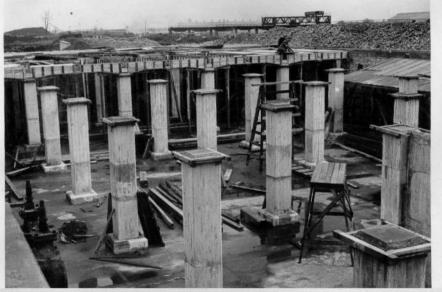
Pillar supports, also showing beam to carry roof

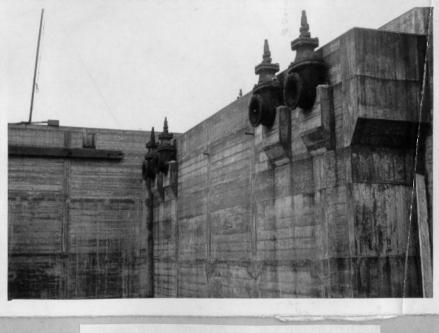
9"Sluice valves, before ball valves are added.

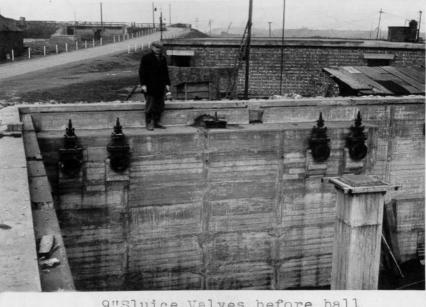
9"Sluice Valves, before ball valves are added.
Mr.Simpson, Clerk of Works.

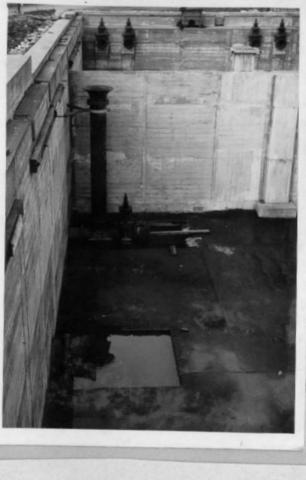
Service Reservoir showing four, inlet valves and overflow.

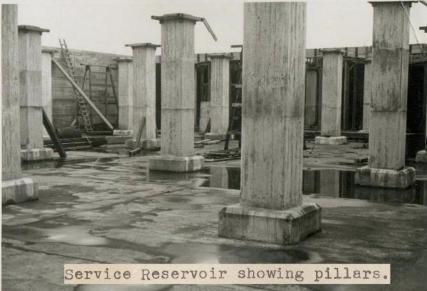
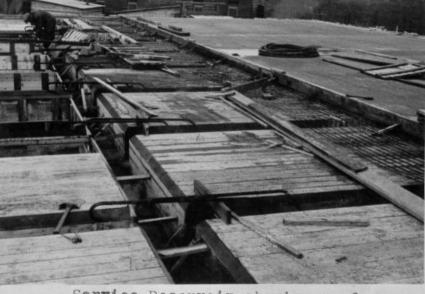
Service Reservoir showing roof.
1940.
